Wetland Mitigation Bank at Pond 20 and Port Master Plan Amendment

Draft Environmental Impact Report

Appendix J. Phase I Environmental Site Assessment

SUBJECT: Phase I Environmental Site Assessment
San Diego Unified Port District
Salt Pond 20, Approximately 90 Acres
Assessor Parcel Numbers: 615-020-(08/12), 616-021-08,
616-021-09 (portion) and 621-020-(04/08)
San Diego, San Diego County, California

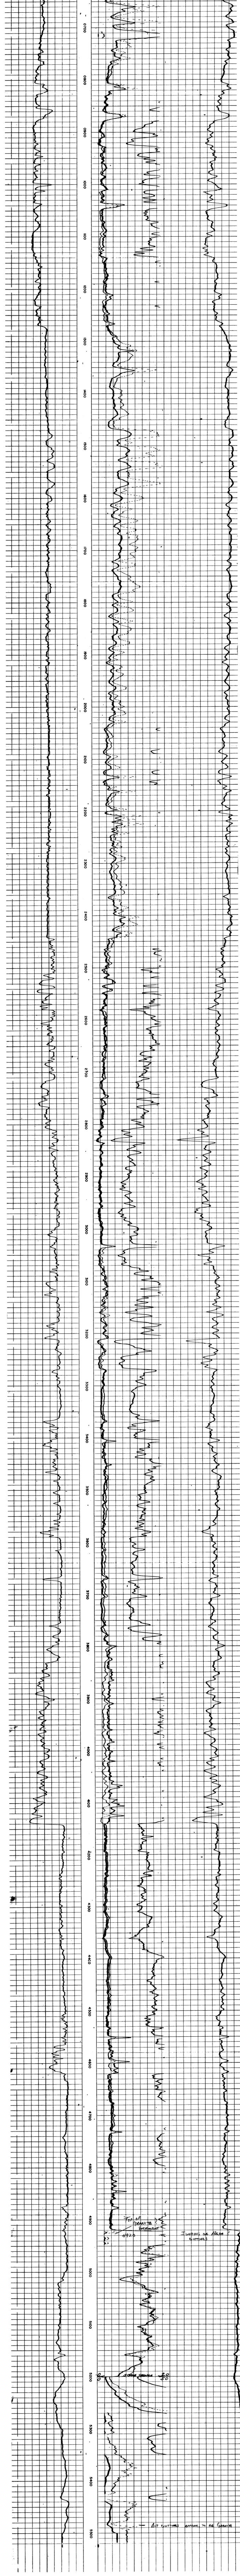
SPONTANEOUS-POTENTIAL millivolts	RESISTIVITY ohms. m ² /m	CONDUCTIVITY millimhos/m = $\frac{1000}{\text{ohms. m}^2/\text{m}}$
	16" NORMAL	INDUCTION

DEPTH	RESISTIVITY	CONDUCTIVITY
0	200	1000
0	200	2000
0	20	
0	200

For an GRANITE BASEMENT
 4920
 5000
 5050
 5100
 5150
 5179
 All cuttings appear to be Granite

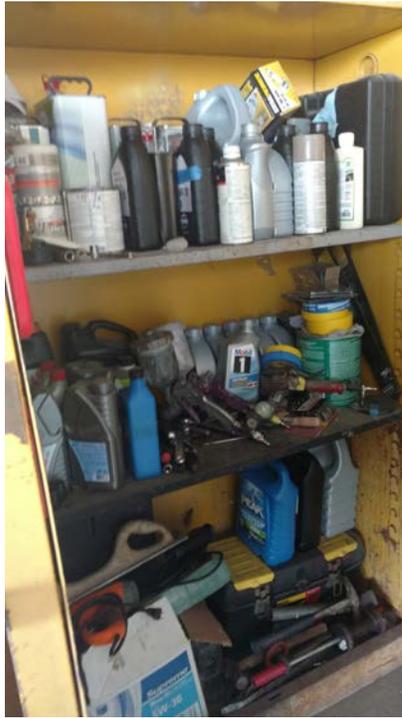
Photograph 3 - Looking north at miscellaneous auto-related materials stored in hazardous material cabinet in VMT Auto Sales storage area.

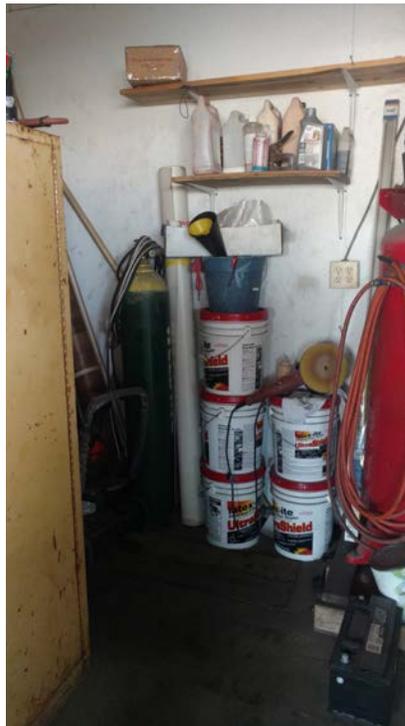
Photograph 4 - Looking east at additional materials (asphalt crack sealant) located in VMT Auto Sales storage area.

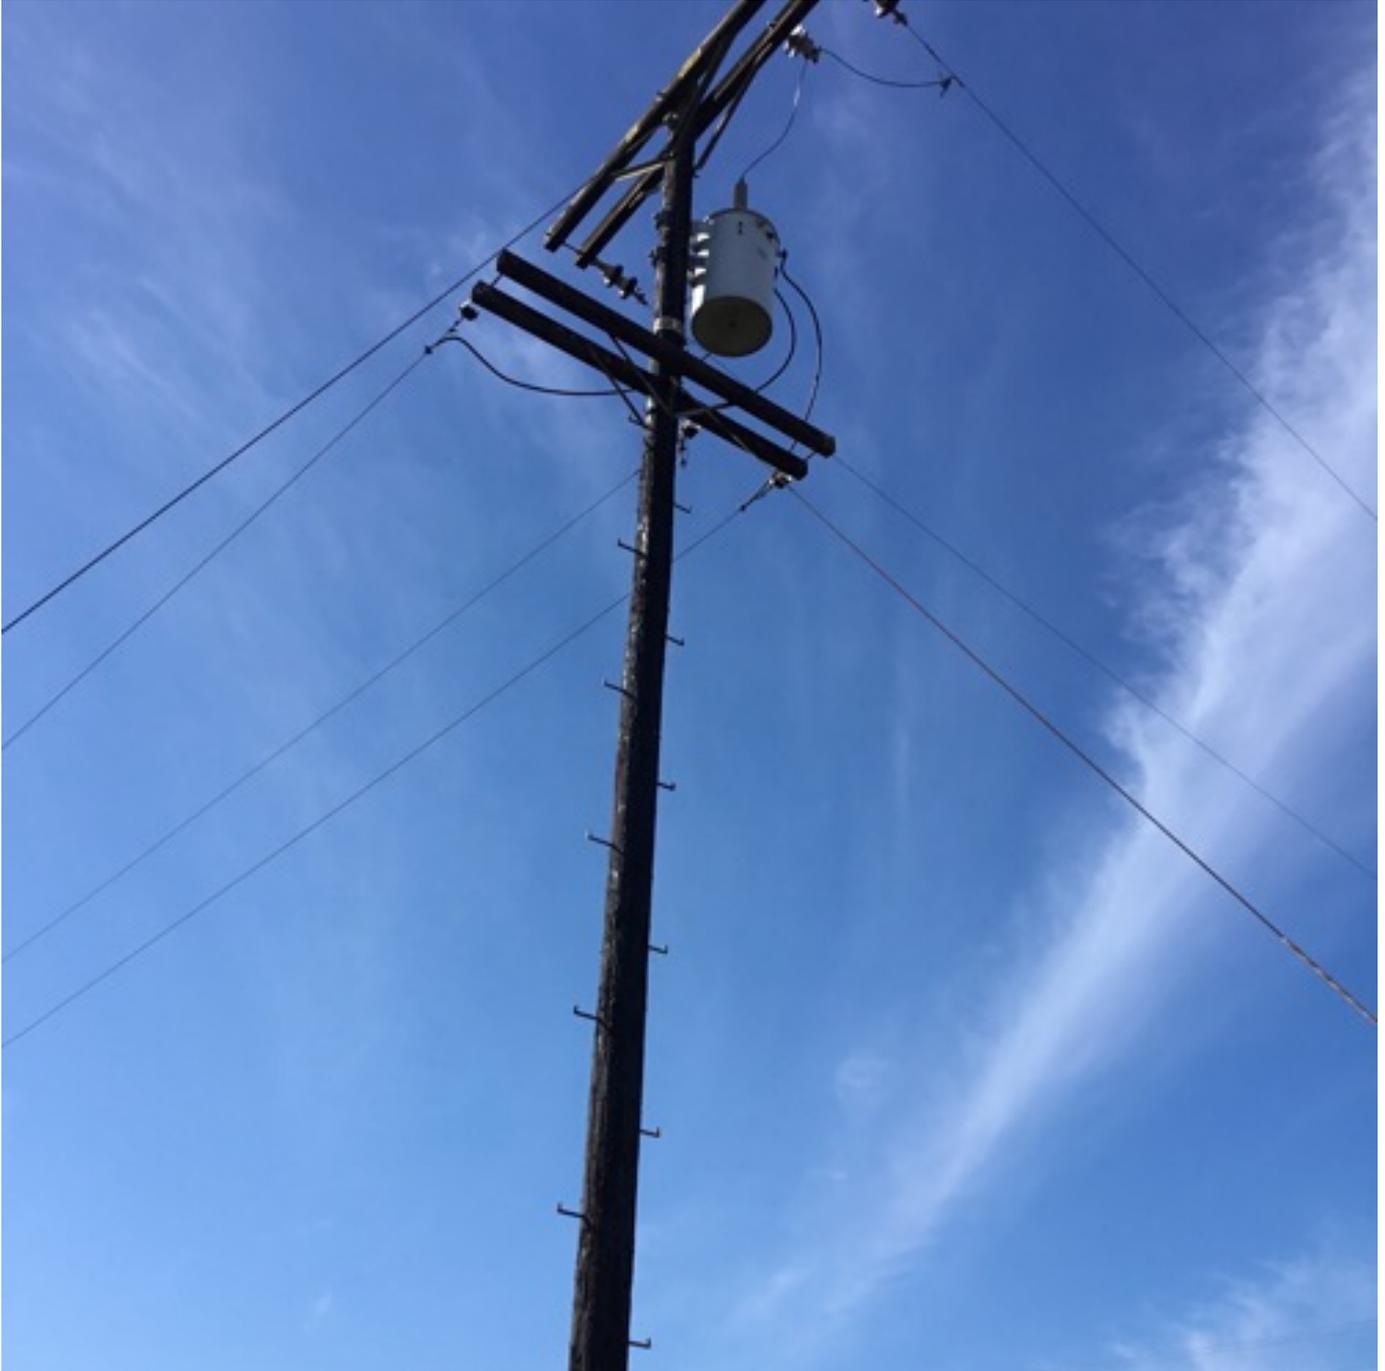
Transformer located on parcel nearest mobile home park community. No staining was observed on ground

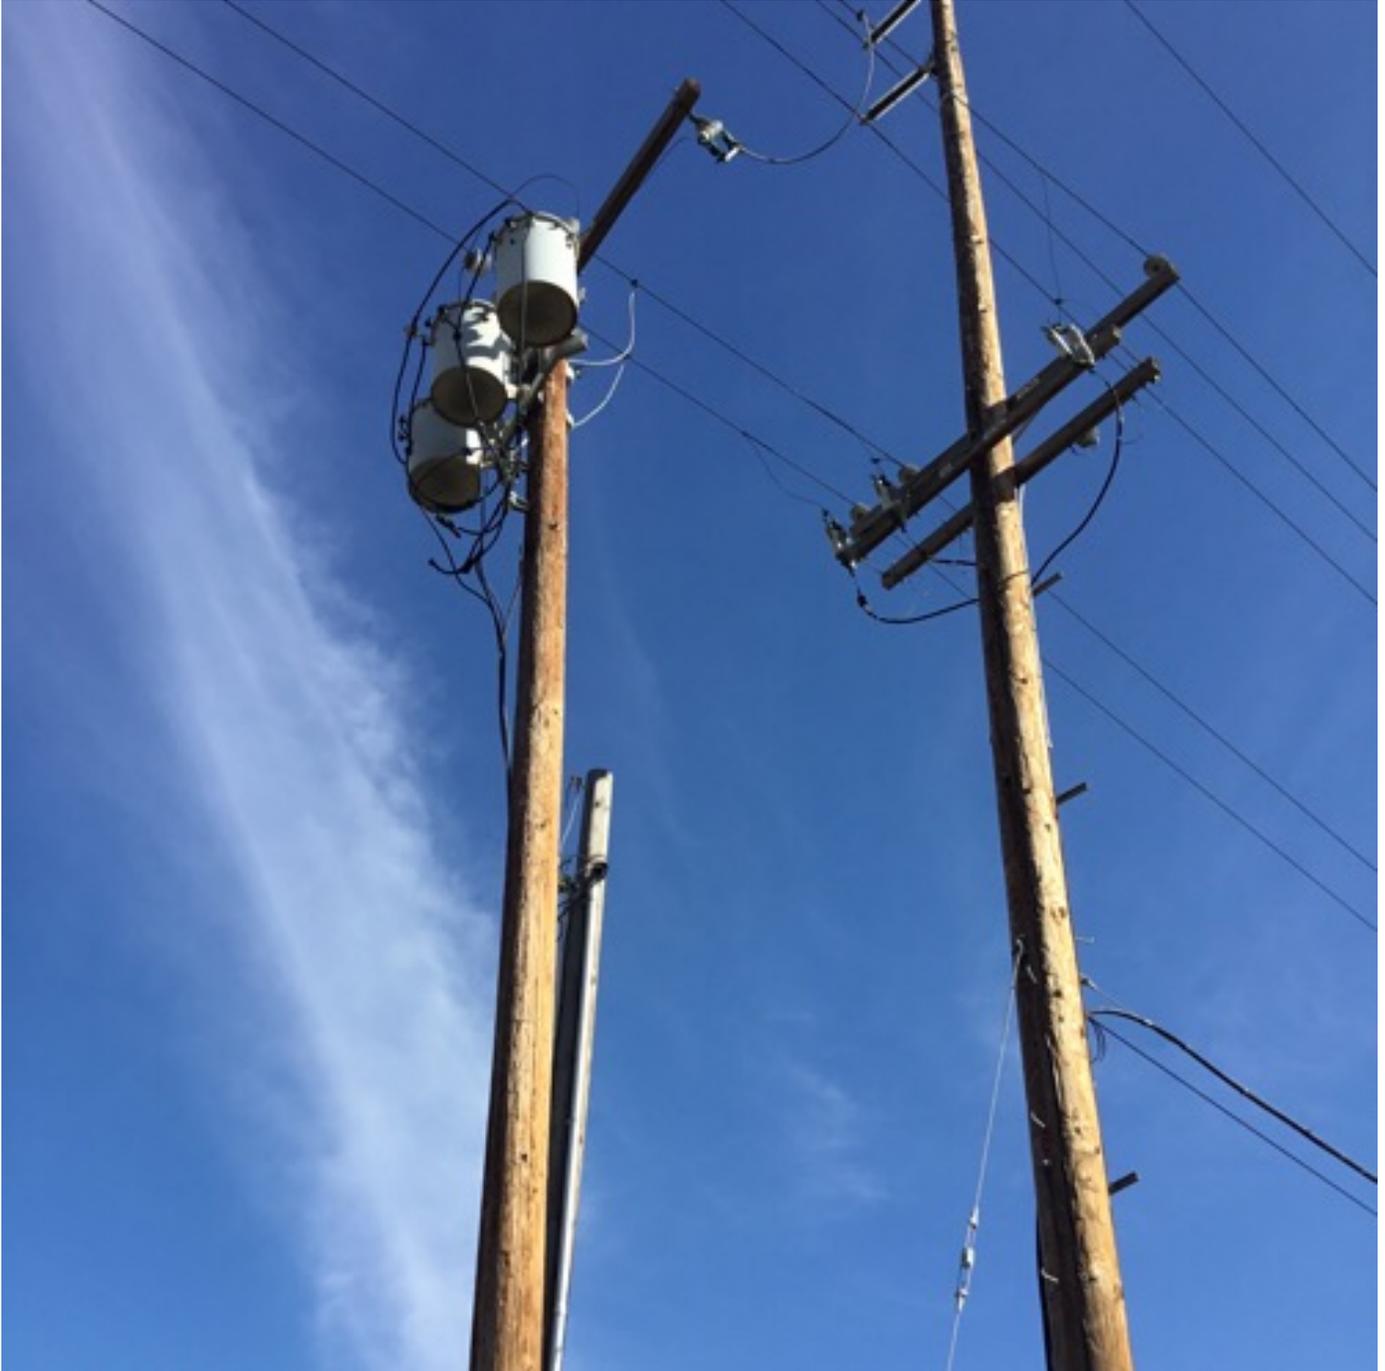
View of transformers located on access road to pump house. No staining was observed on soil around pole

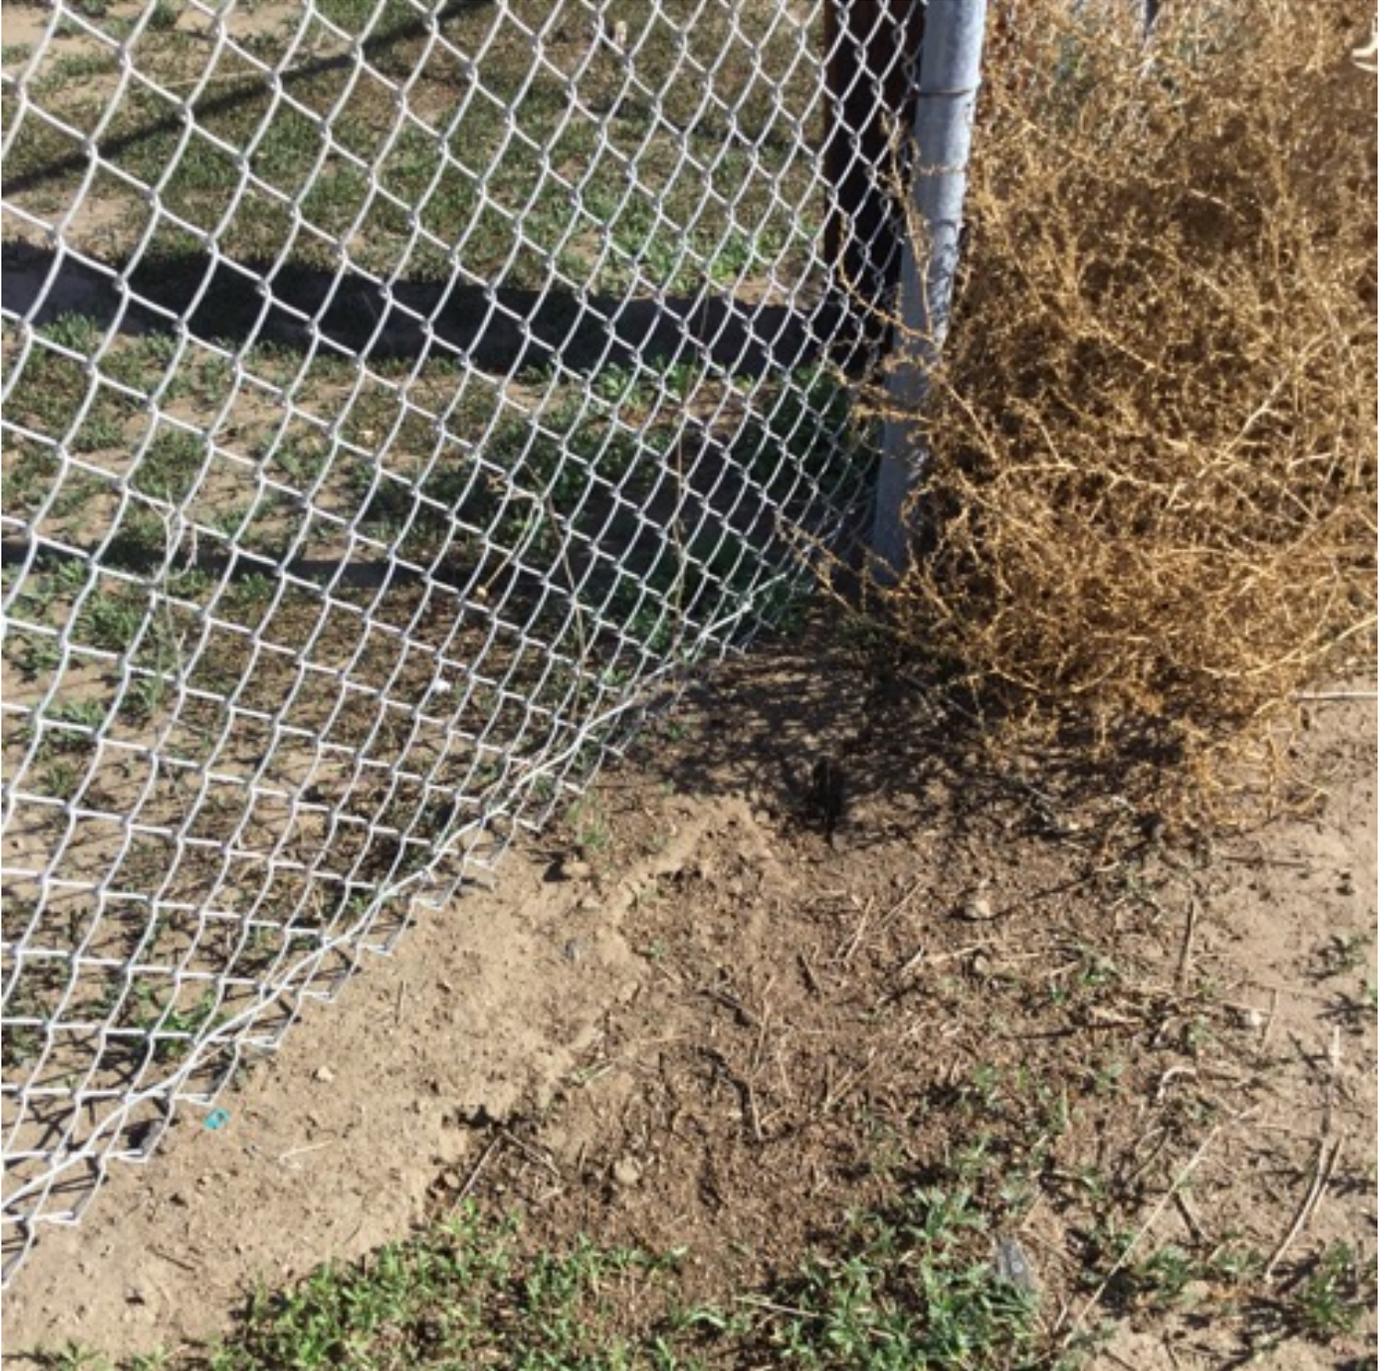
No staining on ground. See previous photo for comments

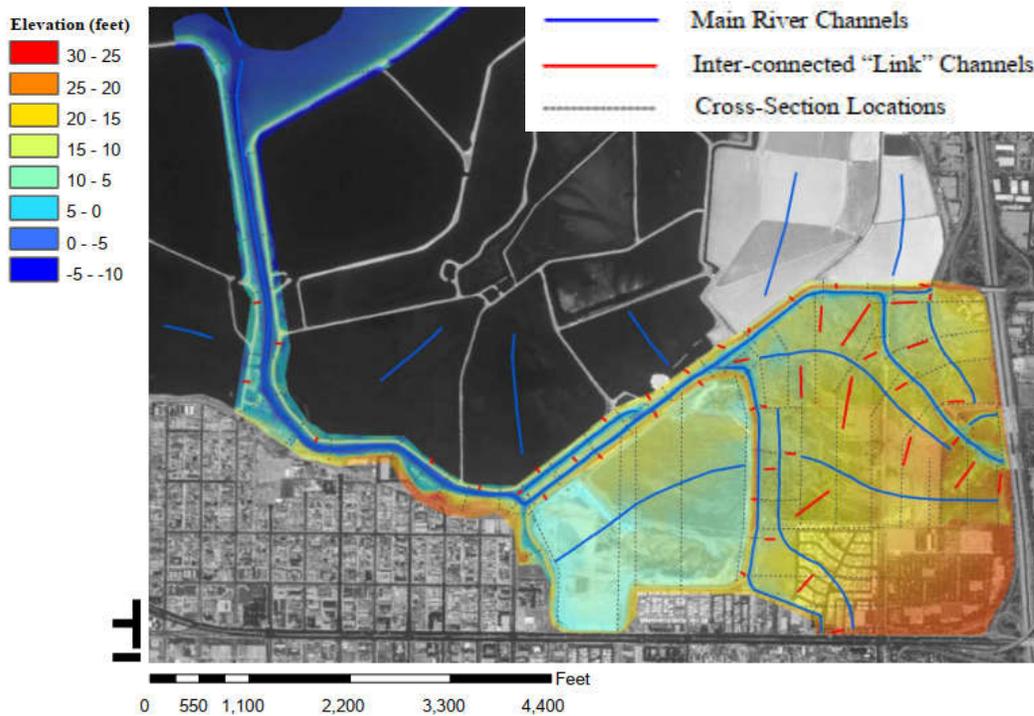
PWA developed a one-dimensional MIKE11 model to represent existing and project conditions. The model included the Lower Otay River, Nestor Creek, and South San Diego Bay (**Figure 1-3**).

SOURCE: PWA 2003
 NOTE: All elevations are in NAVD

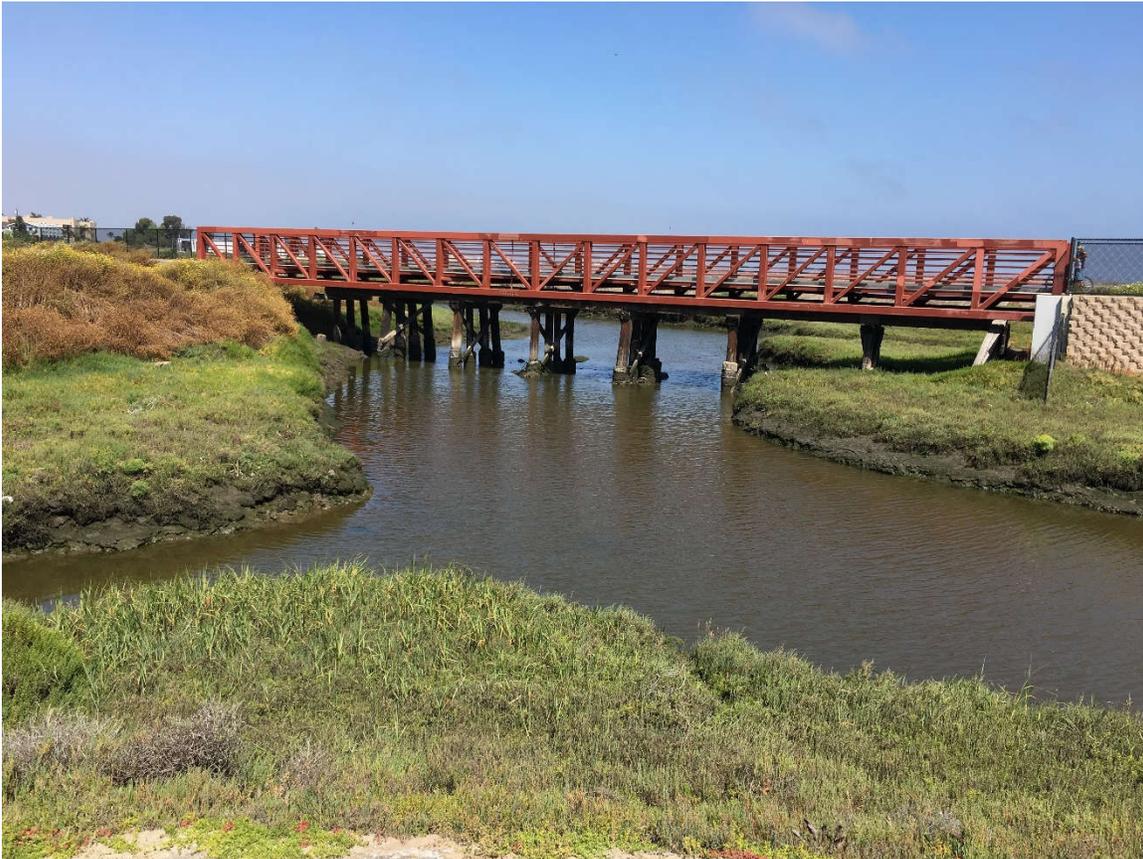
The Bayshore Bikeway bridge that crosses the Otay River (Figure 2-1) is shown in **Figure 2-3** and referred to as the “South Pedestrian Bridge,” throughout this report. The bridge geometry was developed based on available as-builts, field photos, aerial imagery, and model terrain. The bridge is supported by concrete footings at either end of the bridge. Piers from the historic railroad bridge that crossed the river in the same location remain under the South Pedestrian Bridge, but they do not support the bridge.

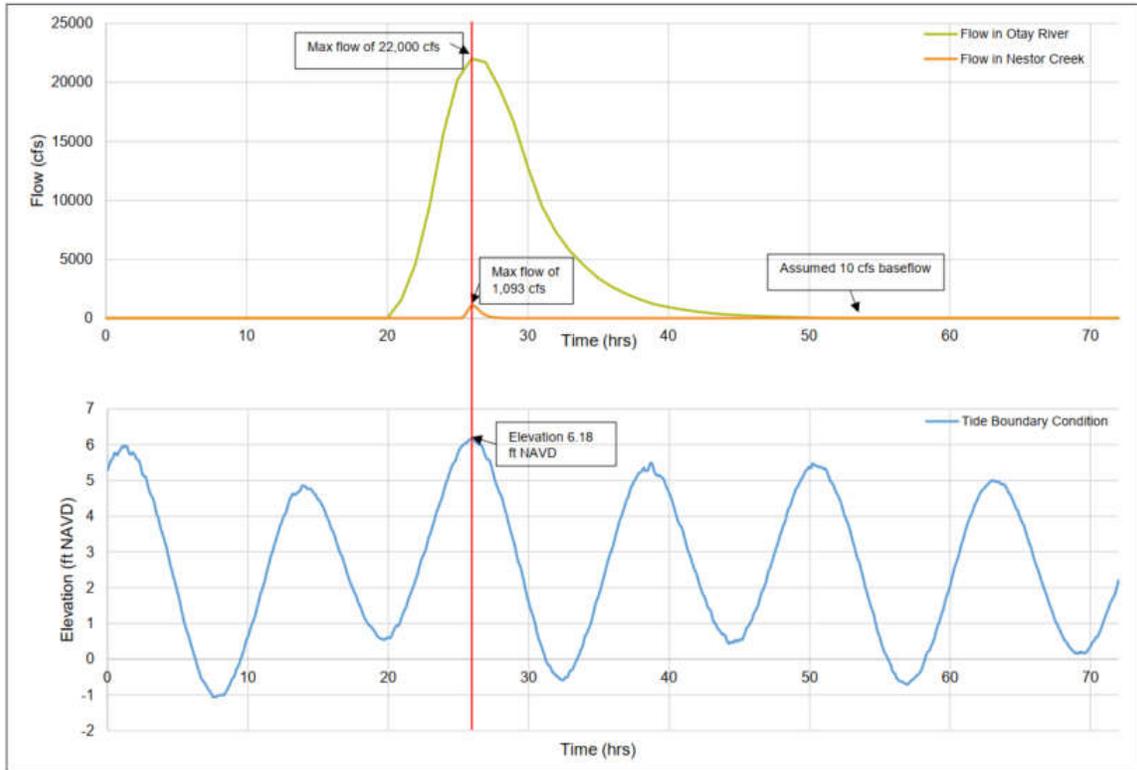
For the storm event model runs, the tide cycle was shortened to a 36-hour period, including the 6.2 ft NAVD high tide, to reduce model times. The peaks of the 10- and 100-year Otay River and Nestor Creek flood discharge hydrographs were set to coincide with the 6.2 ft NAVD high tide as shown in Figure 2-7. For the scour model runs, the peaks of the 100-year flood discharge hydrographs were set to coincide with a -1.3 ft NAVD low tide.

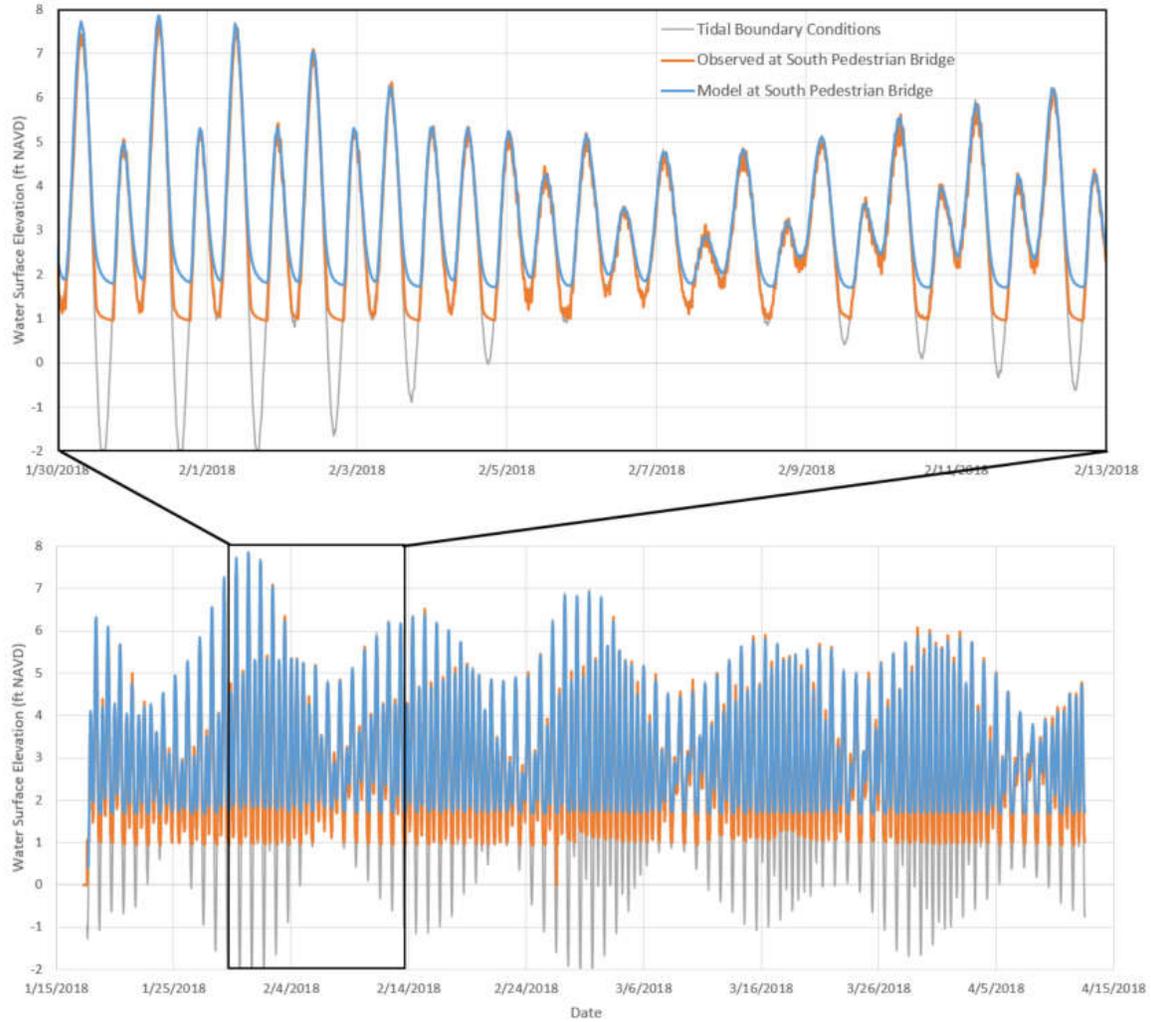
Figure 3-1
Modeled Water Levels at the South Pedestrian
Bridge Compared to Observed Water Levels

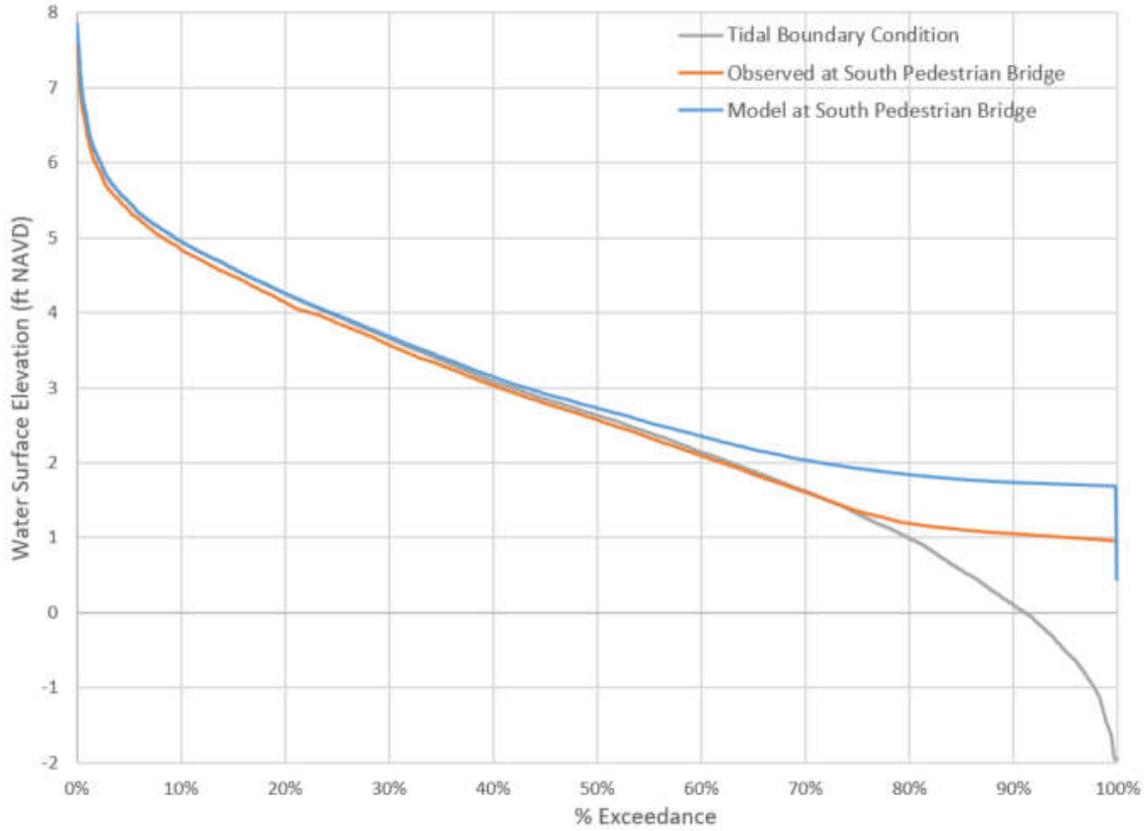
Figure 3-2
Percent Exceedance Curve of Modeled Water Levels at the South Pedestrian Bridge Compared to Observed Water Levels

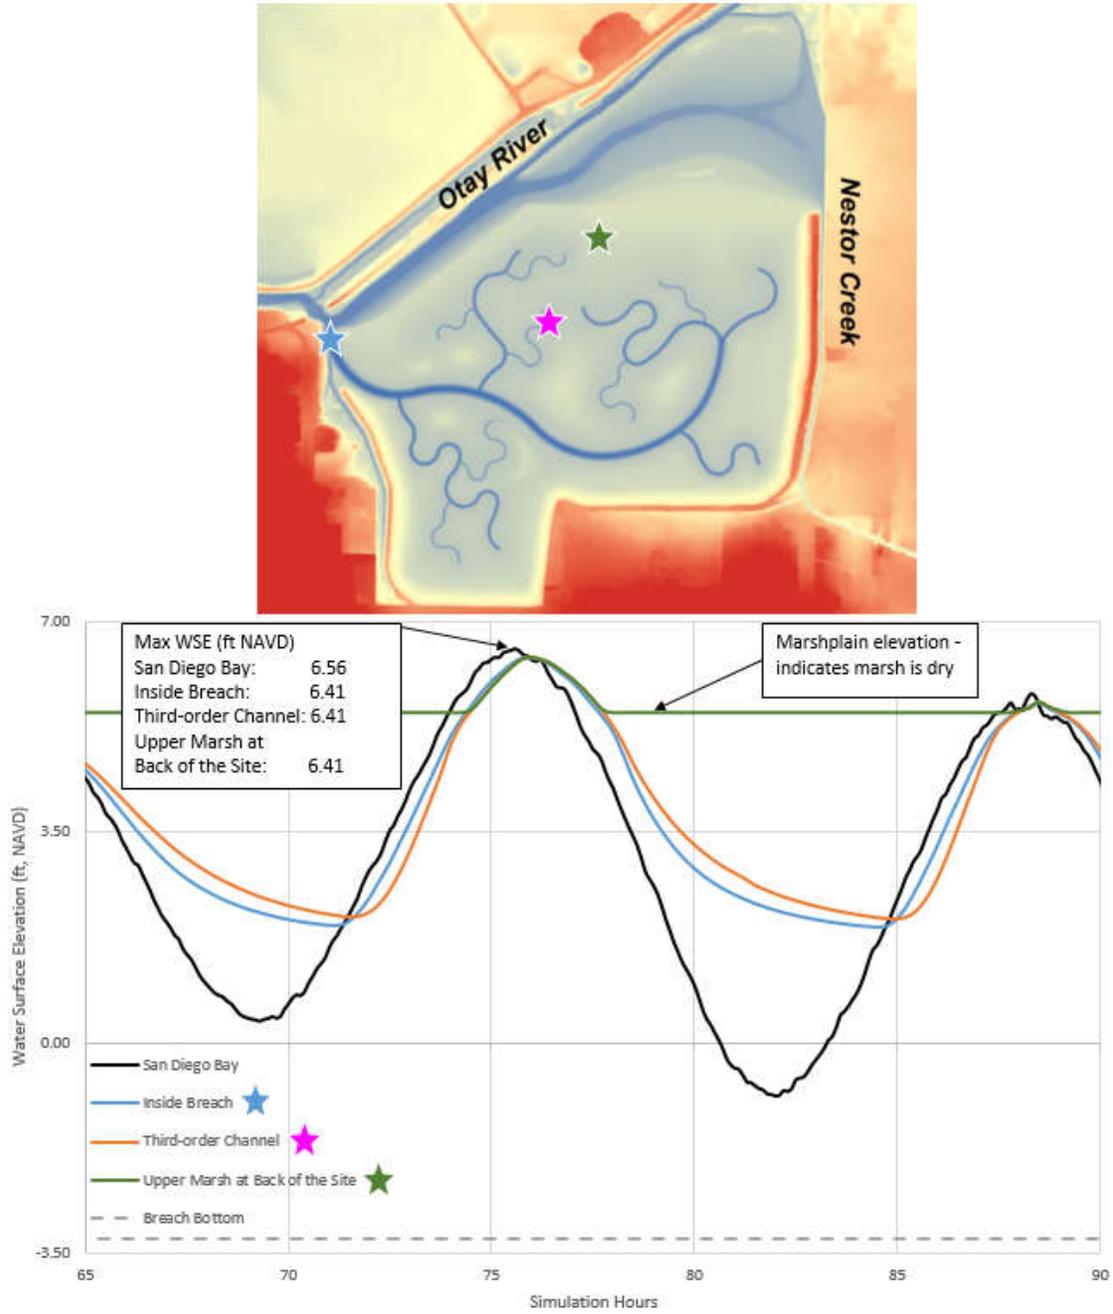
Water levels within the Pond 20 site were also analyzed to evaluate any tidal muting across the floodplain. **Figure 3-4** shows modeled water levels at various locations at the Pond 20 site under Project Conditions. The model results show there is very minimal tidal muting across the marsh.

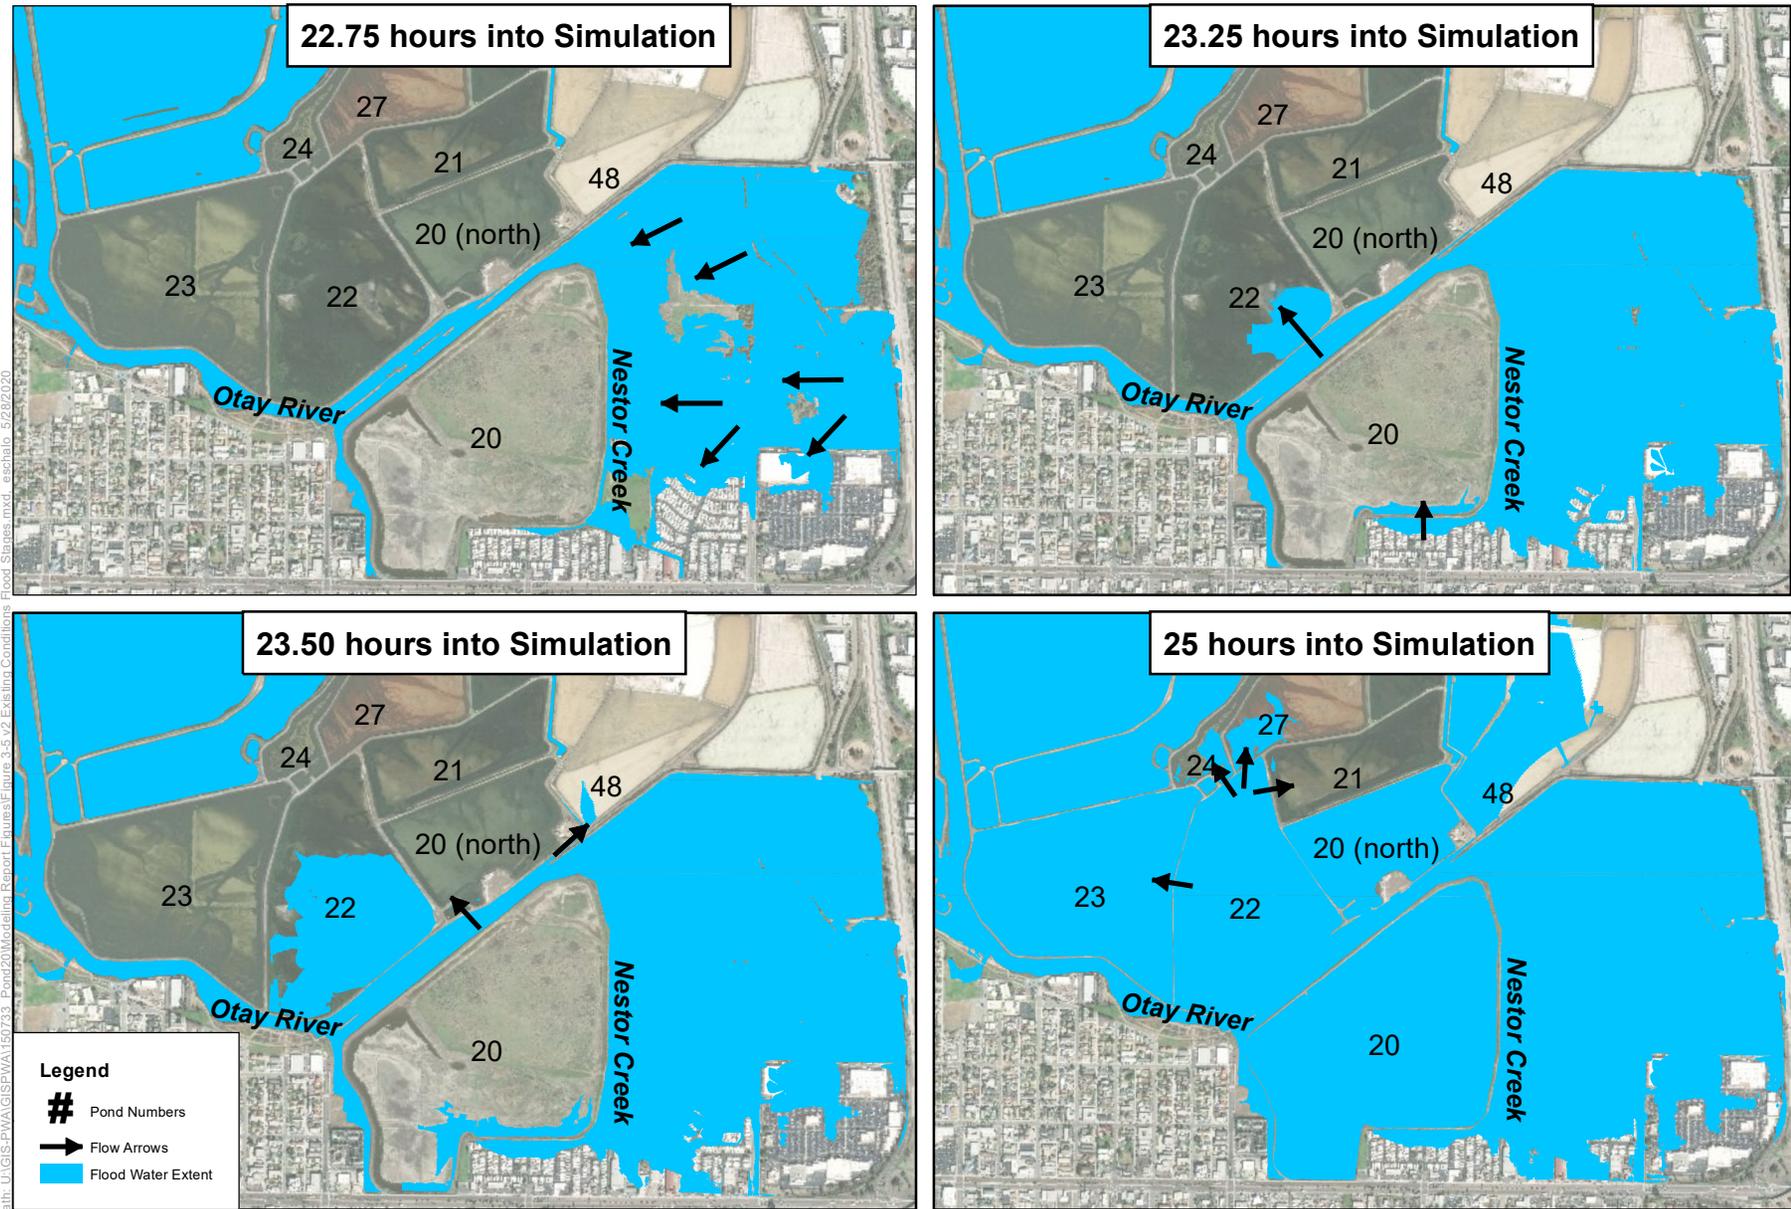
Mitigation Banking at Pond 20. D150733
Figure 3-5
 Existing Conditions Flood Stages

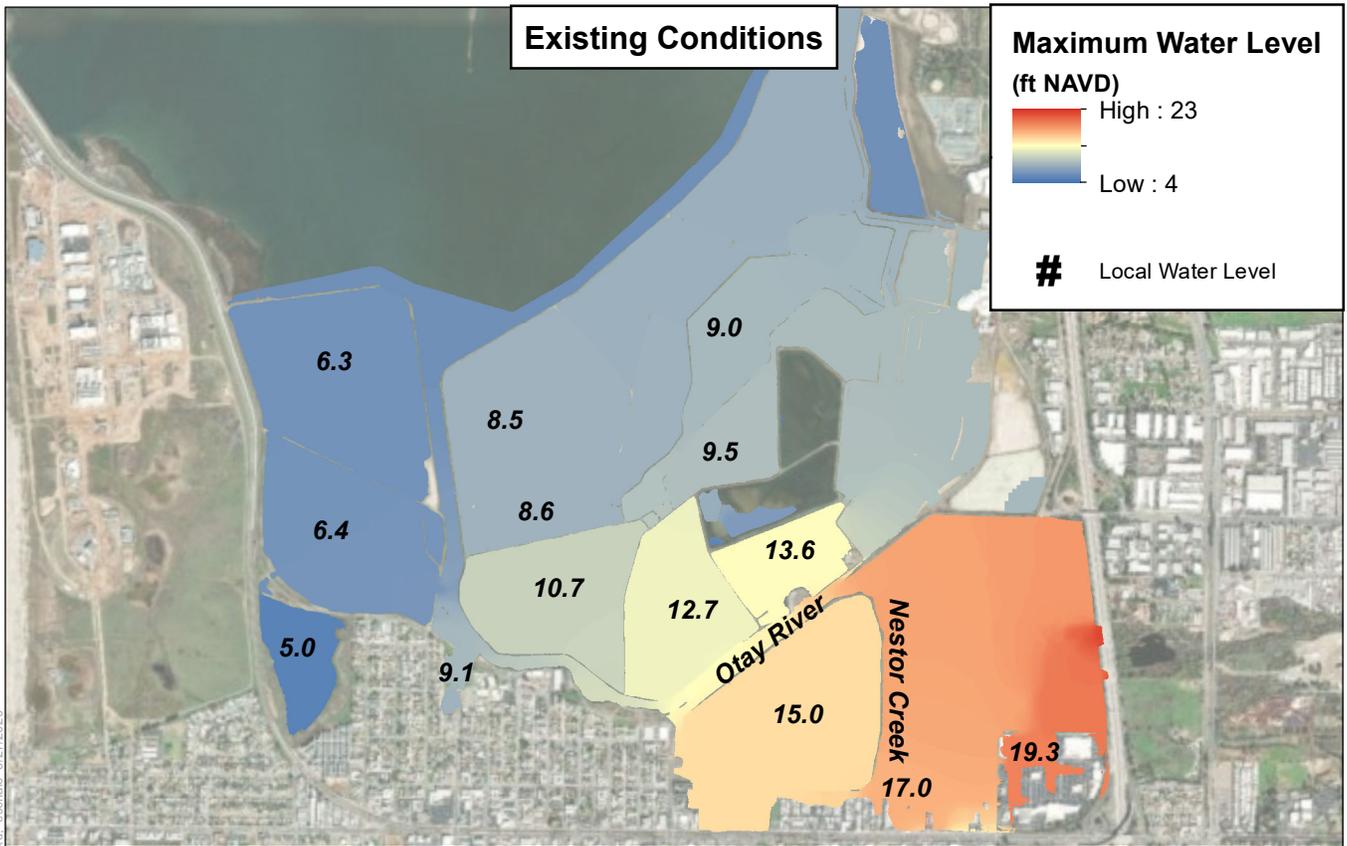
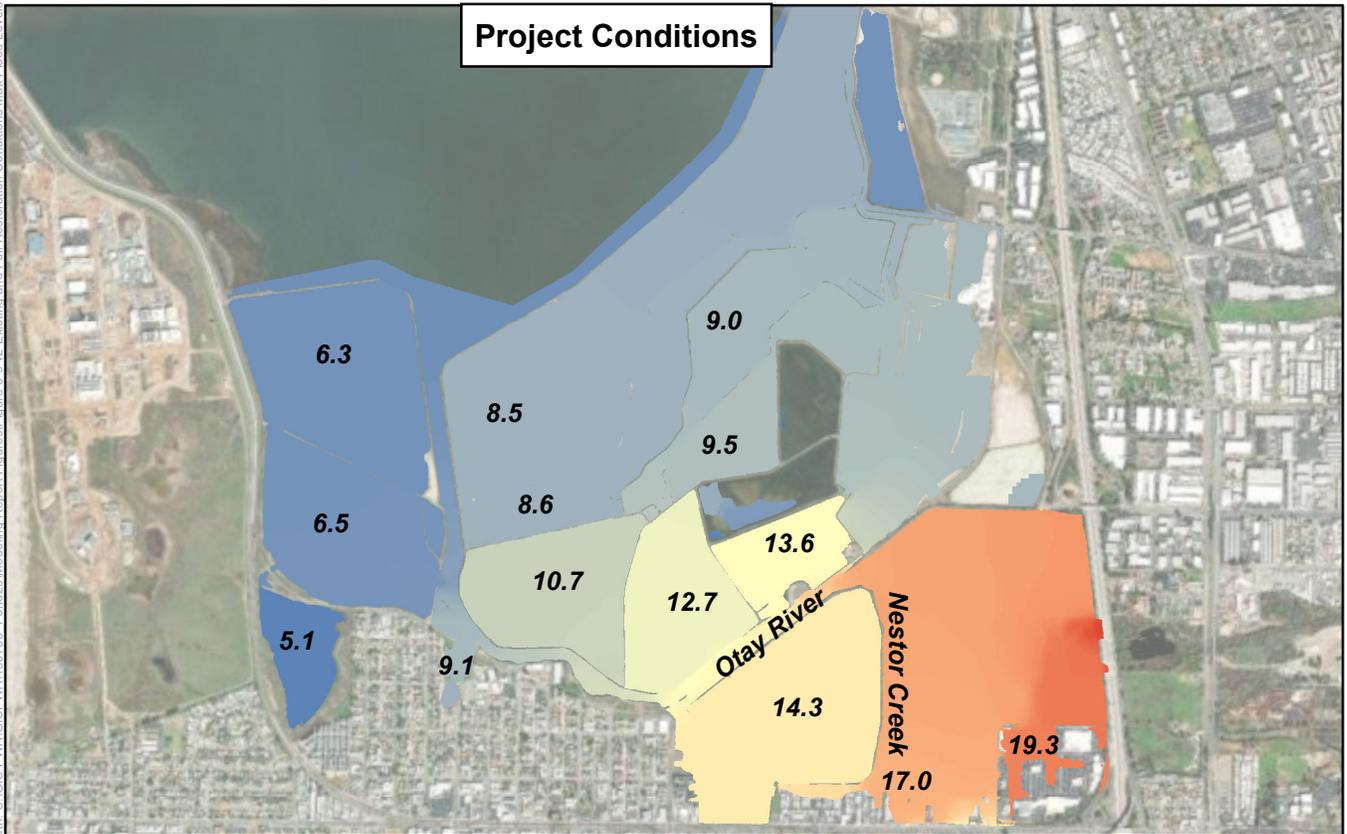
Figure 3-7
Existing and Project Conditions Maximum Flood Water Levels

As discussed in Section 1.2.1, the FEMA (1989) model is a 1D steady-state hydraulic model. In steady-state, the model is run with a continuous peak flow as the upstream boundary condition, as compared to an unsteady model, which applies a time-varying flow hydrograph as the upstream boundary conditions. In effect, this means that the system experiences a much greater volume of water compared to the unsteady model documented in this report. As a result, the 100-year floodplain delineated on the FEMA FIRM is much more extensive than the inundation model results documented in this report, specifically in properties along the river upstream of the site and south of the Pond 20 site where it is closest to Palm Avenue (**Figure 3-9**). The FEMA FIRM 100-year floodplain does not include Bayside Park, although the FIRM shows higher water levels in the Otay River in this area than those modeled as part of this report. The FEMA model may not include the culvert under the Bayshore Bikeway and/or other recent changes to the area.

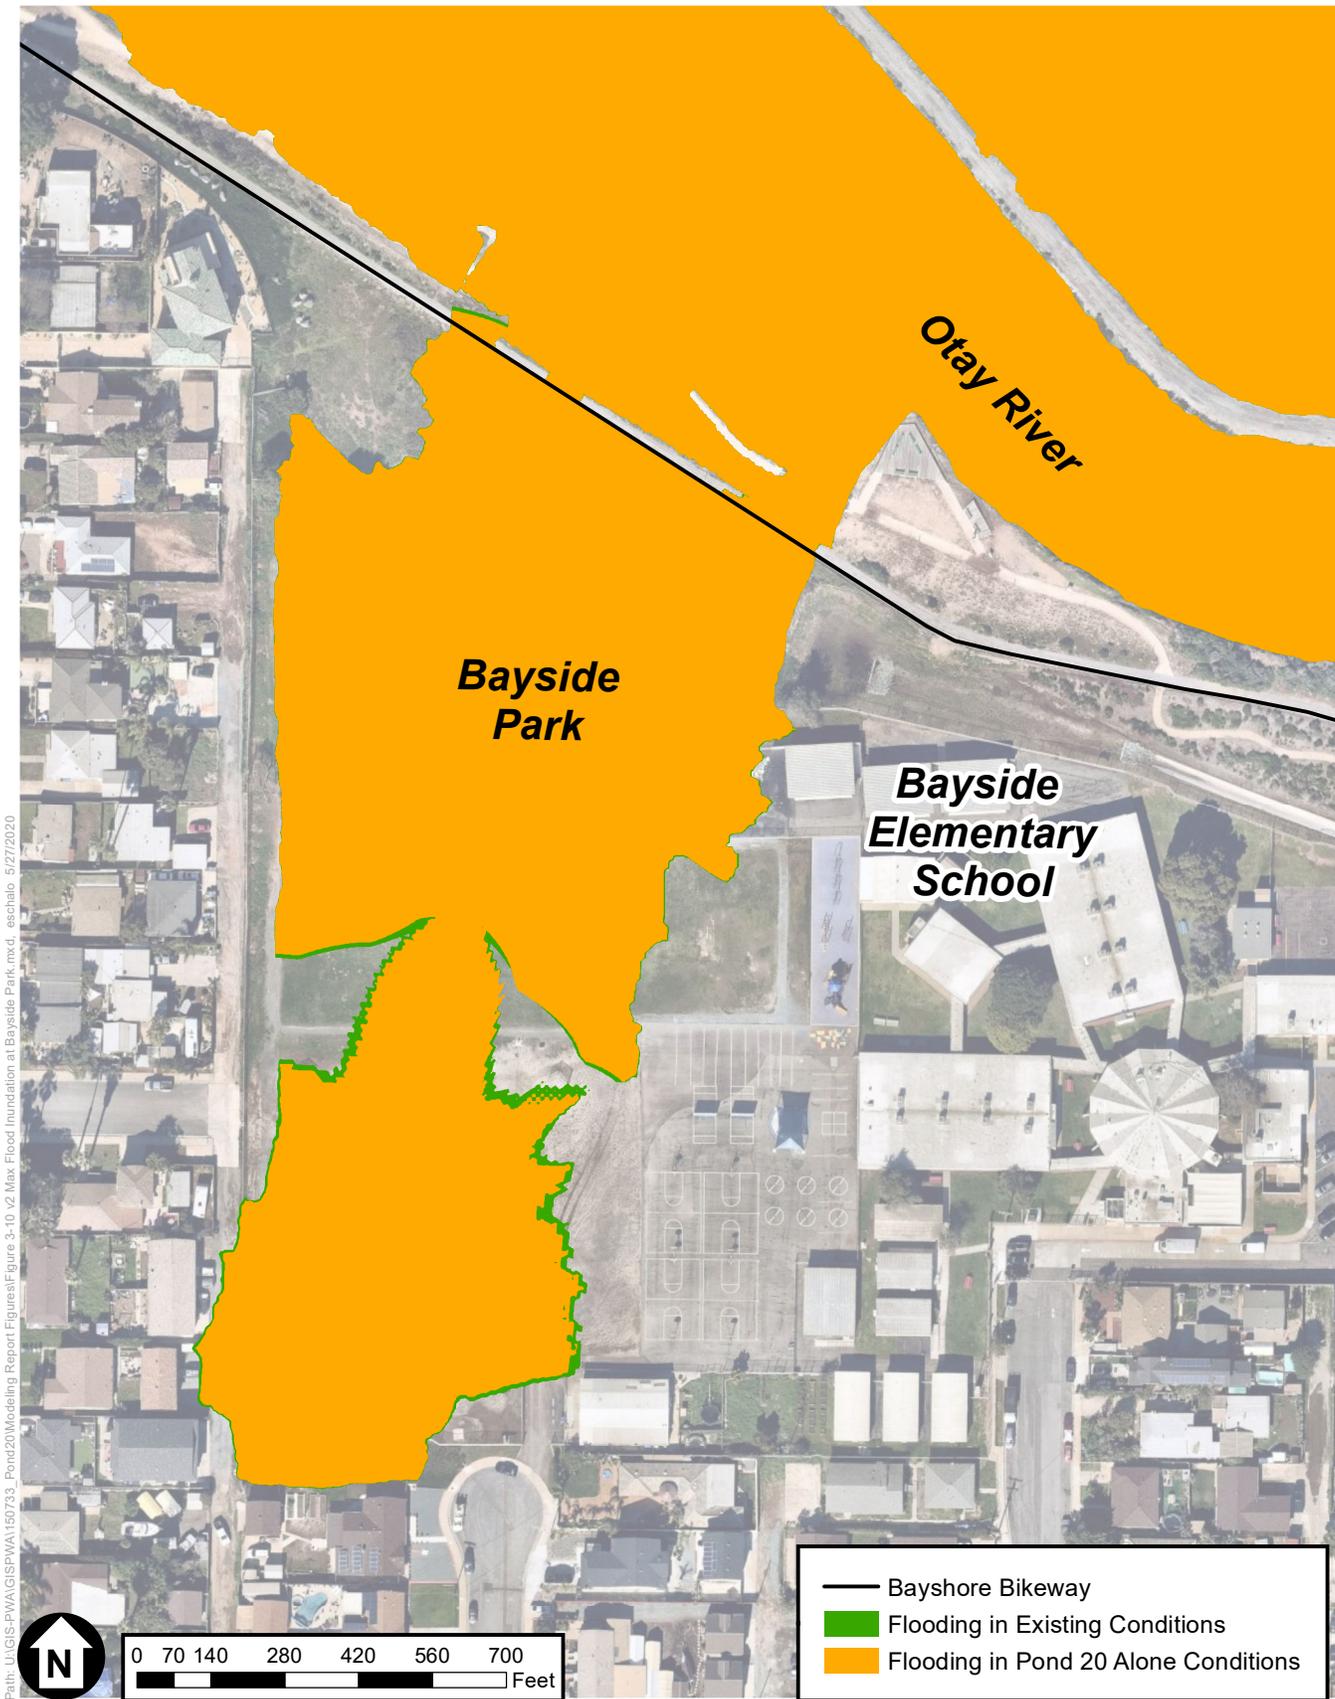
Figure 3-8
 Modeled Conditions Maximum Flood Water Extent at Bayside Park
 During 100-Year Storm Event

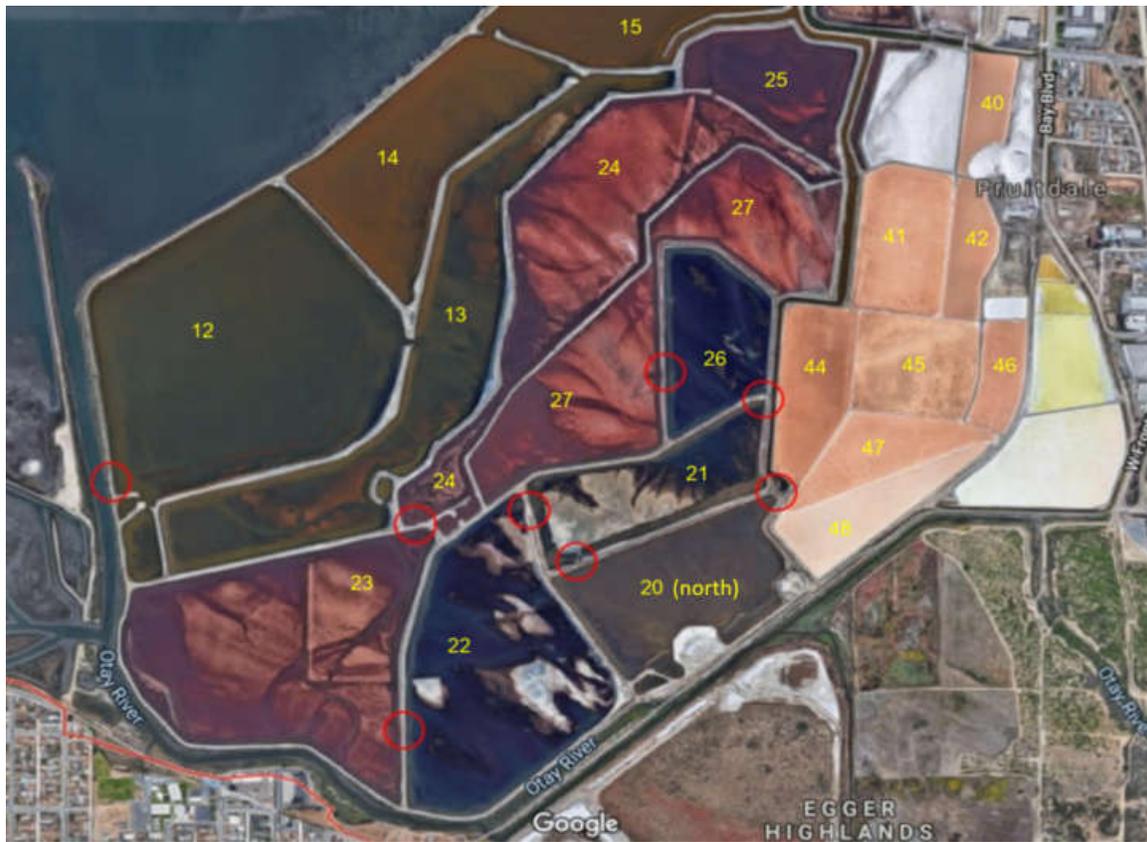
South Bay Salt Works provided data on the culverts connecting various salt ponds (correspondence with Tracy Strahl on 9/24/2019). These culverts, shown in the red circles in **Figure 3-10**, would allow flood flows to move through the system before overtopping the pond berms, which may lower overall flood levels during major storm events. The project is not expected to worsen flooding compared to Existing Conditions if the culverts are considered because model results show that the storm flows move through the system similarly for Existing and Project Conditions.
