Wetland Mitigation Bank at Pond 20 and Port Master Plan Amendment

Draft Environmental Impact Report

Appendix J. Phase I Environmental Site Assessment

SUBJECT: Phase I Environmental Site Assessment
San Diego Unified Port District
Salt Pond 20, Approximately 90 Acres
Assessor Parcel Numbers: 615-020-(08/12), 616-021-08,
616-021-09 (portion) and 621-020-(04/08)
San Diego, San Diego County, California

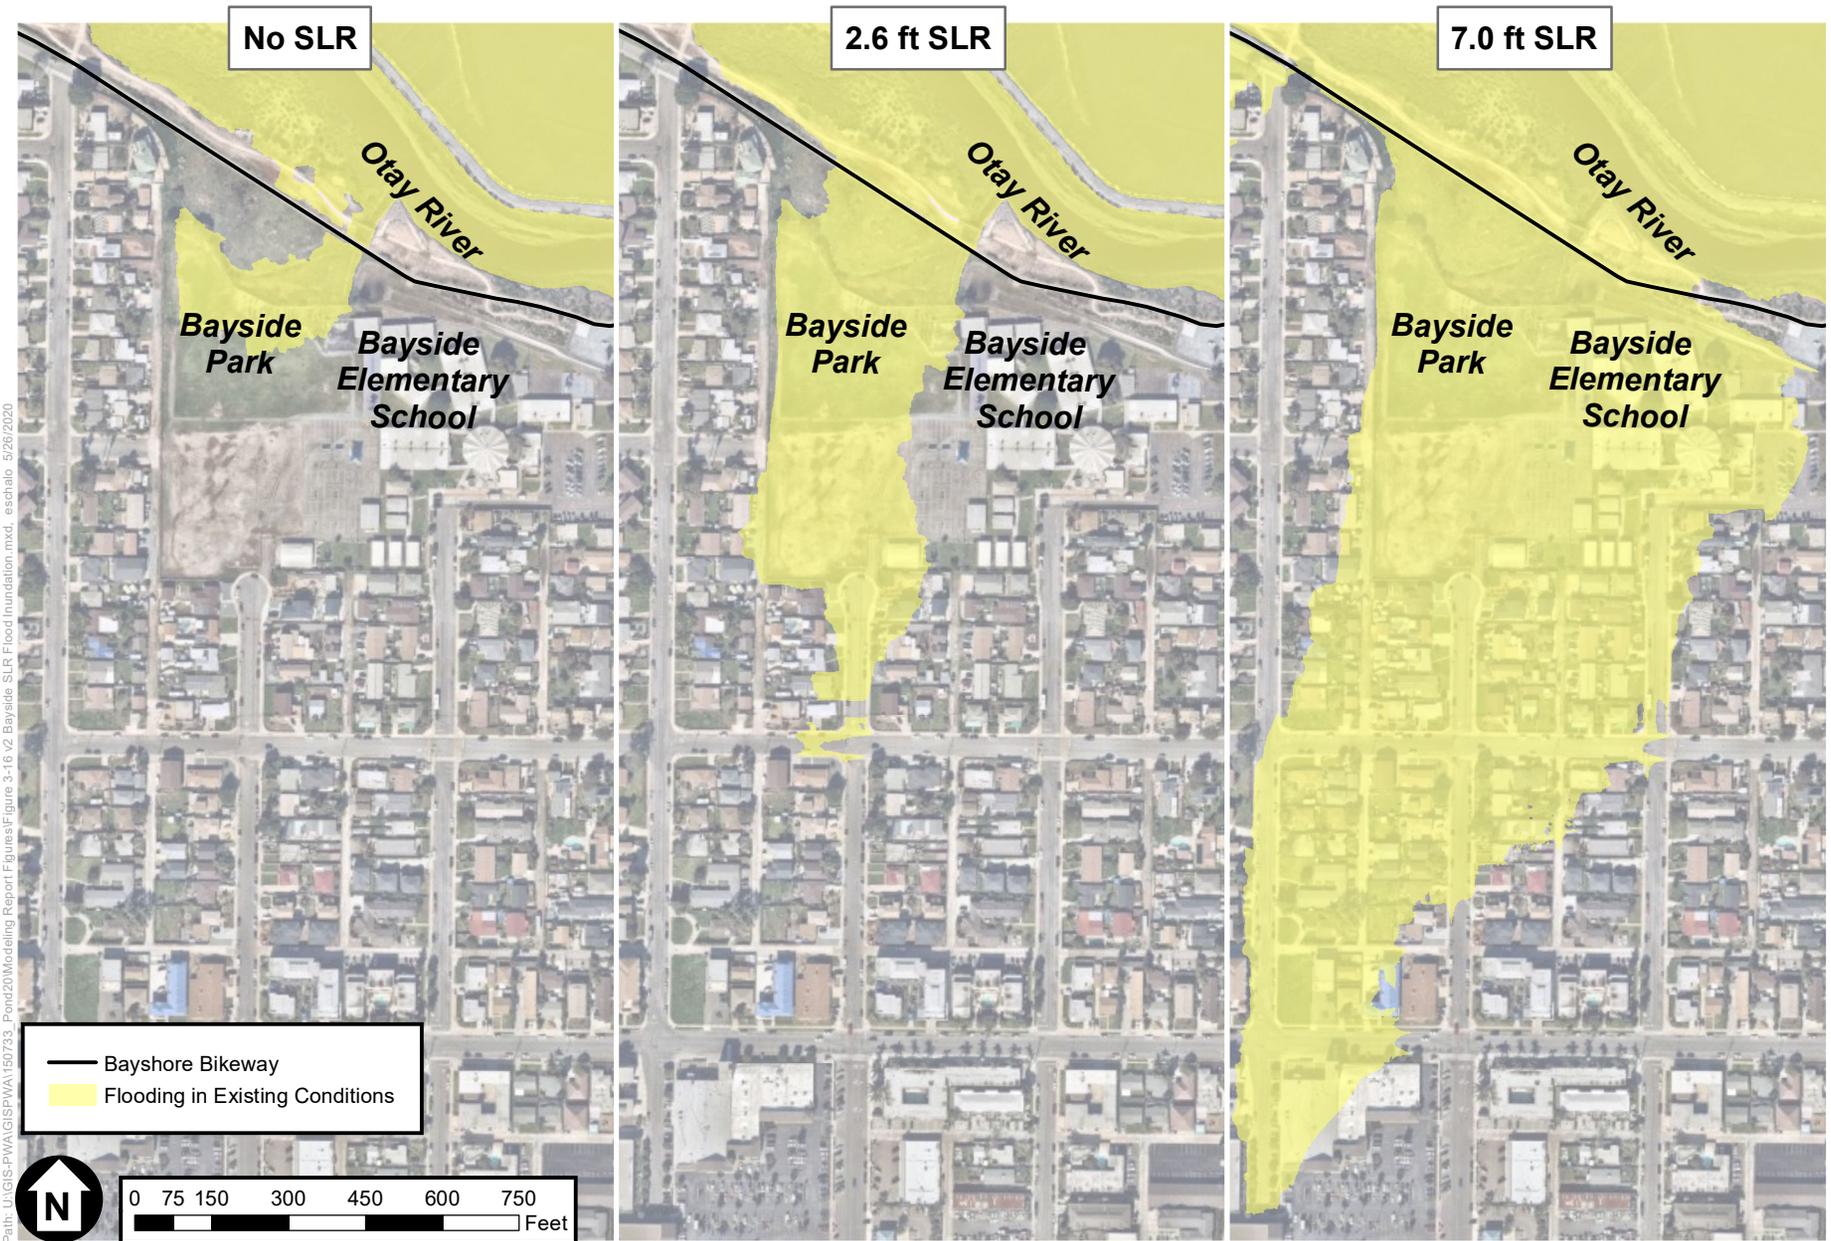
Figure 3-13
SLR Flood Extent at Bayside Park under Existing Conditions

Figure 3-14 shows the modeled flooding around Pond 20 with increasing amounts of sea-level rise. The flood extent looks very similar with up to 7.0 ft of sea-level rise, since upstream on the Otay River and near Pond 20, the flood levels are controlled by the riverine flow more than the tides. Project Conditions flooding is not expected to worsen flooding from sea-level rise compared to Existing Conditions.

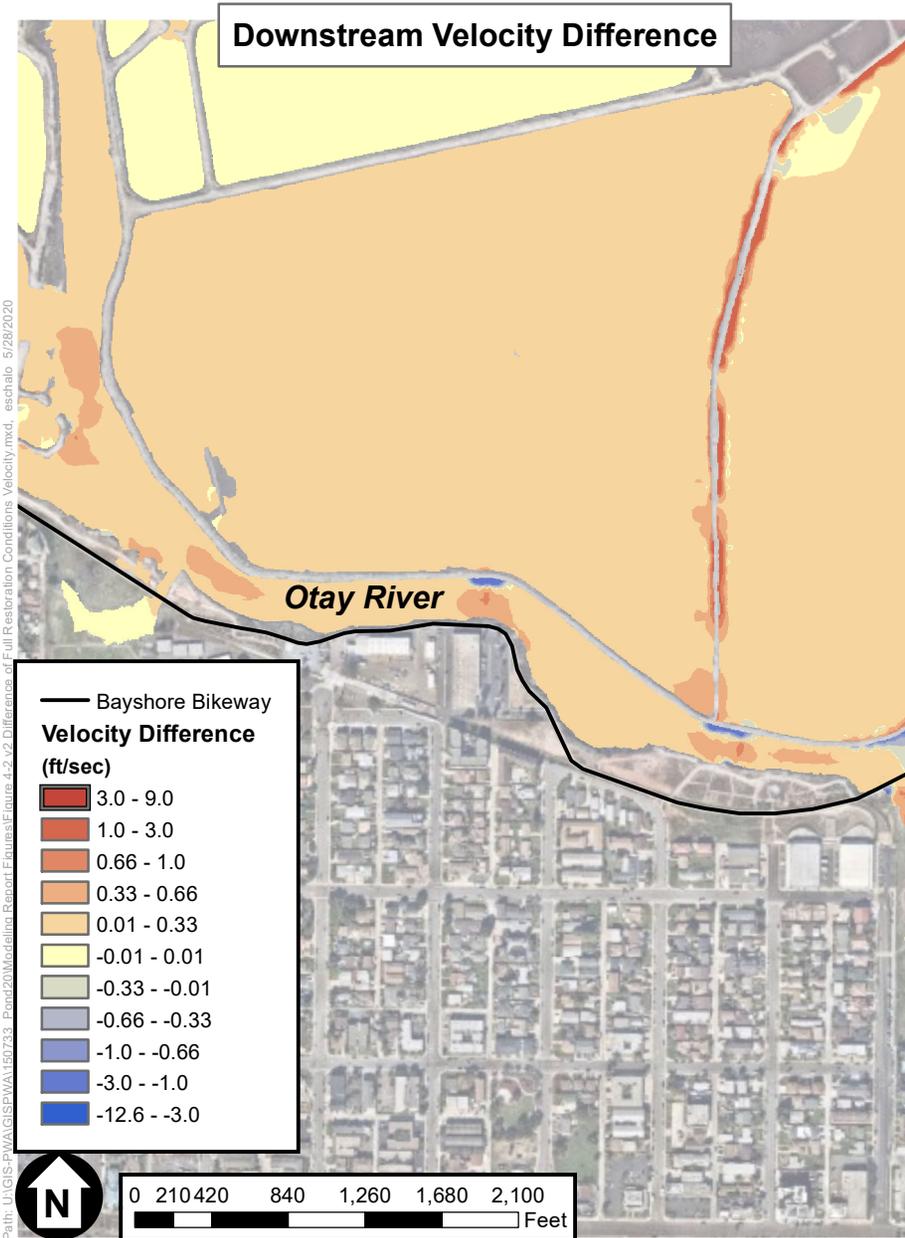
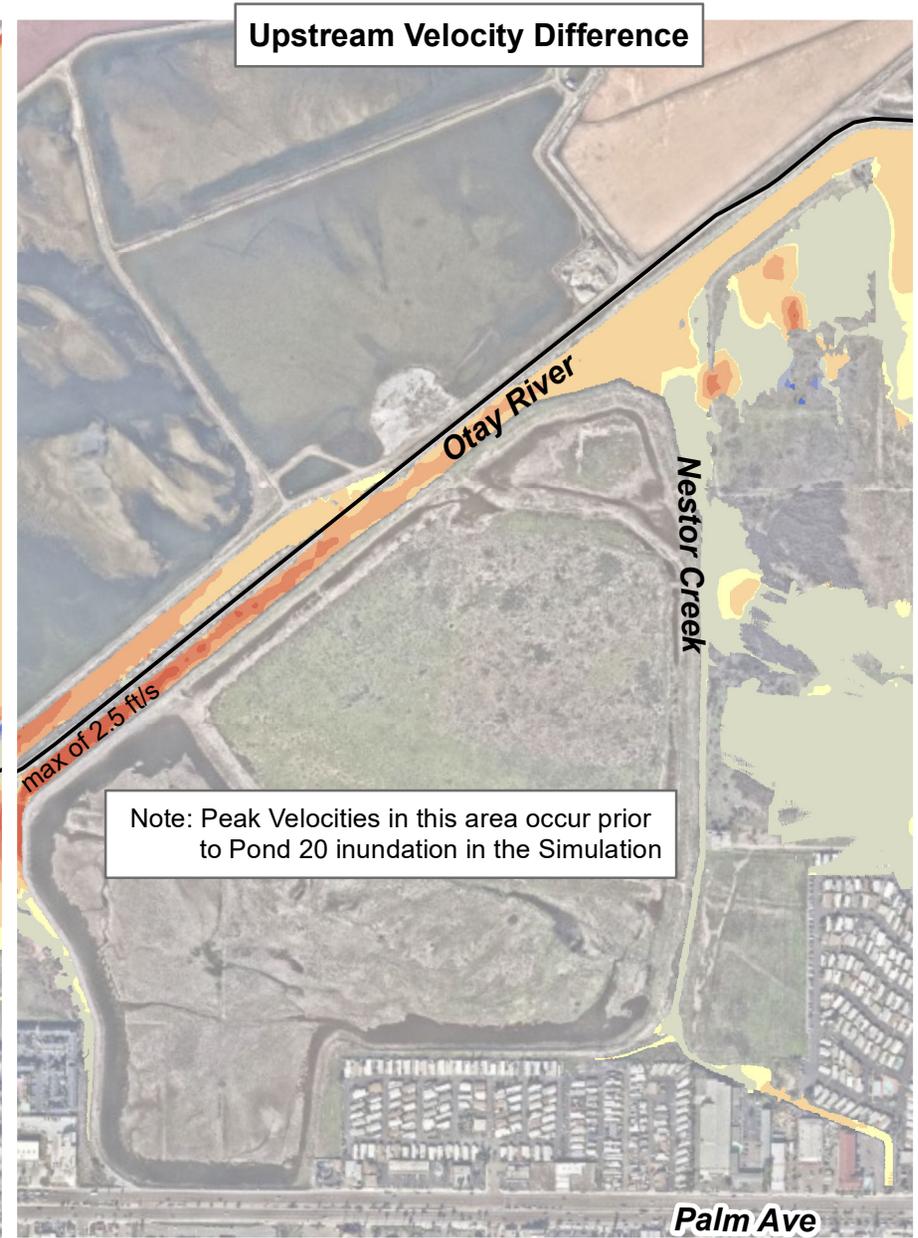
Figure 4-1
100-Year Storm Event Velocities of Existing and Project Conditions
