**JURISDICTIONAL WETLAND
DELINEATION REPORT
FOR WESTERN SALT POND 20
IMPERIAL BEACH, CALIFORNIA**

San Diego Unified Port District
3165 Pacific Highway
San Diego, CA 92101
Attention: Eileen Maher

Merkel & Associates, Inc.
5434 Ruffin Road
San Diego, CA 92123
Phone: (858) 560-5465
Fax: (858) 560-7779

August 18, 2008

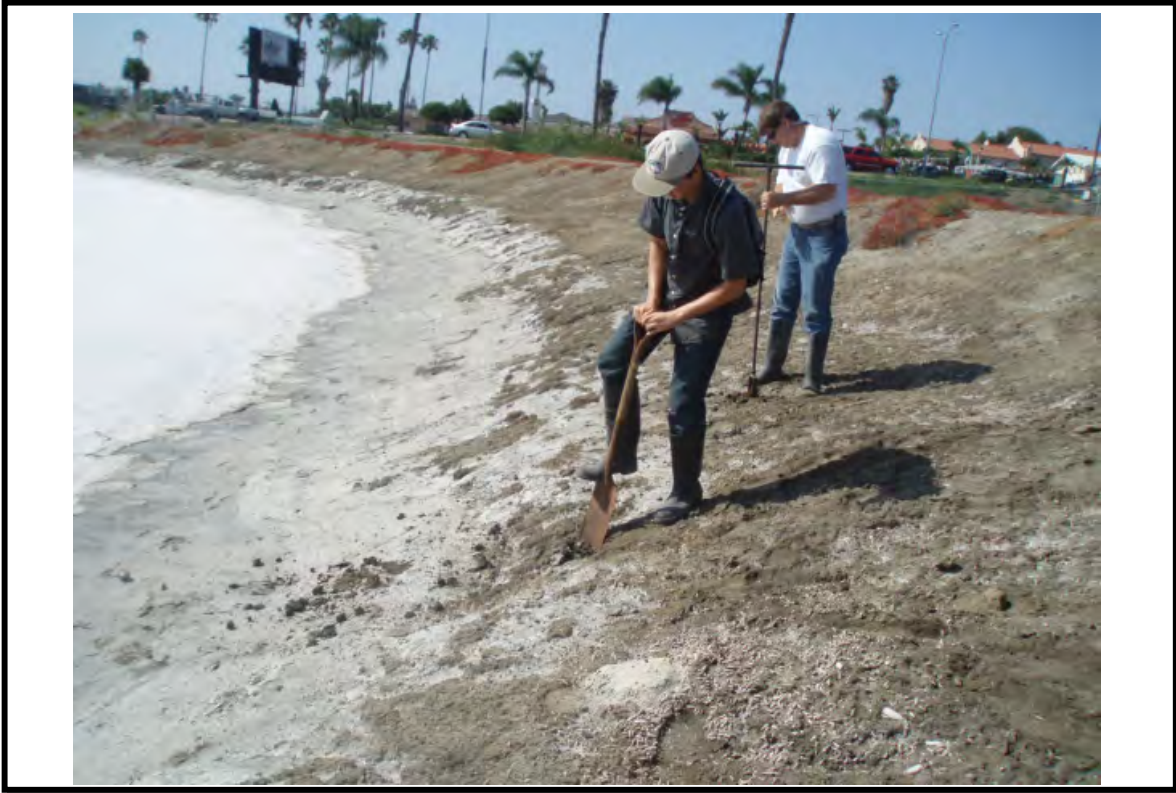
Photo Point 1. Data point 1 is located mid-slope of an unvegetated berm, within the southwestern portion of the site. Photo is directed southwest and was taken June 30, 2008.

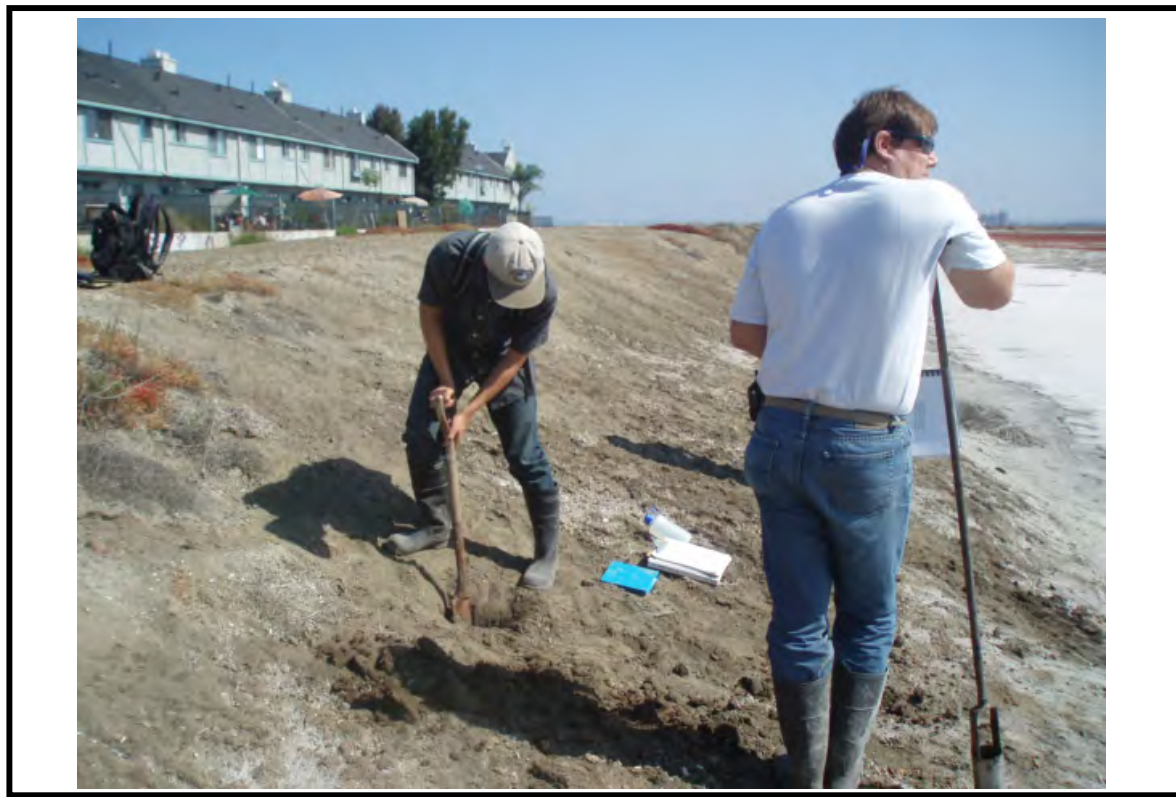
Photo Point 2. Data point 2 is located mid-slope of an unvegetated berm, above salt line, immediately southwest of DP 1, within the southwestern portion of the site. Photo is directed north and was taken June 30, 2008.

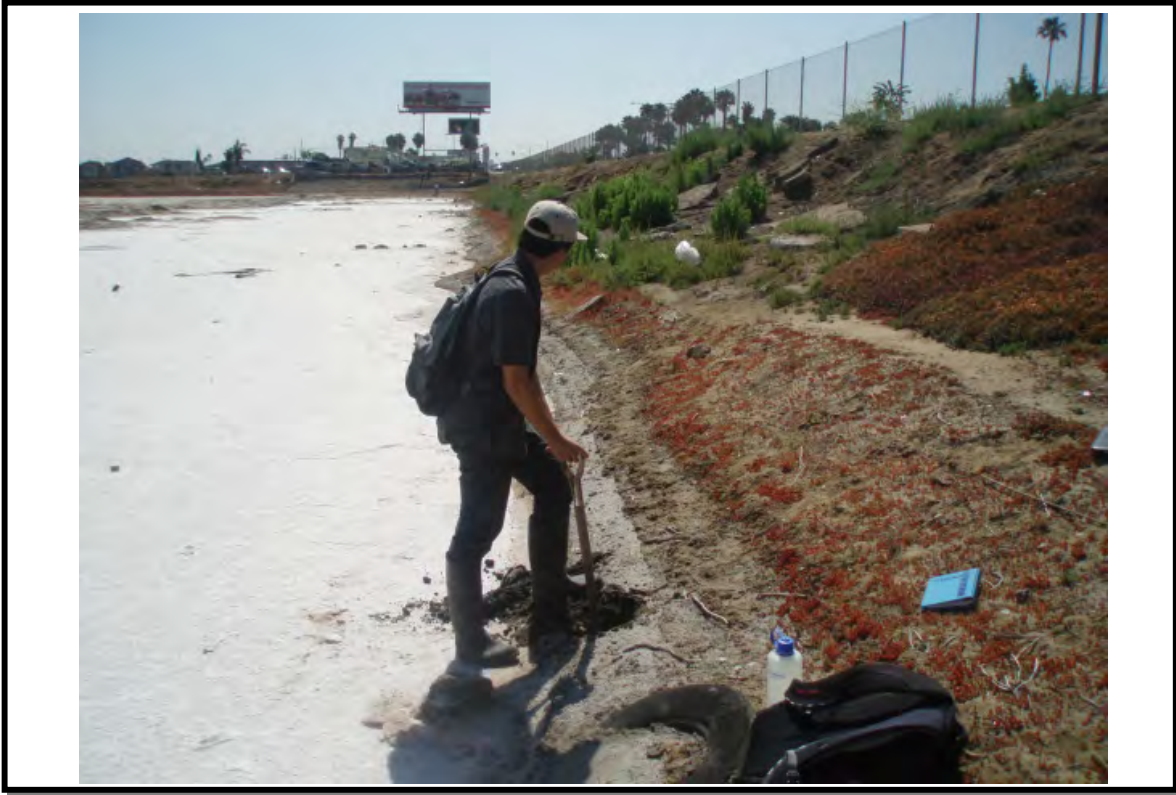
Photo Point 3. Data point 3 is located at the toe of the southern berm, which runs parallel to Palm Avenue. Photo is directed east and was taken June 20, 2008.

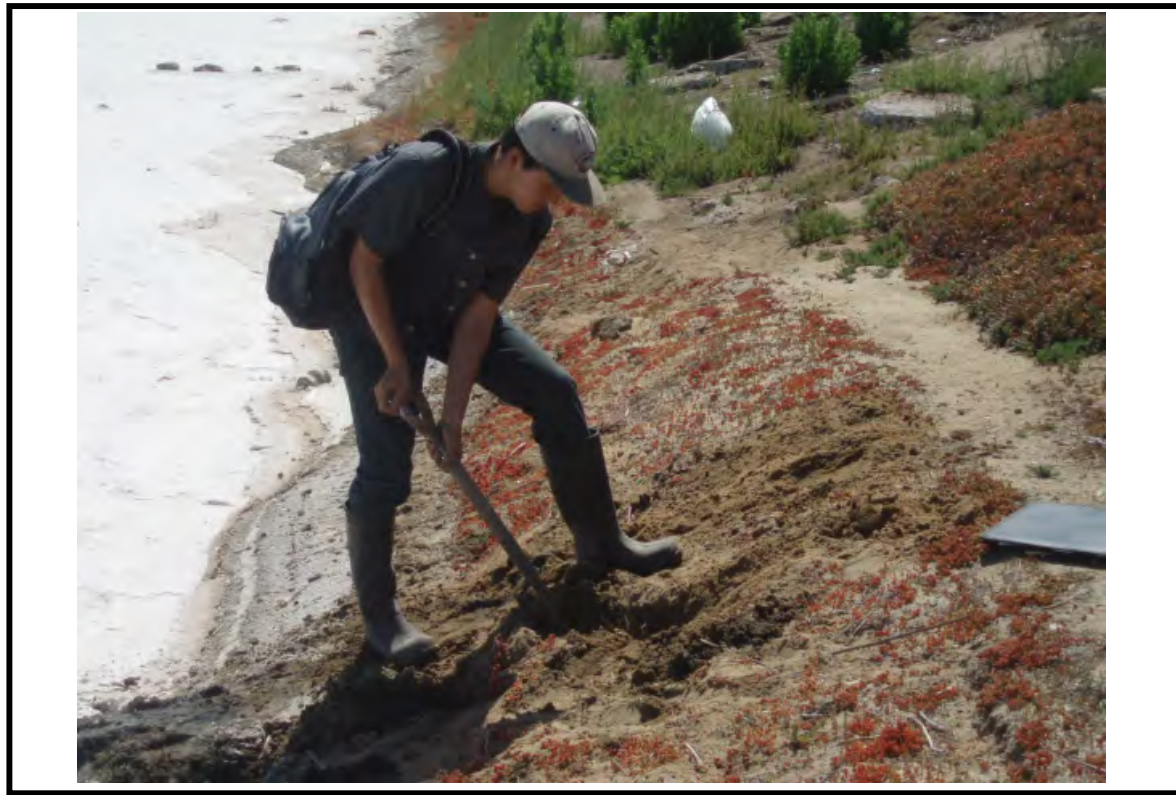
Photo Point 4. Data point 4 is located mid-slope of the southern berm, immediately south of DP 3. Photo is directed east and was taken June 30, 2008.

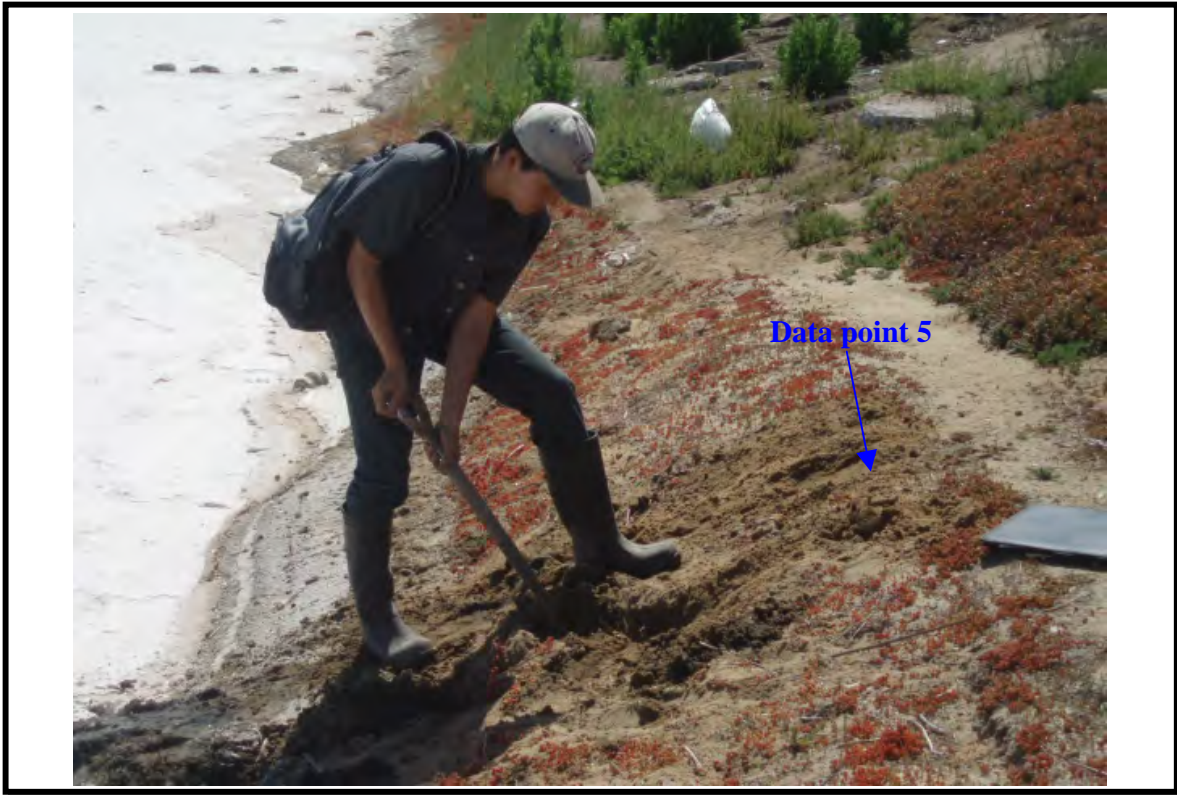
Photo Point 5. Data point 5 is located at top of slope of the southern berm (2.0' south of Data Point 4). Photo is directed east and was taken June 30, 2008.

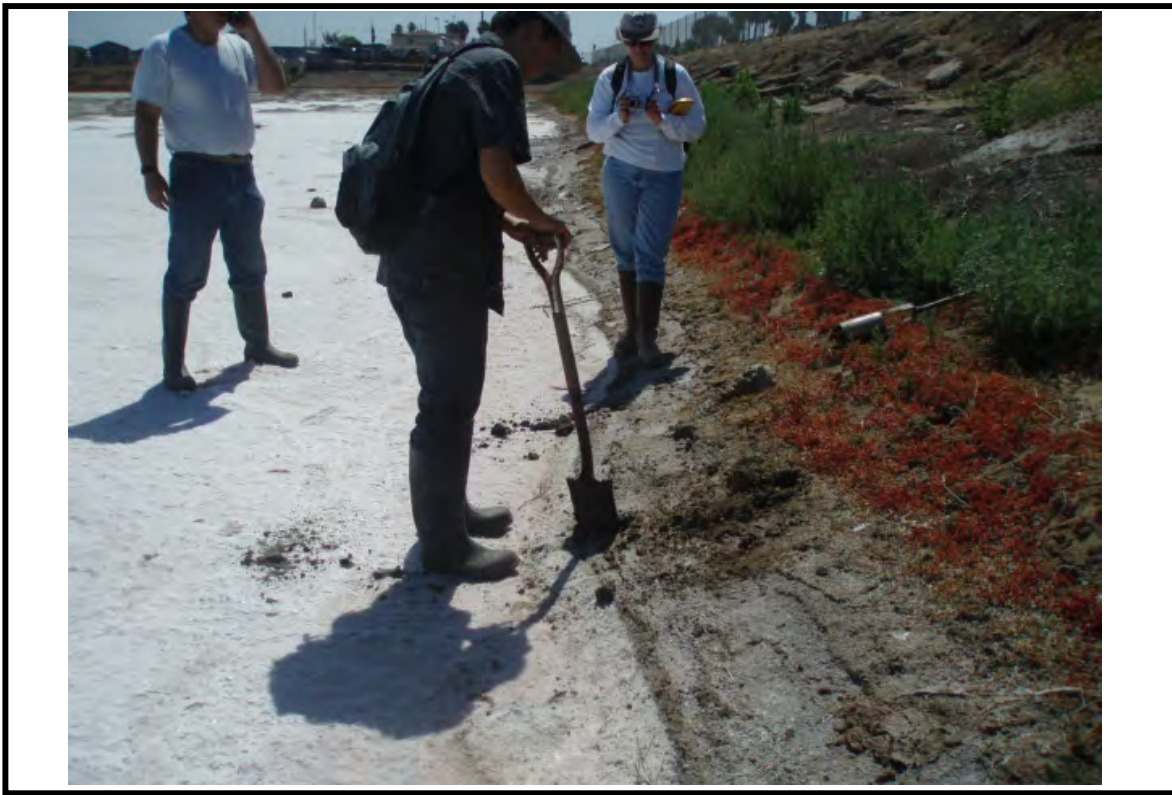
Photo Point 6. Data point 6 is located east of DP 5 at the toe of the southern berm, which runs parallel to Palm Avenue. Photo is directed east and was taken June 20, 2008.

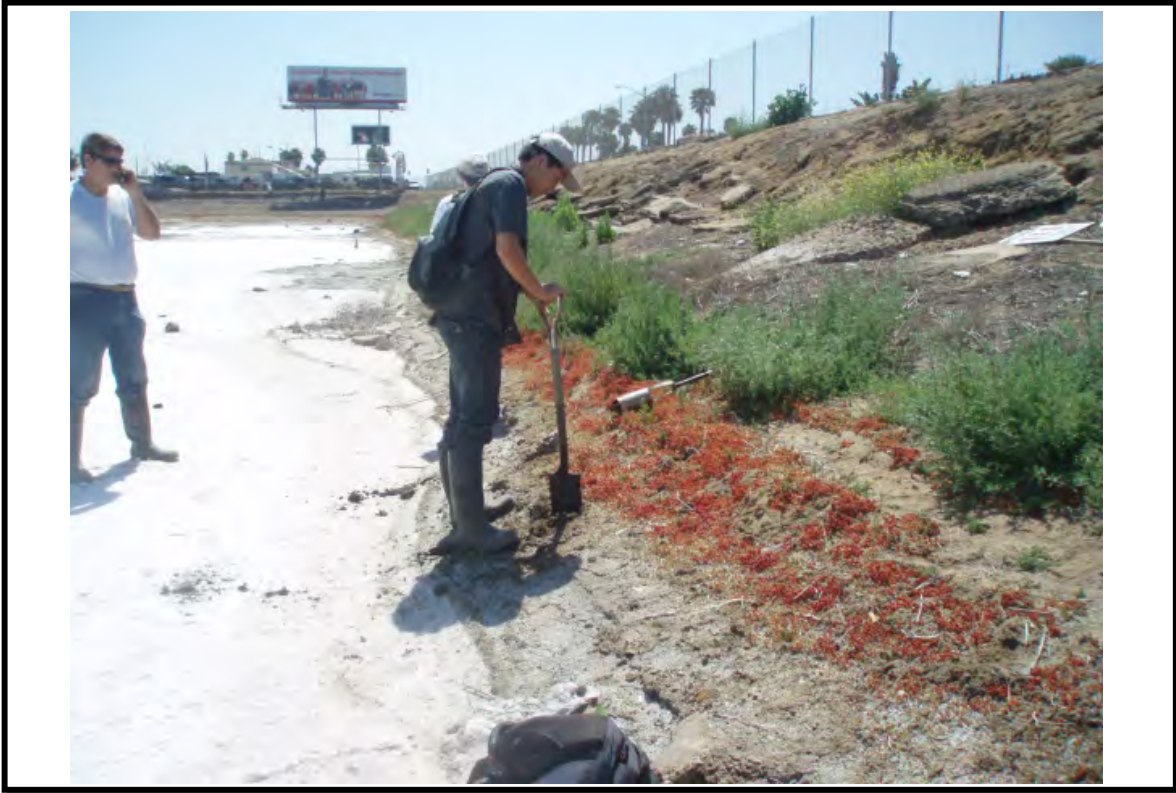
Photo Point 7. Data point 7 is located mid-slope of the southern berm, immediately south of DP 6. Photo is directed east and was taken June 30, 2008.

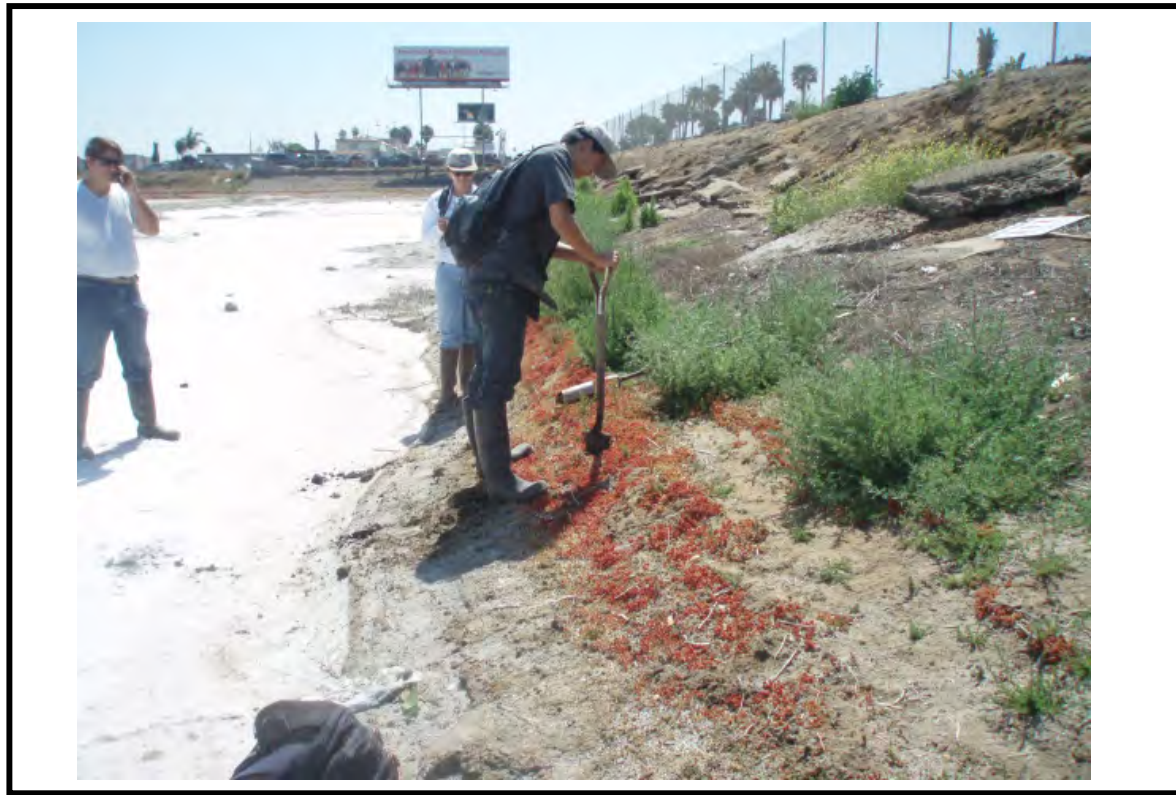
Photo Point 8. Data point 8 is located mid-slope of the southern berm, immediately south of DP 7. Photo is directed east and was taken June 30, 2008.

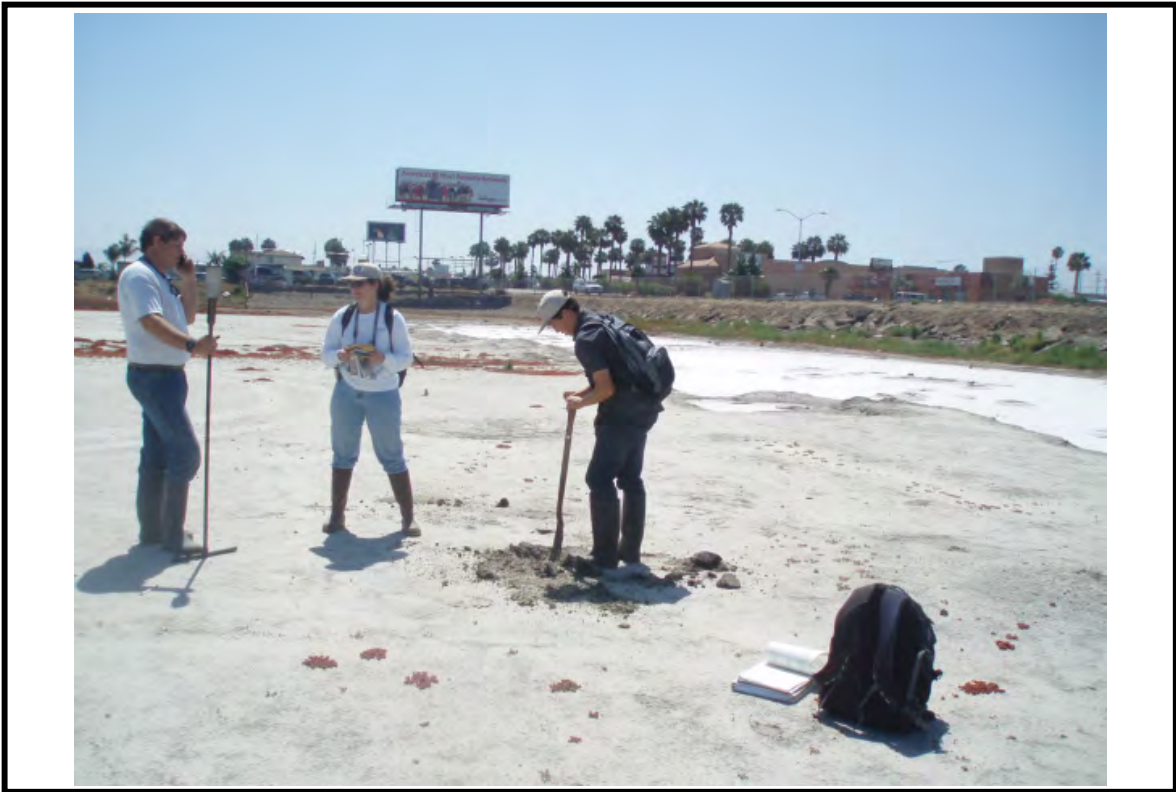
Photo Point 9. Data point 9 is located on salt panne within the southern portion of study area, north of DP 8. Photo is directed east and was taken June 30, 2008.

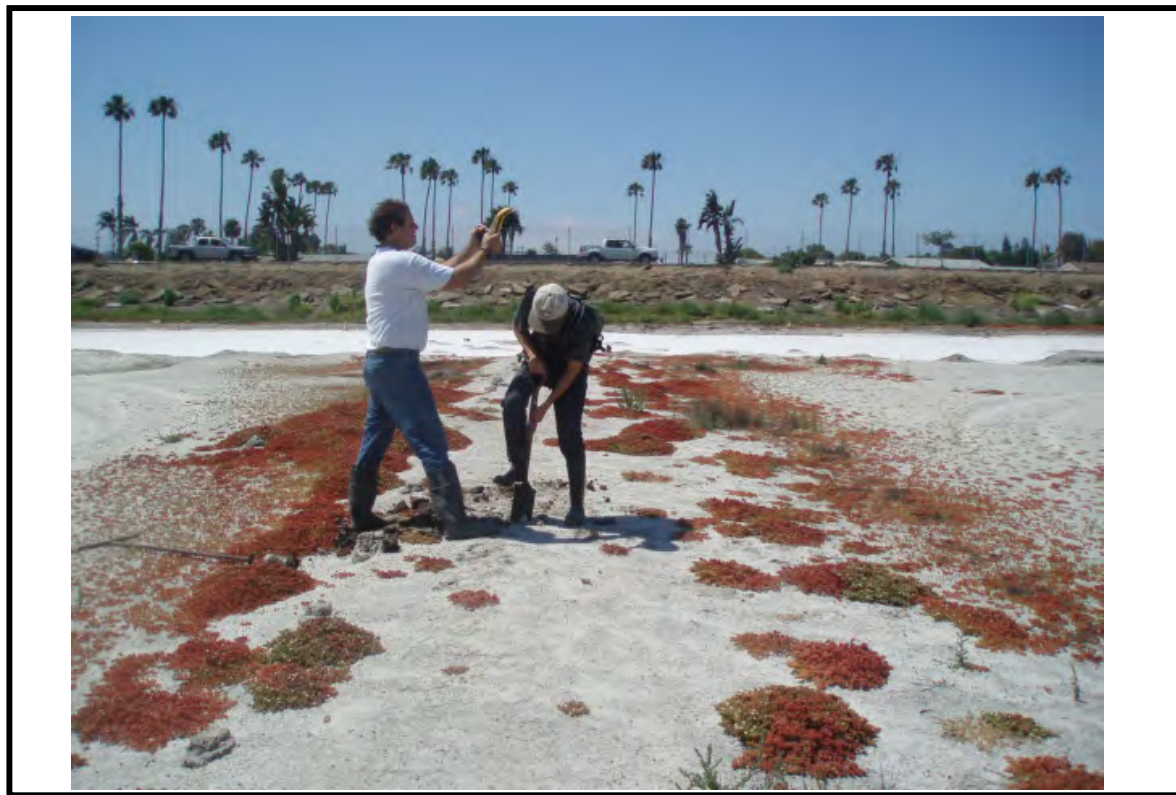
Photo Point 10. Data point 10 is located along an old berm in southern portion of site, northeast of DP 9. Photo is directed south and was taken June 30, 2008.

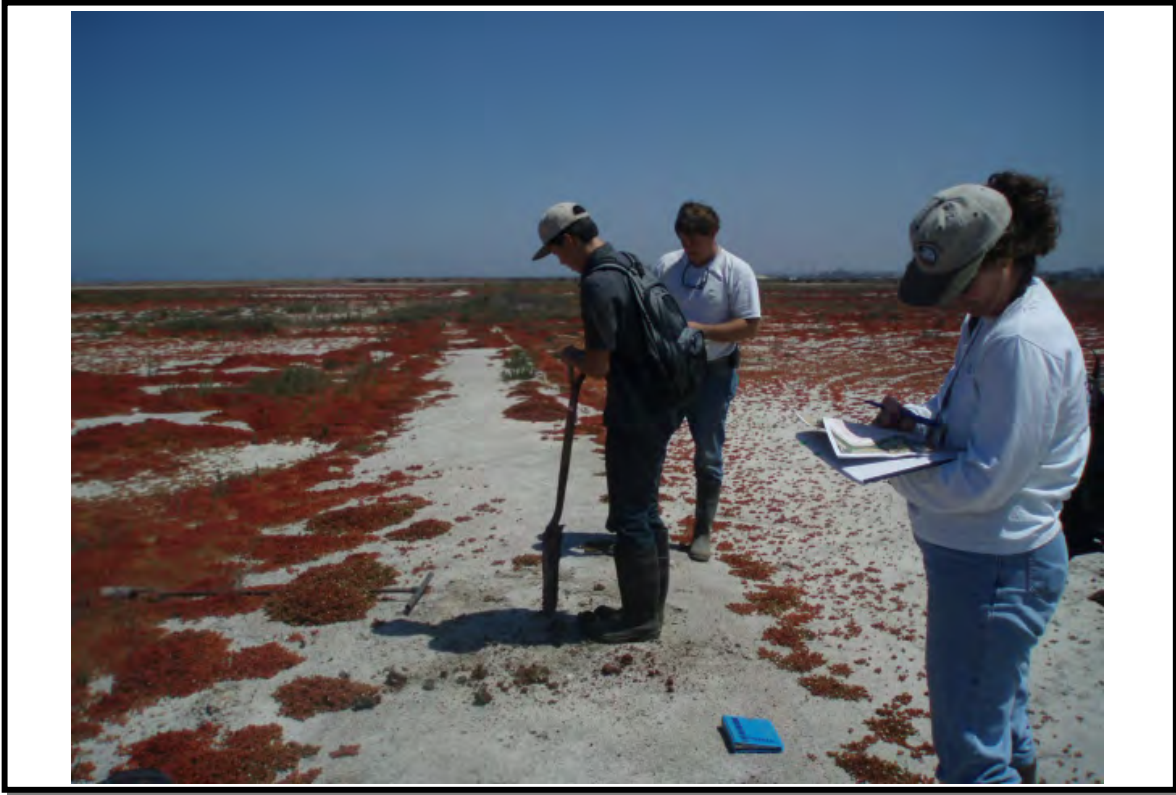
Photo Point 11. Data point 11 is located along an old berm in southern portion of site, north of DP 10. Photo is directed north and was taken June 30, 2008.

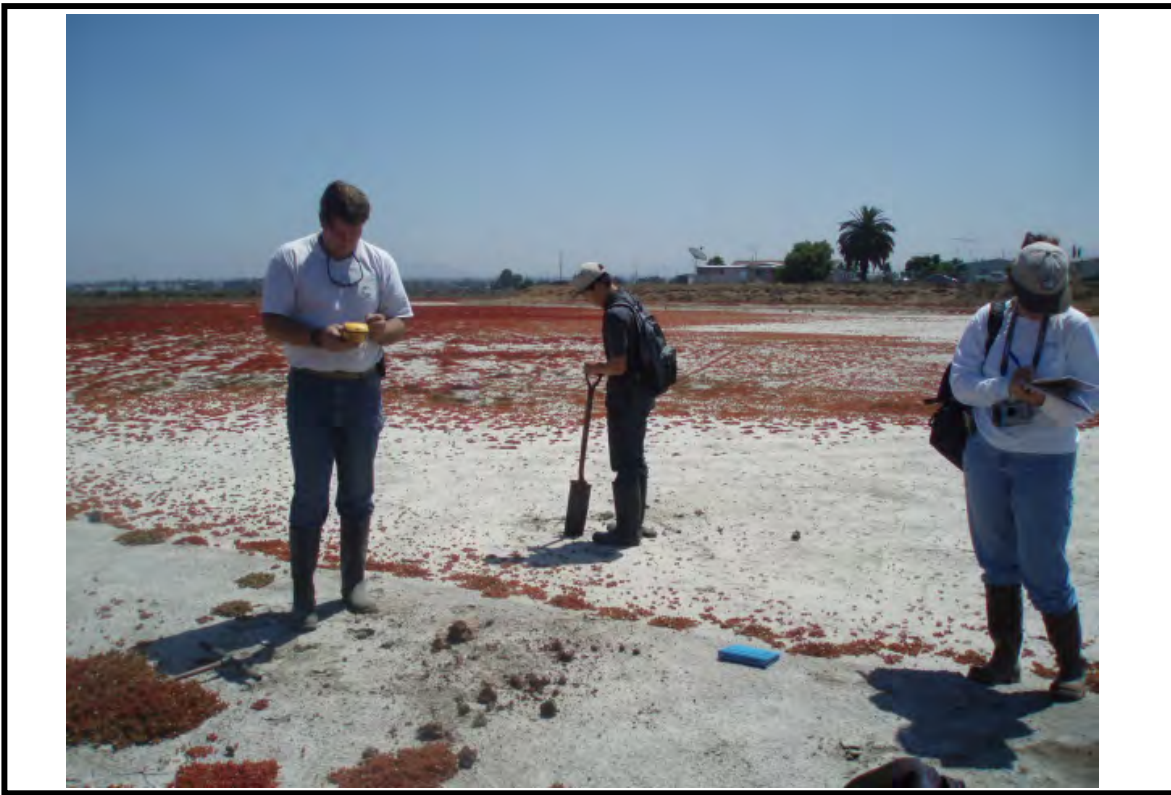
Photo Point 12. Data point 12 is located just east of the edge of the old berm referenced in DP 10 and 11, above. Photo is directed east and was taken June 30, 2008.

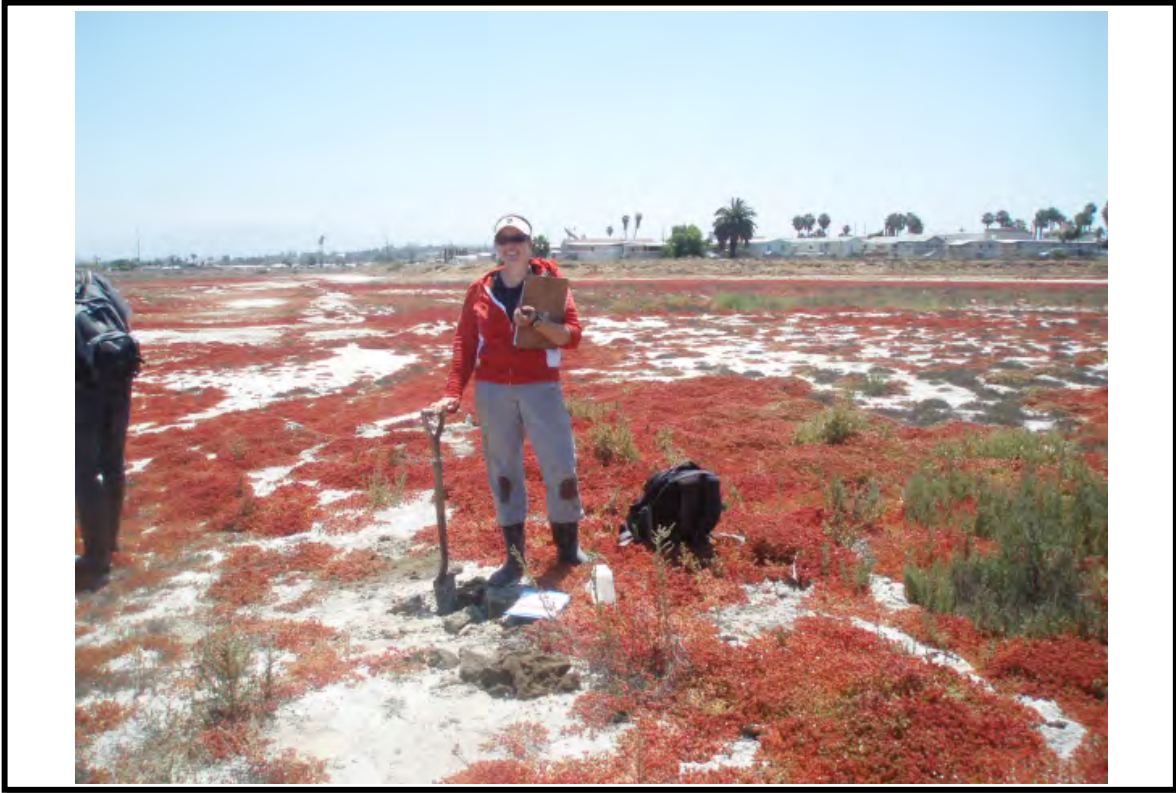
Photo Point 13. Data point 13 is located in the south-central portion of study area, northwest of DP 12, at the slightly elevated edge of a historically flooded area. Photo is directed northwest and was taken June 30, 2008.

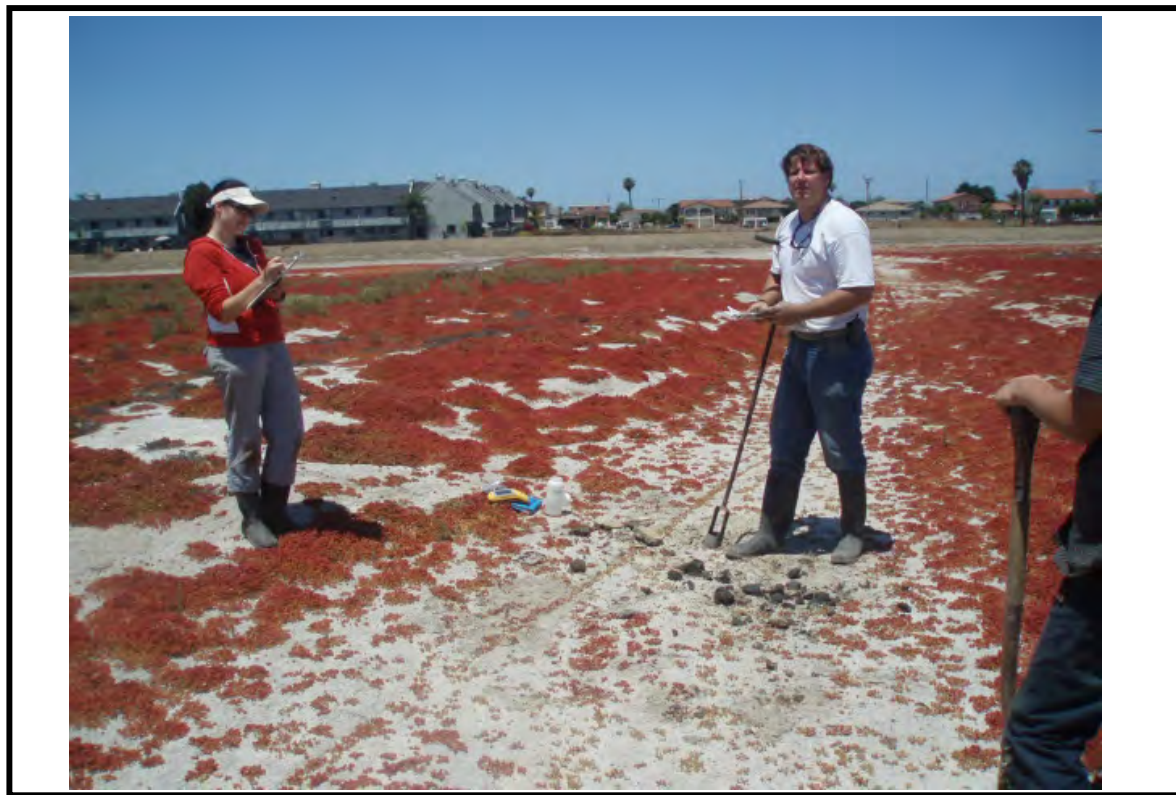
Photo Point 14. Data point 14 is located in the south-central portion of study area, north of DP 13, within a historically flooded area. Photo is directed west and was taken June 30, 2008.

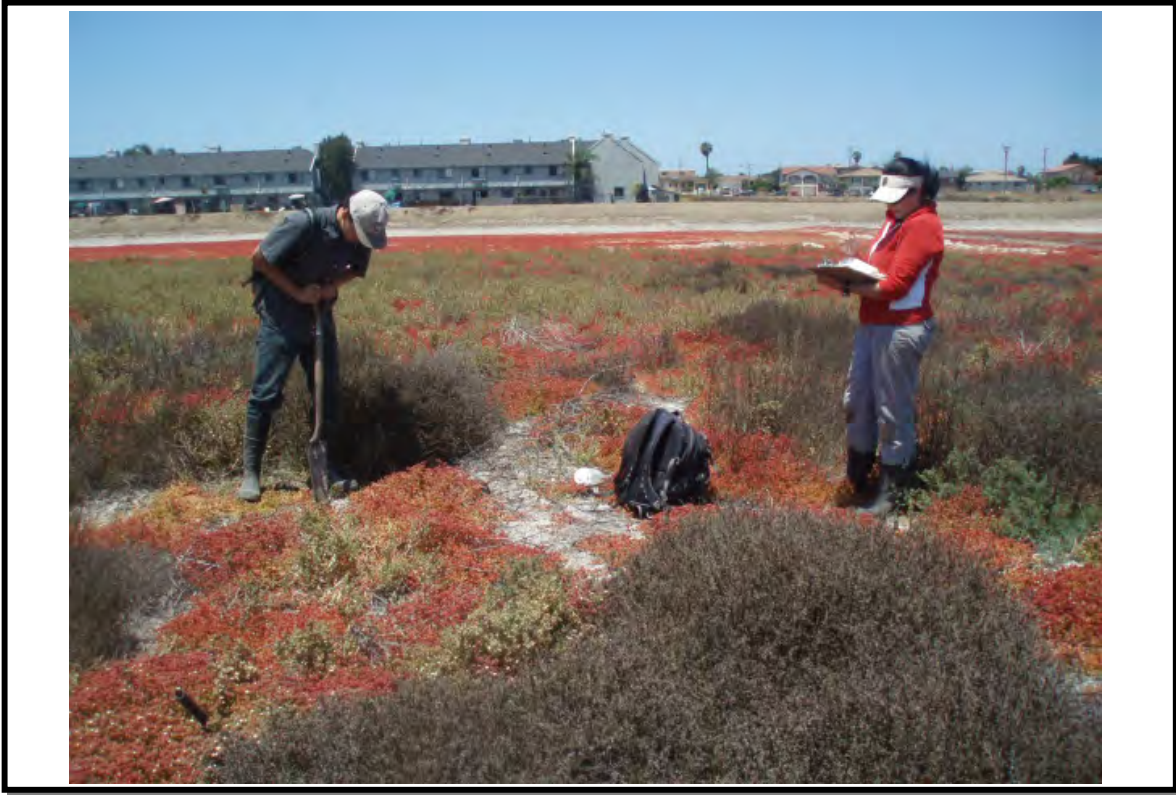
Photo Point 15. Data point 15 is located in upland area south of DP 13 and 14. Photo is directed west and was taken June 30, 2008.

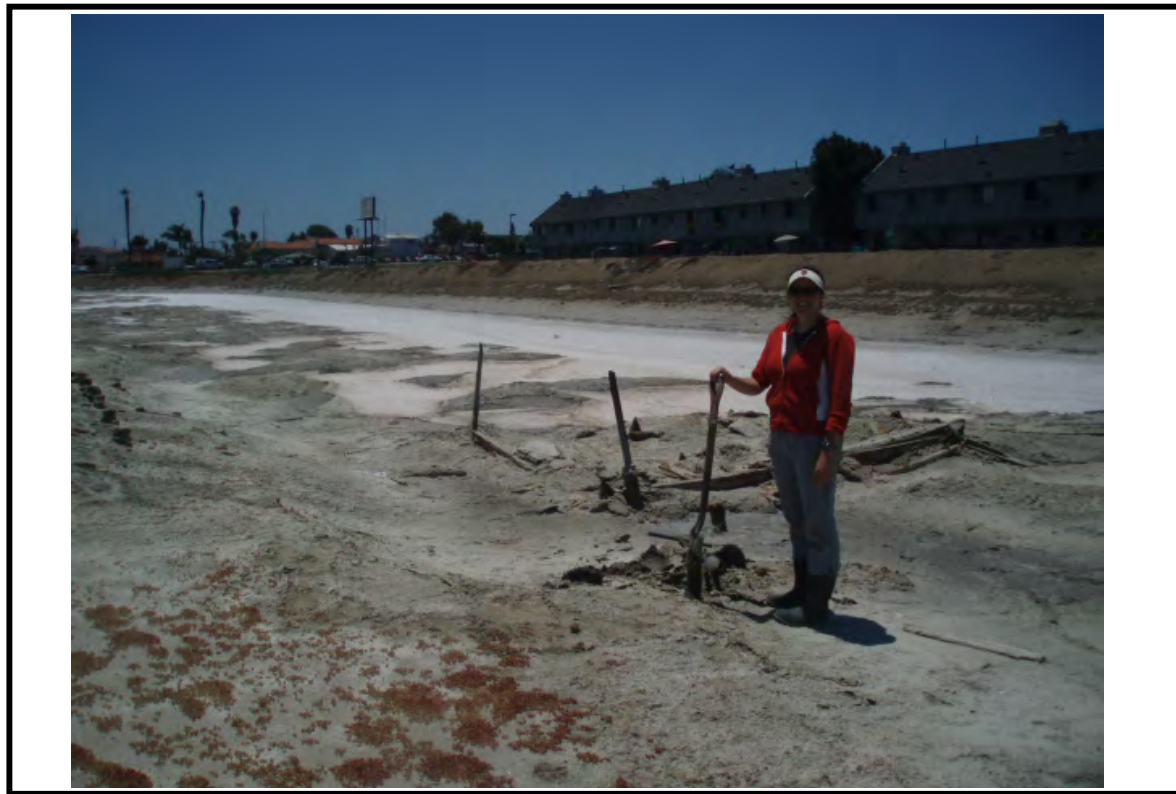
Photo Point 16. Data point 16 is located in the southwest portion of site within a historically flooded area northwest of DP 15. Photo is directed southwest and was taken June 30, 2008.

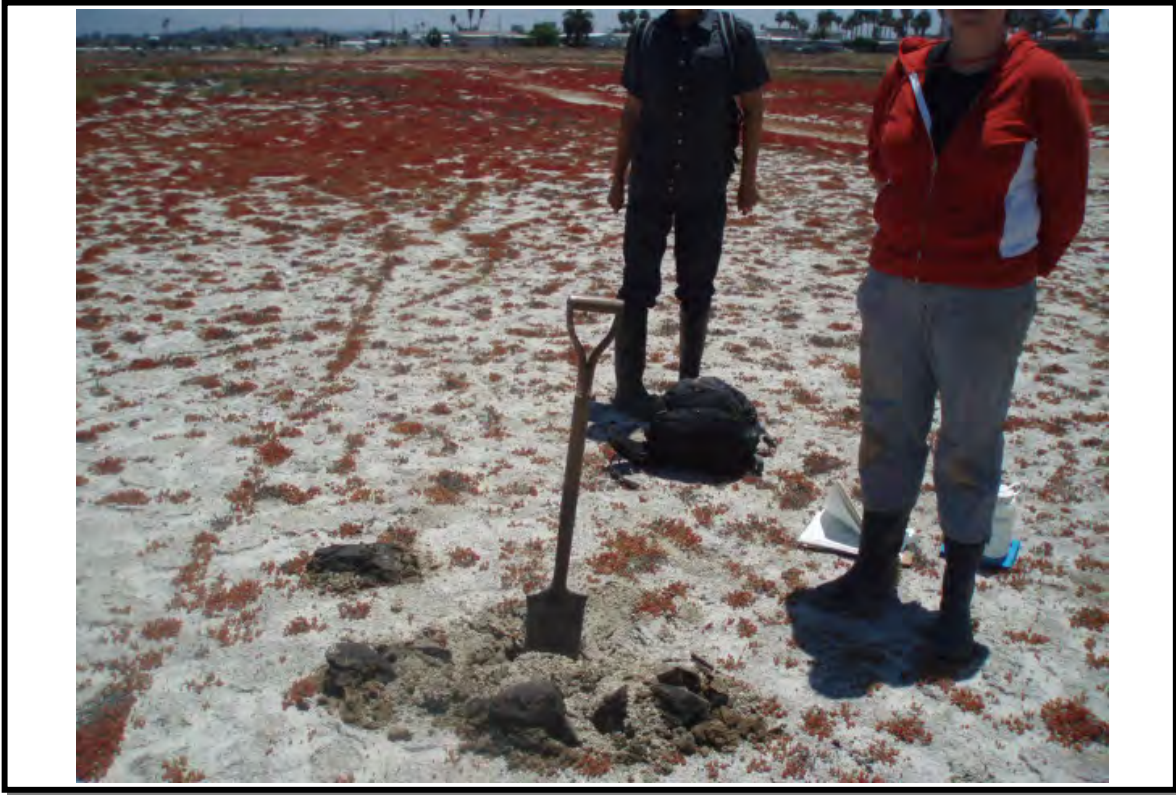
Photo Point 17. Data point 17 is located in the west-central portion of study area, north of DP 16. Photo is directed southeast and was taken June 30, 2008.

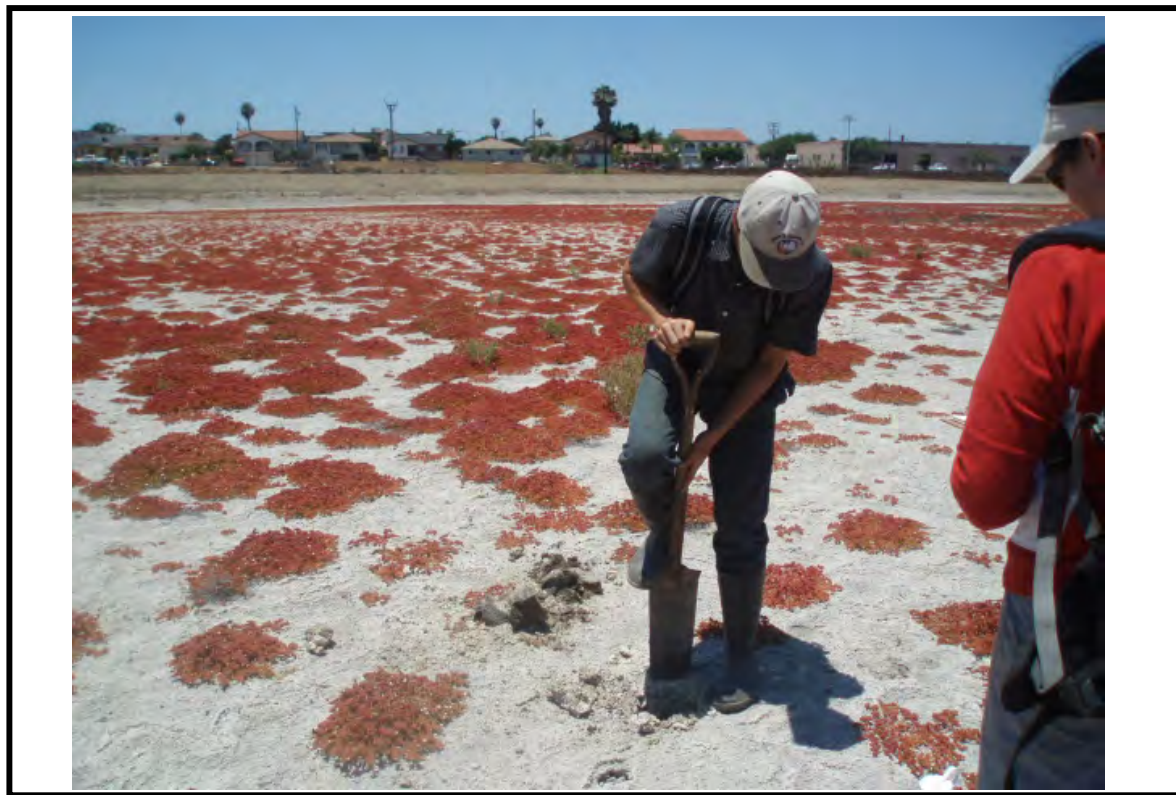
Photo Point 18. Data point 18 is located in an upland portion of the west-central portion of study area, northeast of DP 17. Photo is directed west and was taken June 30, 2008.

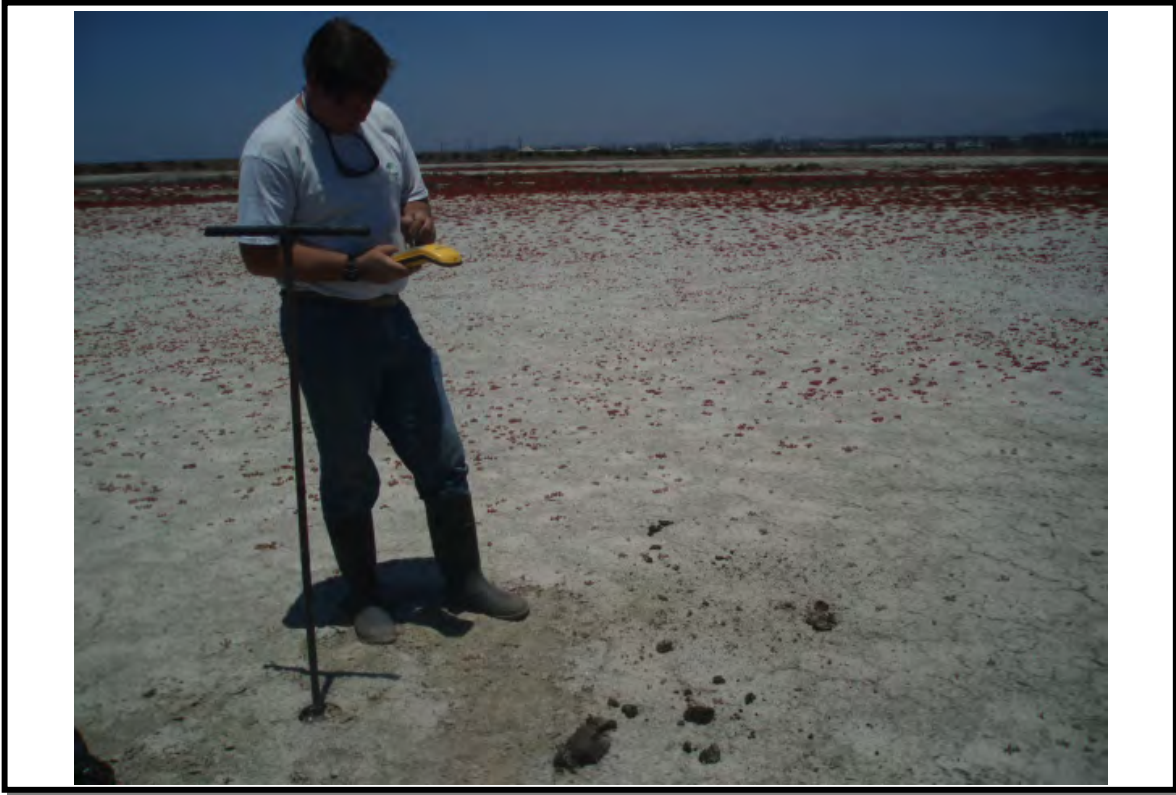
Photo Point 19. Data point 19 is located in the northwestern portion of study area, north of DP 18. Photo is directed northeast and was taken June 30, 2008.

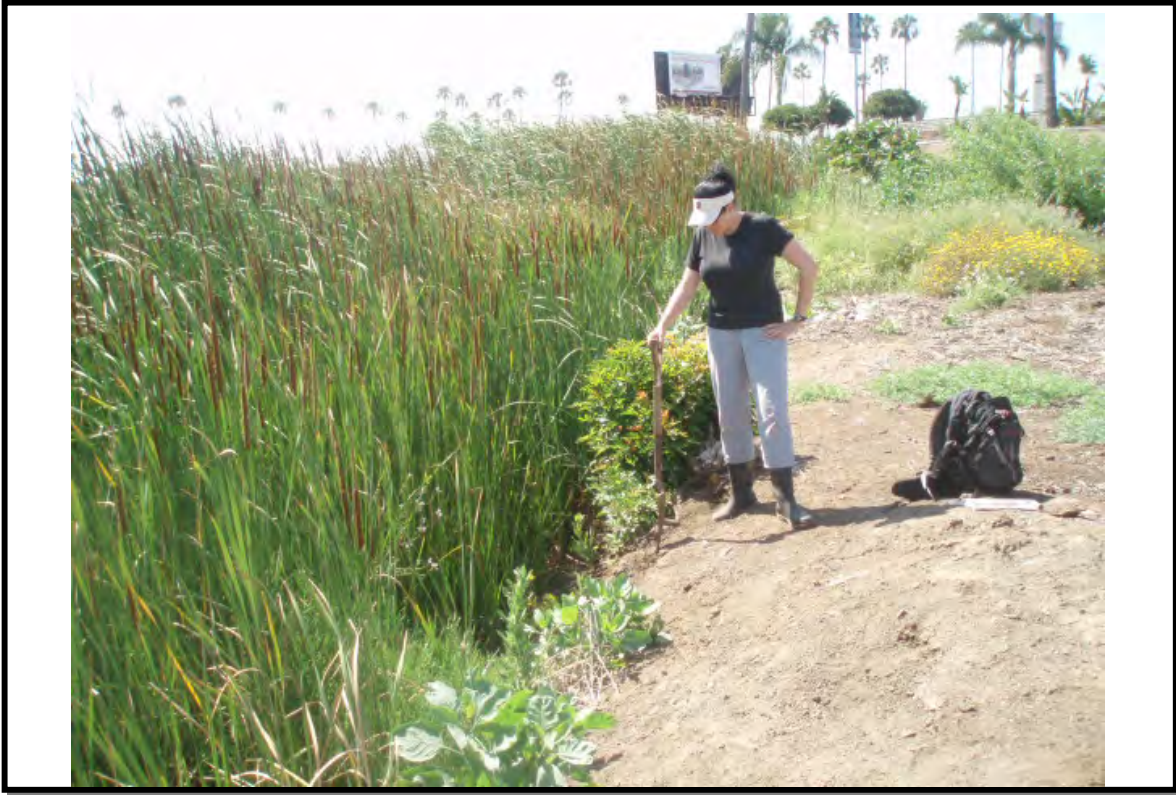
Photo Point 21. Data point 21 is located on the west bank of a channel which runs perpendicular to Palm Avenue on the southwest side of the study area, known to receive runoff from the surrounding area. Photo is directed south and was taken July 1, 2008.

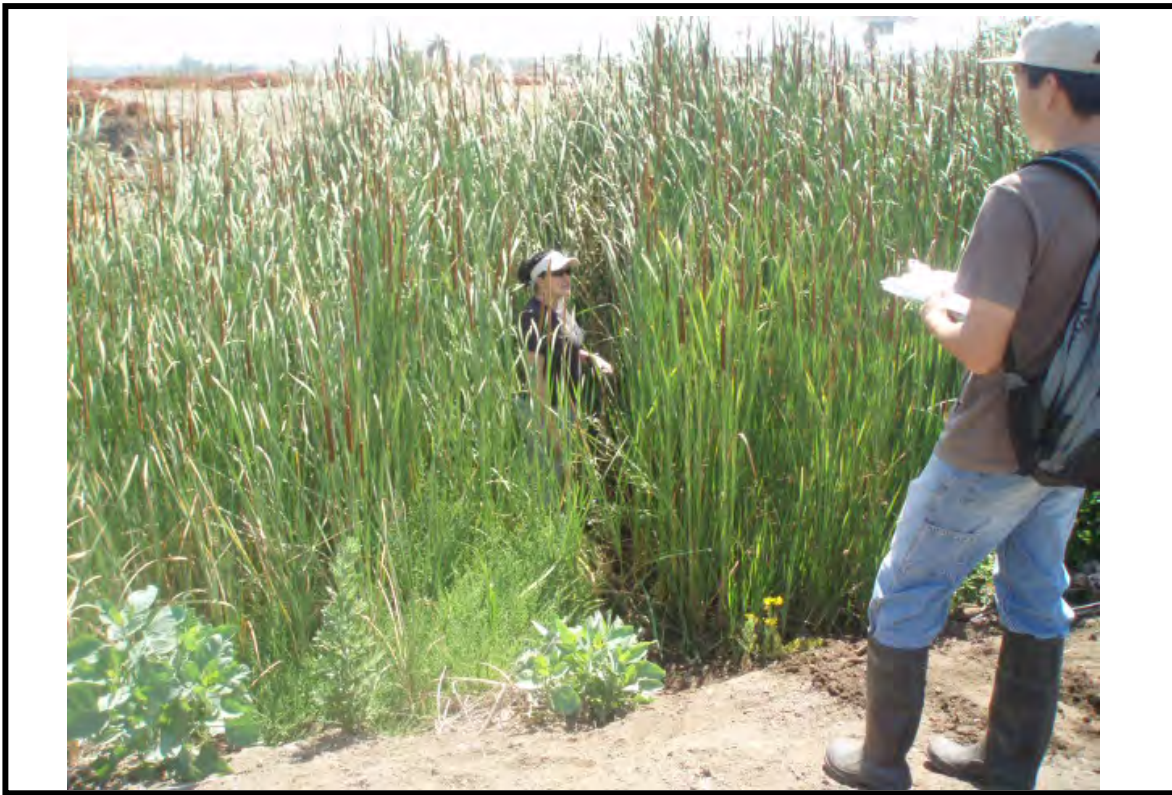
Photo Point 22. Data point 22 is located in center of the channel, east of DP 21. Photo is directed southeast and was taken July 1, 2008.

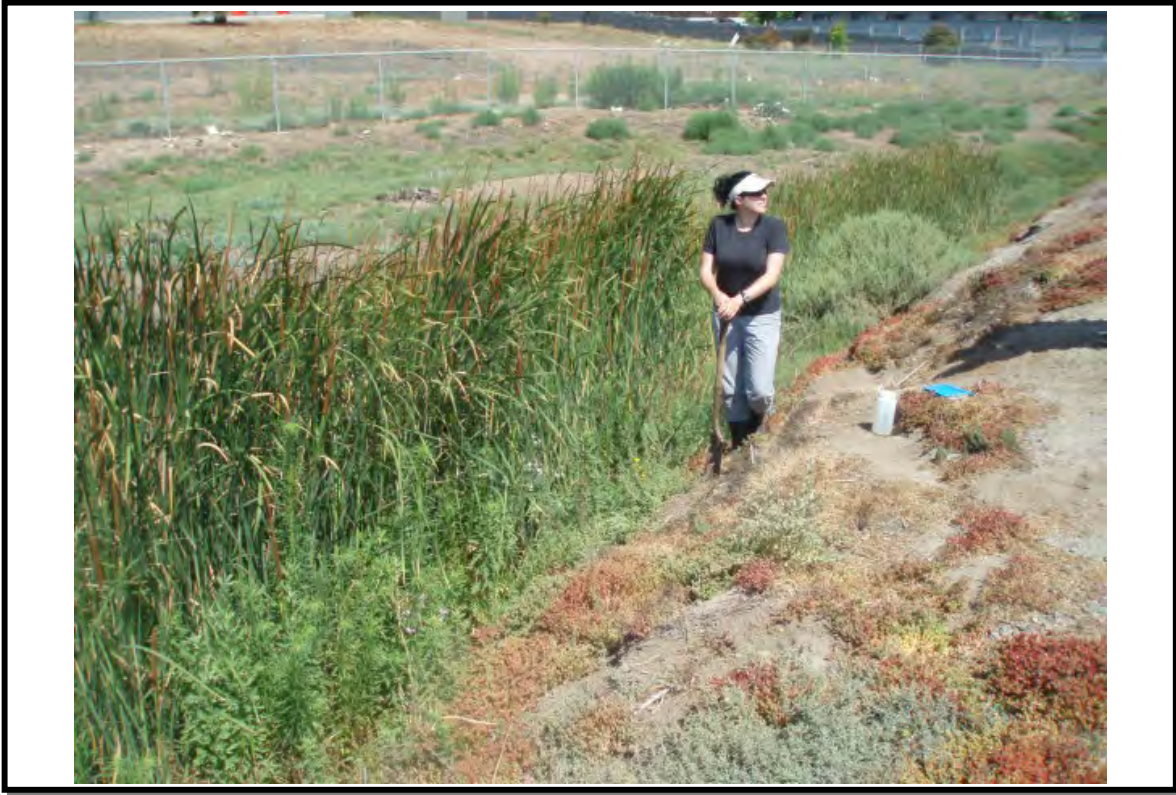
Photo Point 23. Data point 23 is located on west bank of the channel in DP 22. Photo is directed northwest and was taken July 1, 2008.

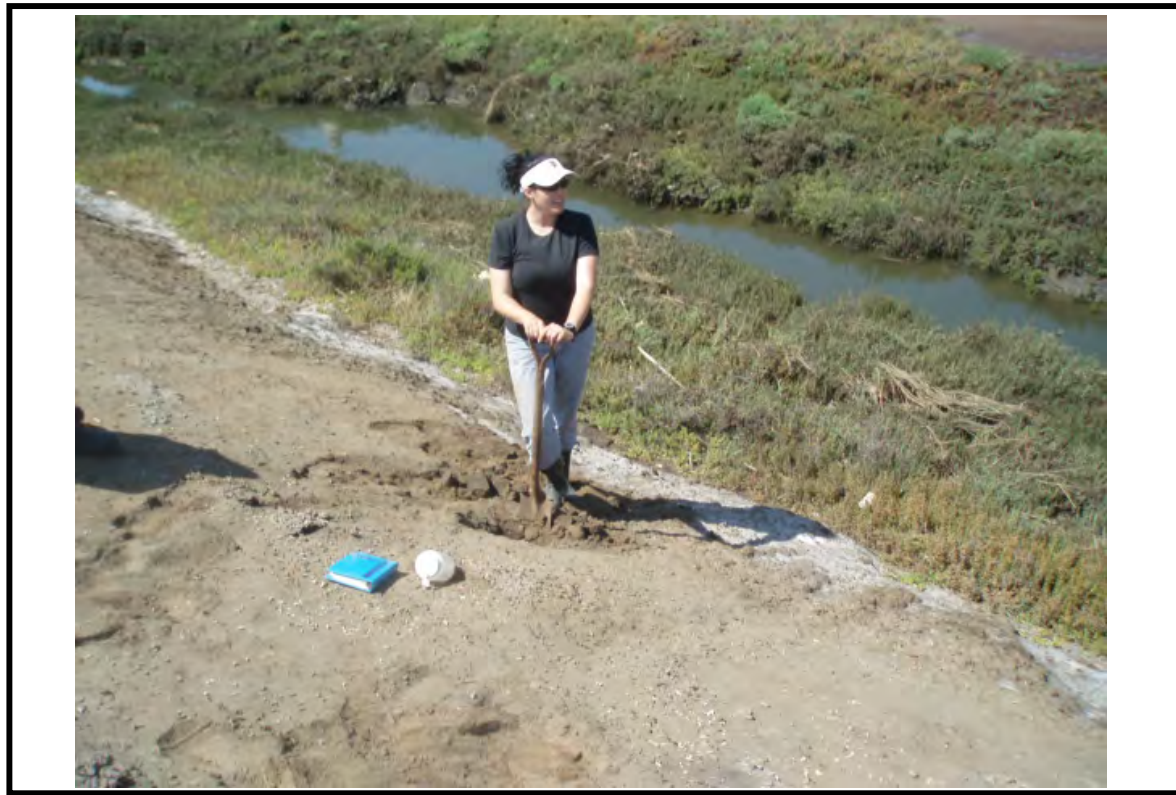
Photo Point 24. Data point 24 is located on the west-central bank of the western berm, northwest of DP 23. Photo is directed southwest, downslope and was taken July 1, 2008.
