**JURISDICTIONAL WETLAND
DELINEATION REPORT
FOR WESTERN SALT POND 20
IMPERIAL BEACH, CALIFORNIA**

San Diego Unified Port District
3165 Pacific Highway
San Diego, CA 92101
Attention: Eileen Maher

Merkel & Associates, Inc.
5434 Ruffin Road
San Diego, CA 92123
Phone: (858) 560-5465
Fax: (858) 560-7779

August 18, 2008

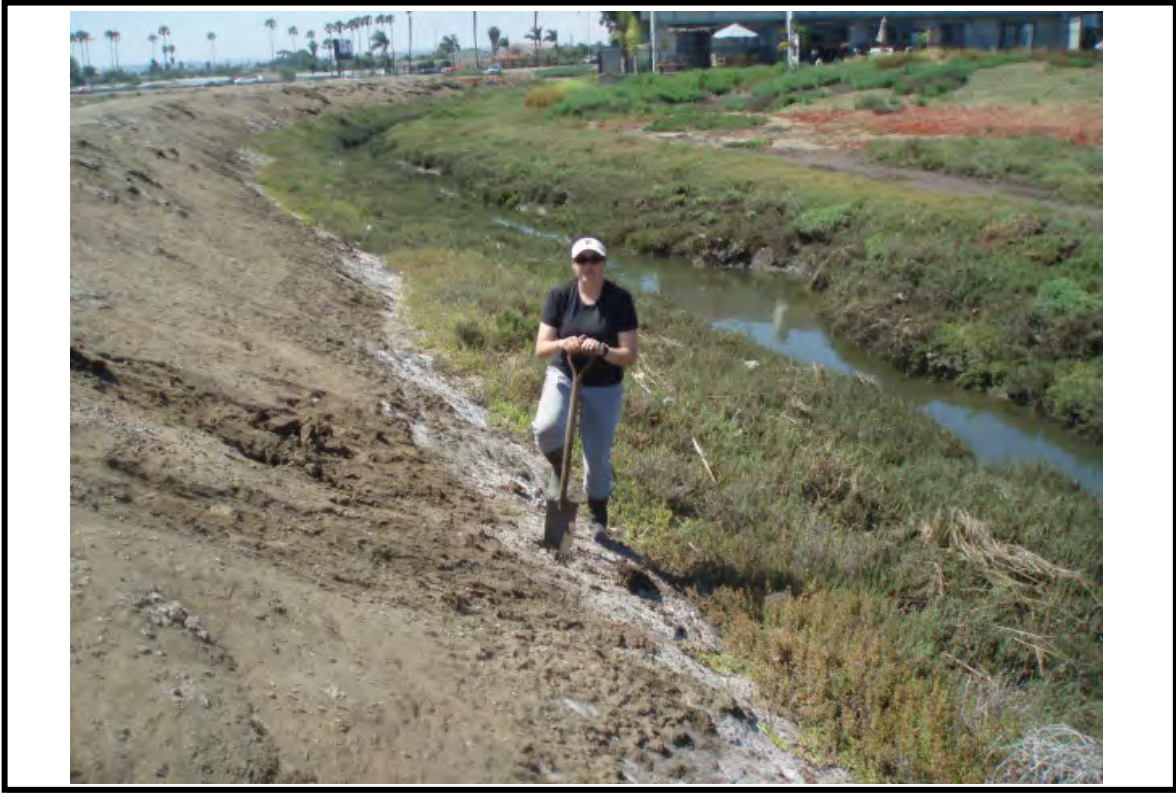
Photo Point 25. Data point 25 is located at the toe of slope, immediately west of DP 24. Photo is directed south and was taken July 1, 2008.

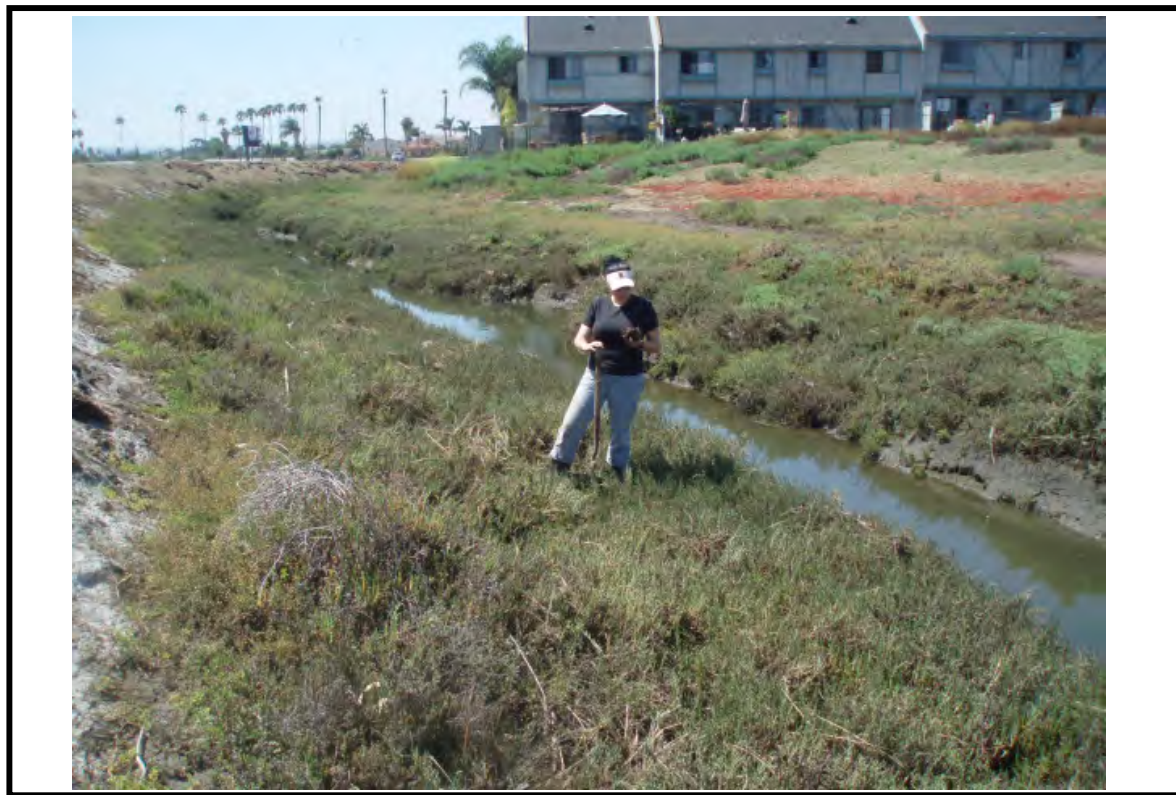
Photo Point 26. Data point 26 is located on the lower bank on east side of western stream channel, west of DP 25. Photo is directed south and was taken July 1, 2008.

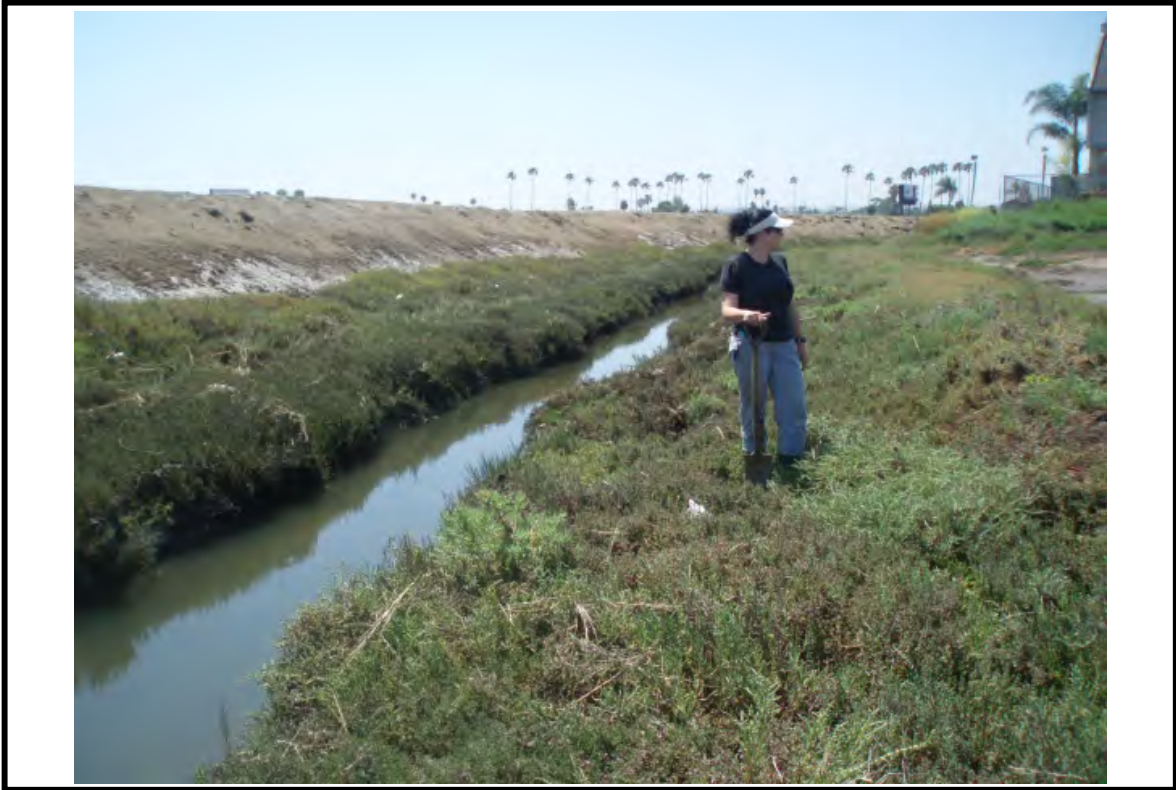
Photo Point 27. Data point 27 is located on the lower bank on west side of western stream channel, west of DP 26. Photo is directed south and was taken July 1, 2008.

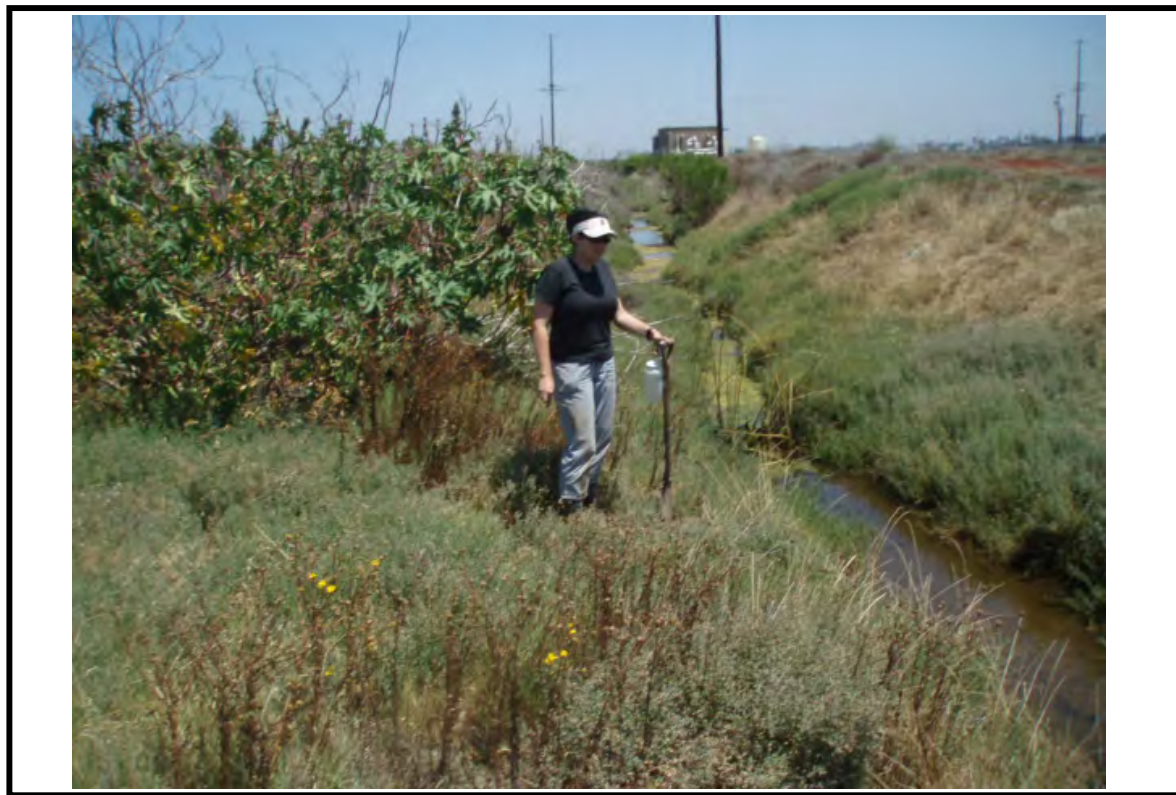
Photo Point 28. Data point 28 is located on the western bank of eastern stream channel. Photo is directed north and was taken July 1, 2008.

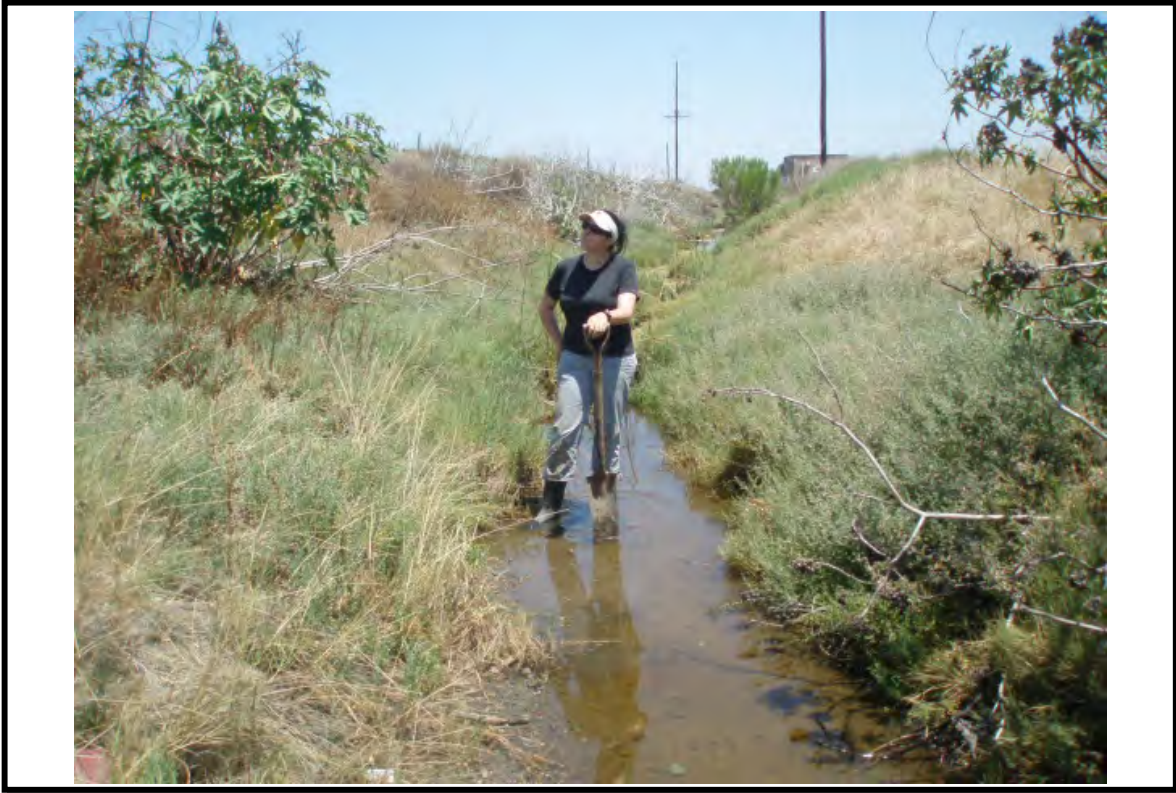
Photo Point 29. Data point 29 is located within center of eastern stream channel. Photo is directed north and was taken July 1, 2008.

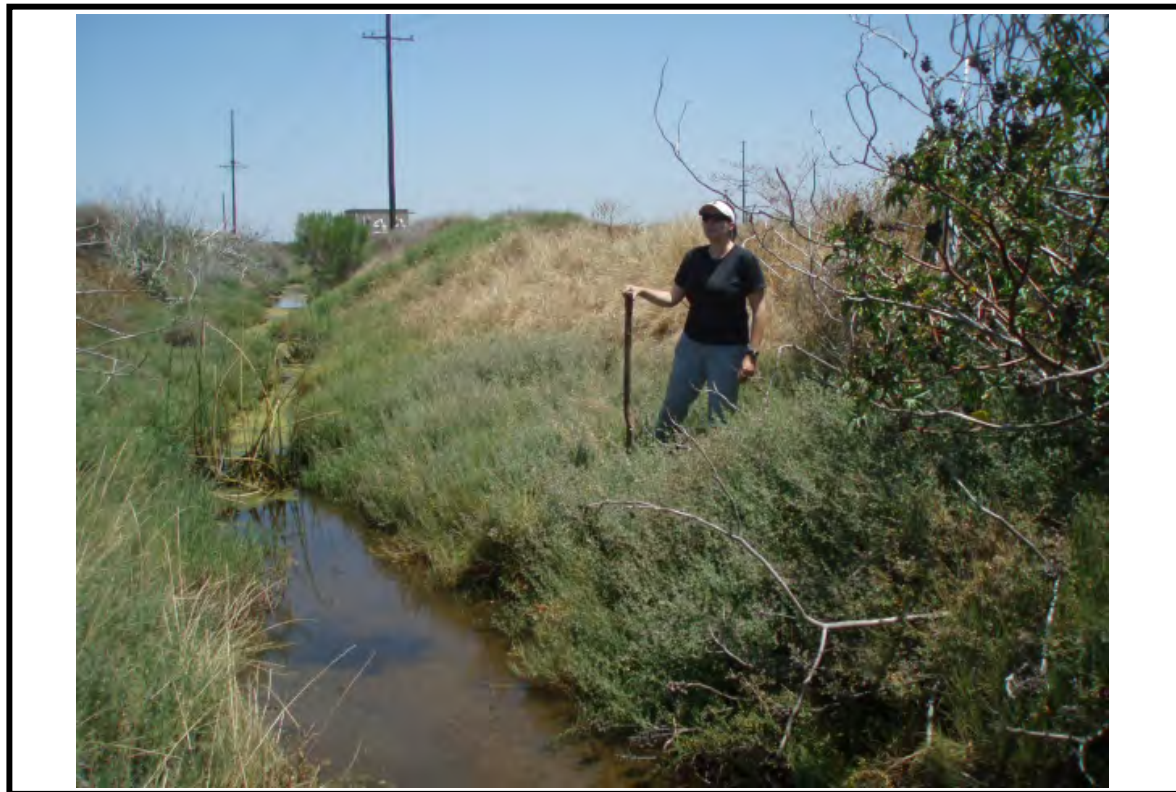
Photo Point 30. Data point 30 is located on the eastern bank of eastern stream channel. Photo is directed north and was taken July 1, 2008.

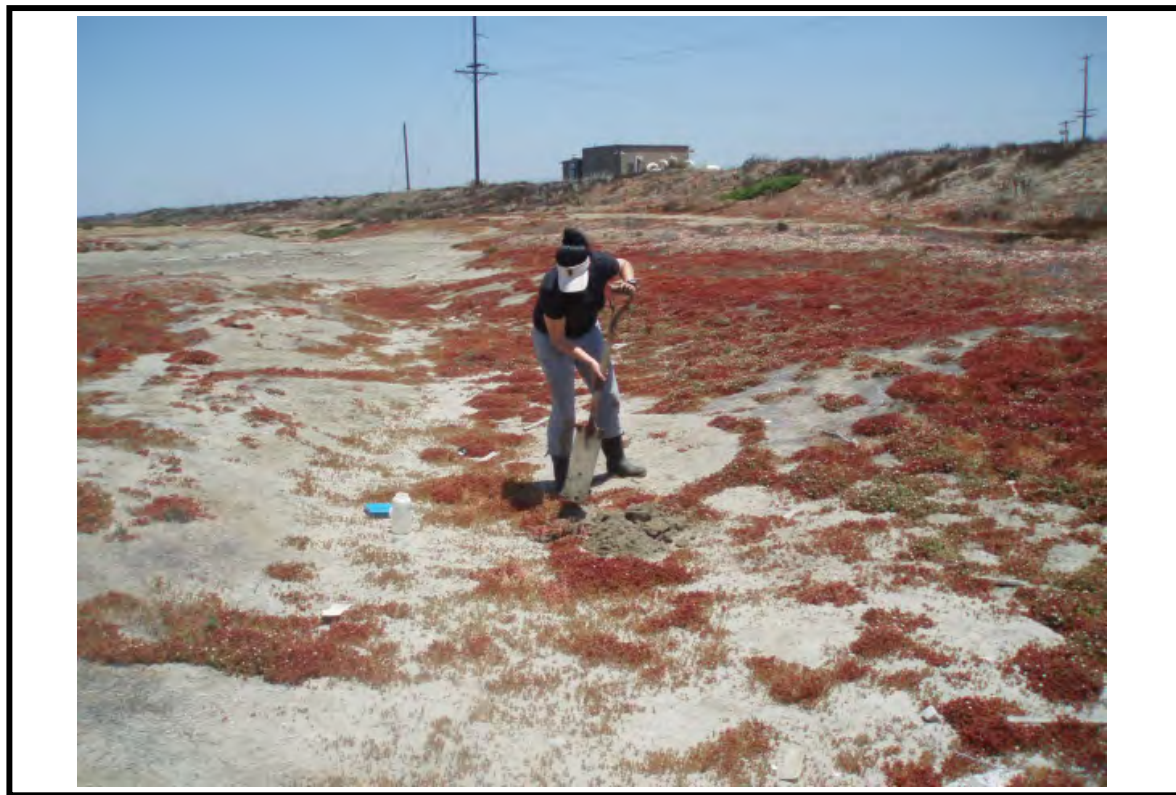
Photo Point 32. Data point 32 is located in a slight depression created by historical drainage patterns in the southeastern portion of study area, immediately northwest of DP 31. Photo is directed north and was taken July 1, 2008.

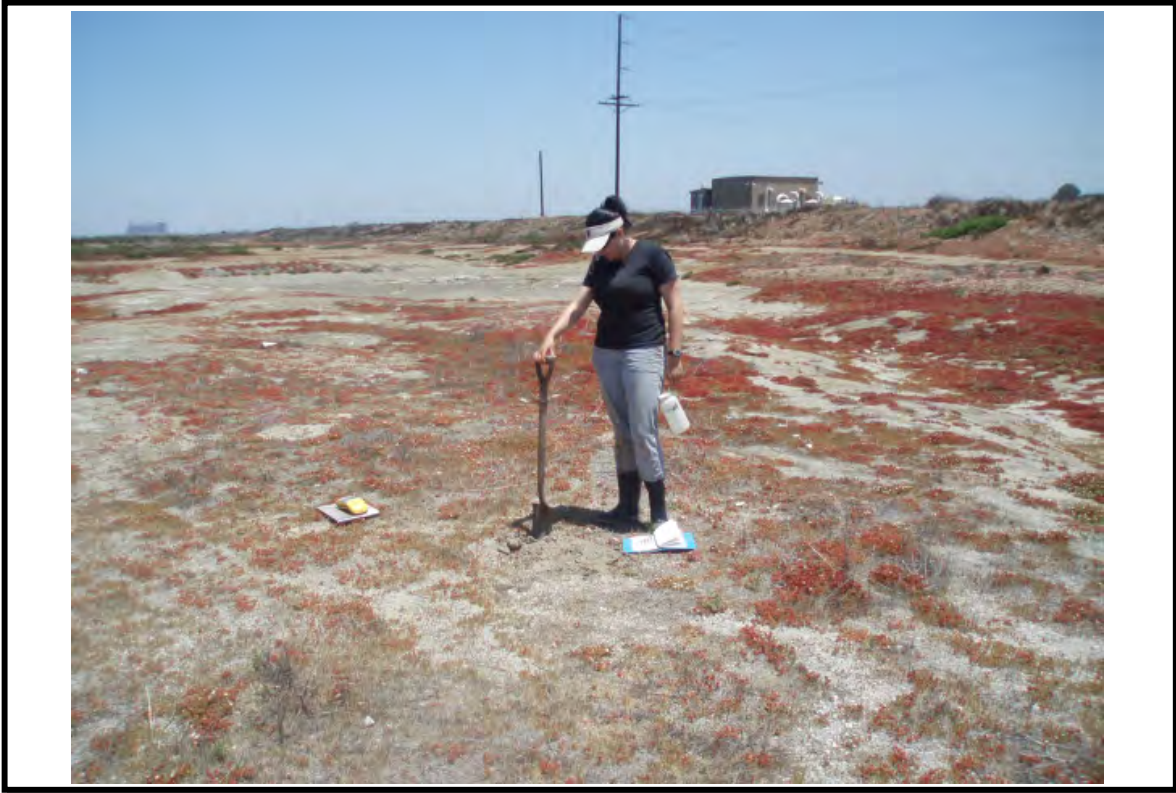
Photo Point 33. Data point 33 is located in a slightly raised area within southeastern portion of study area, immediately west of DP 32. Photo is directed northeast and was taken July 1, 2008.

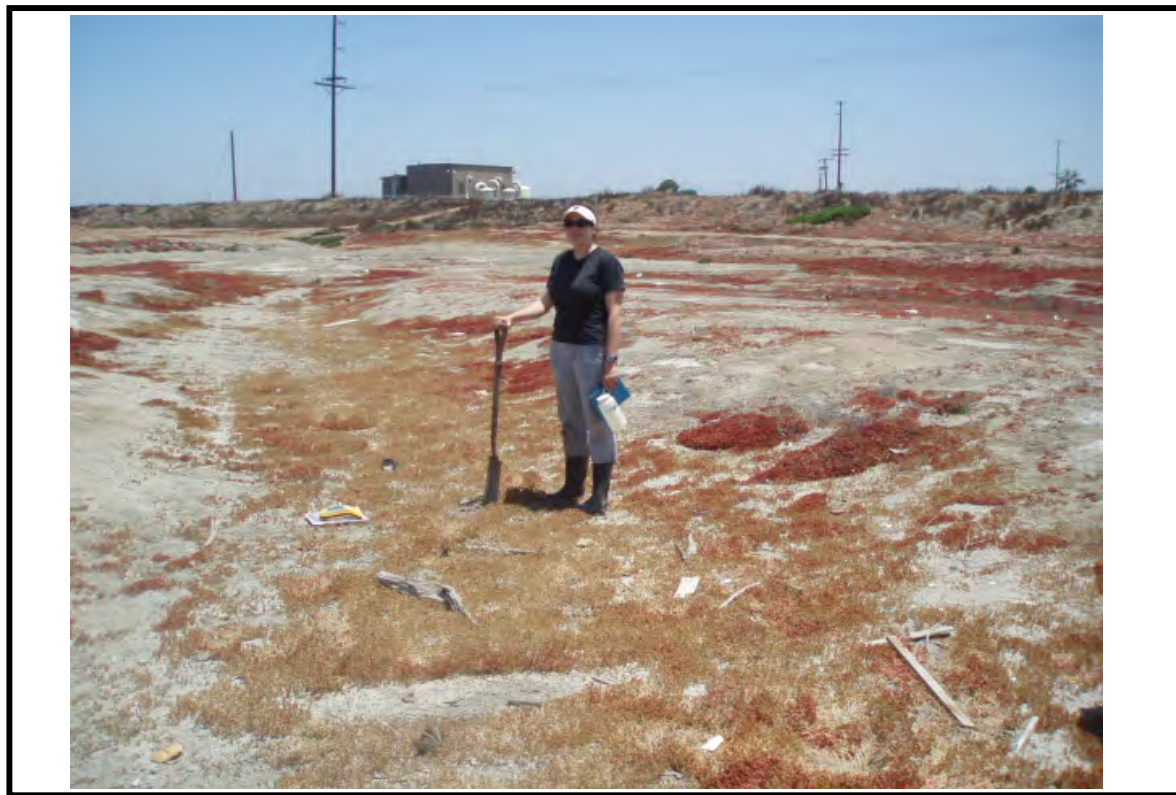
Photo Point 34. Data point 34 is located in a slight depression created by historical drainage patterns in southeastern portion of study area, immediately northwest of DP 33. Photo is directed northeast and was taken July 1, 2008.

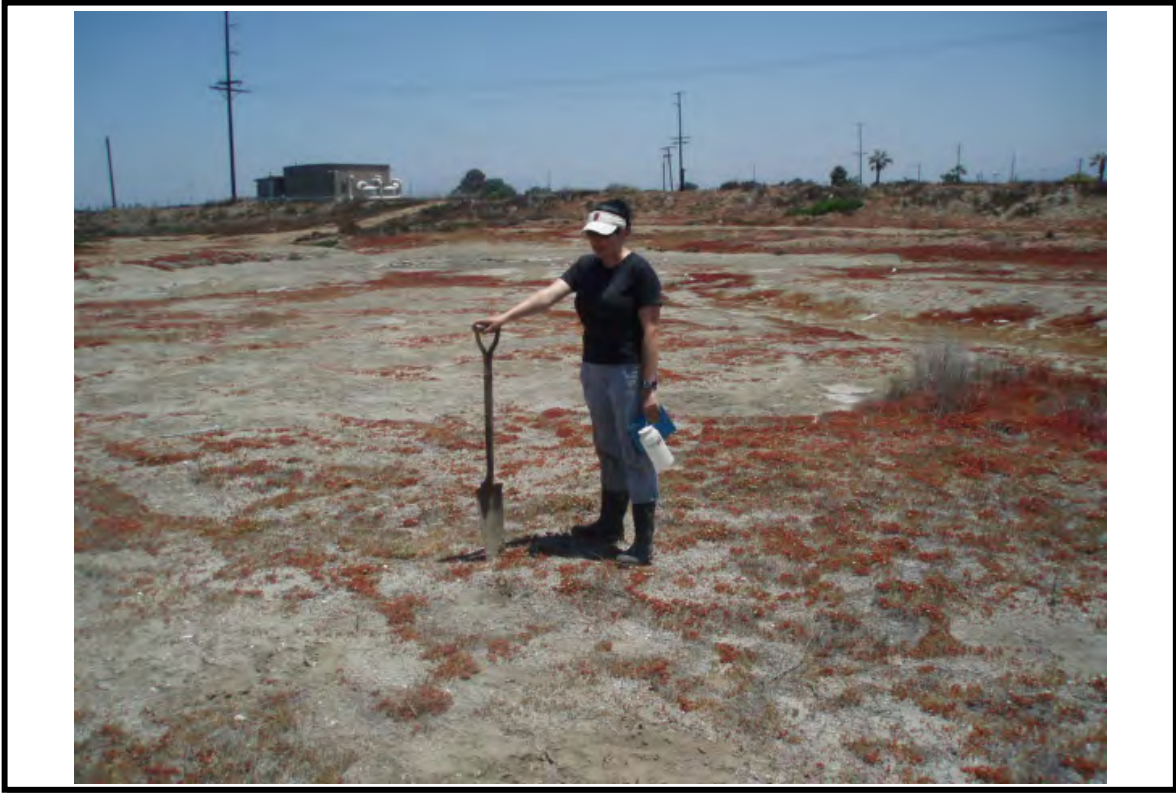
Photo Point 35. Data point 35 is located in a slightly raised area within southeastern portion of study area, immediately northwest of DP 34. Photo is directed northeast and was taken July 1, 2008.

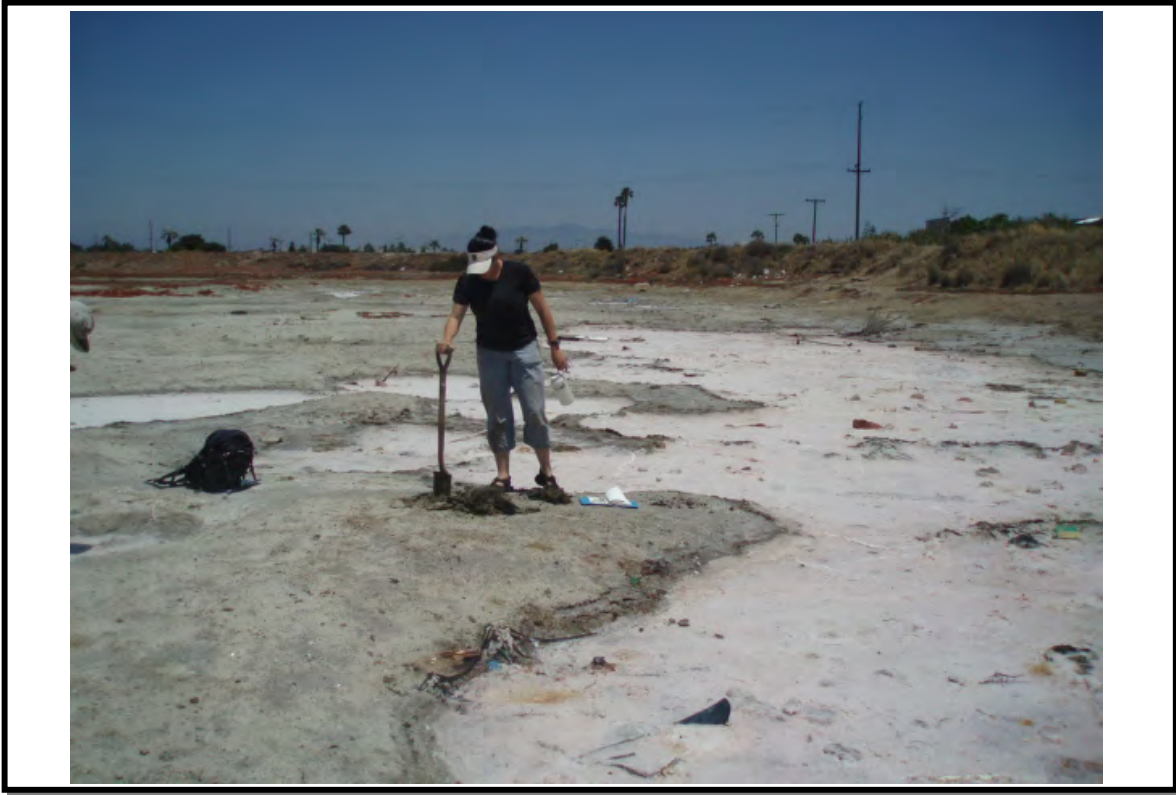
Photo Point 37. Data point 37 is located on island within center of channel, comprised of drift deposits and salt crusts, created by historical drainage patterns. DP 37 is located immediately north of DP 36. Photo is directed east and was taken July 1, 2008.

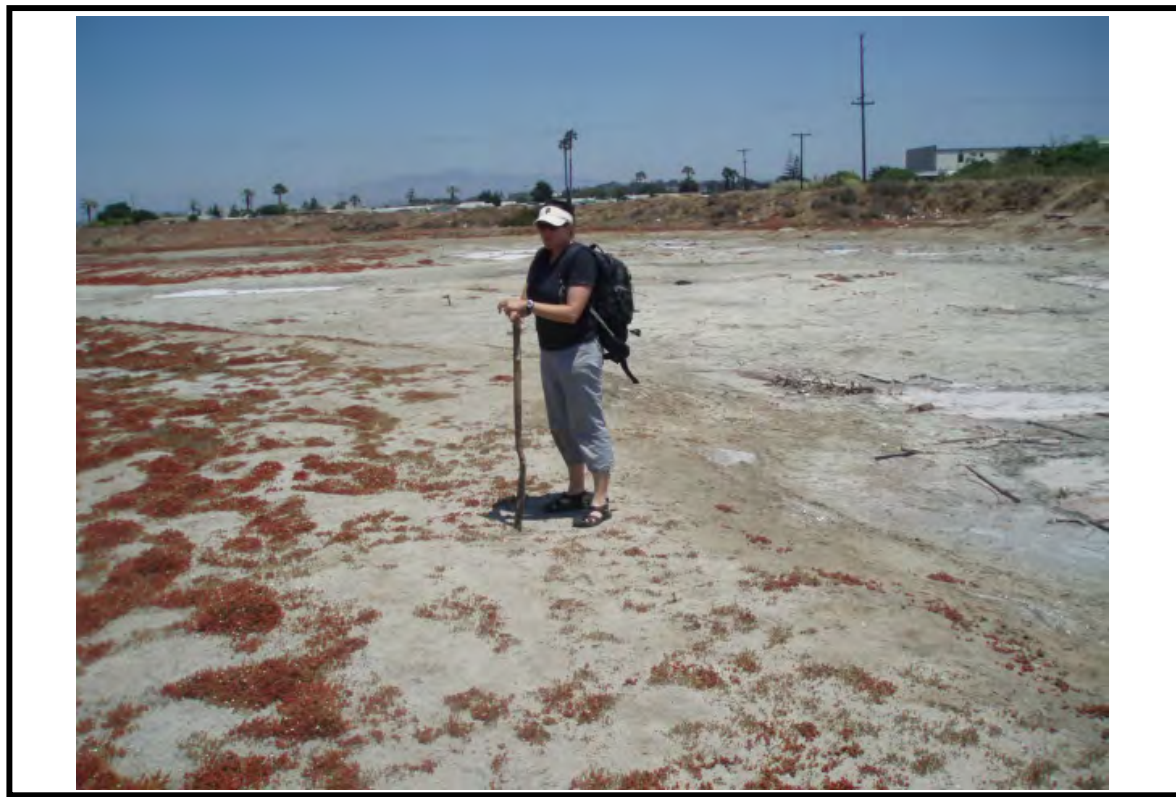
Photo Point 38. Data point 38 is located on the northern outside edge of the historic channel in DP 37. Photo is directed east and was taken July 1, 2008.

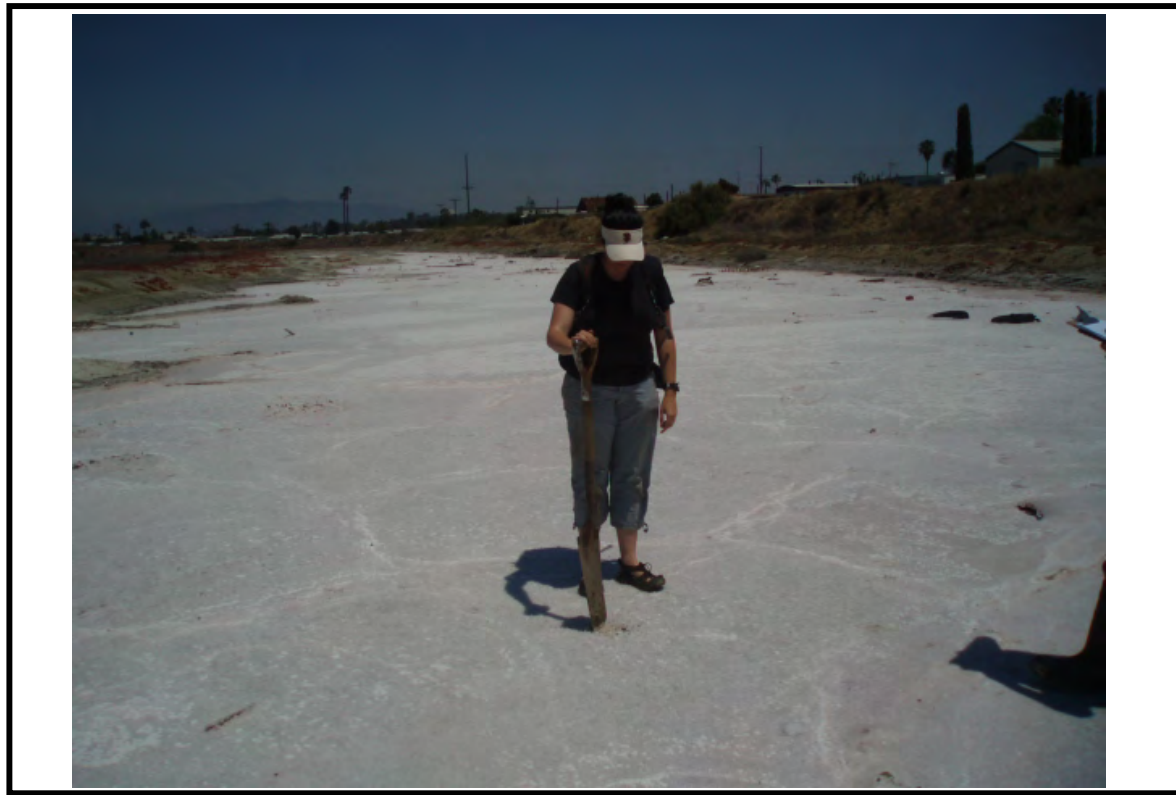
Photo Point 40. Data point 40 is located within salt panne, directly west of DP 37. This area exhibits historic drainage patterns parallel to the southern berm surrounding the site. Photo is directed east and was taken July 1, 2008.

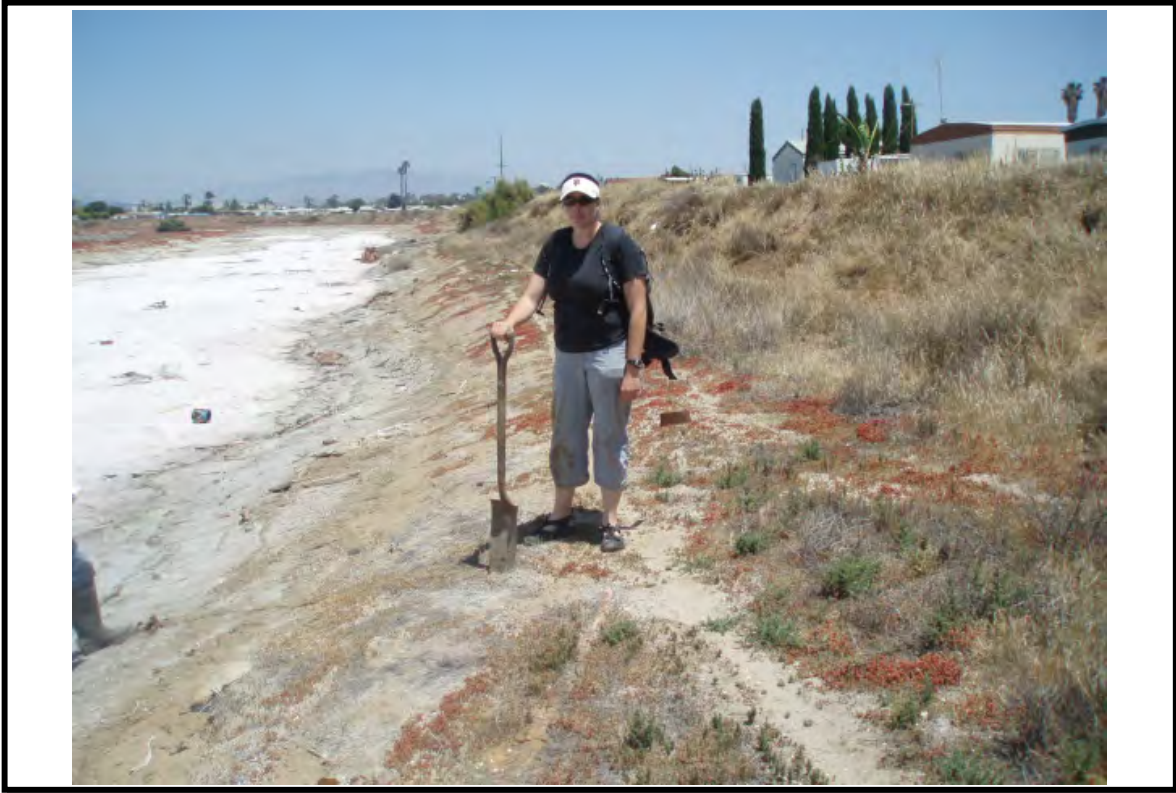
Photo Point 41. Data point 41 is located directly west of DP 36, in upland habitat. Photo is directed east and was taken July 1, 2008.

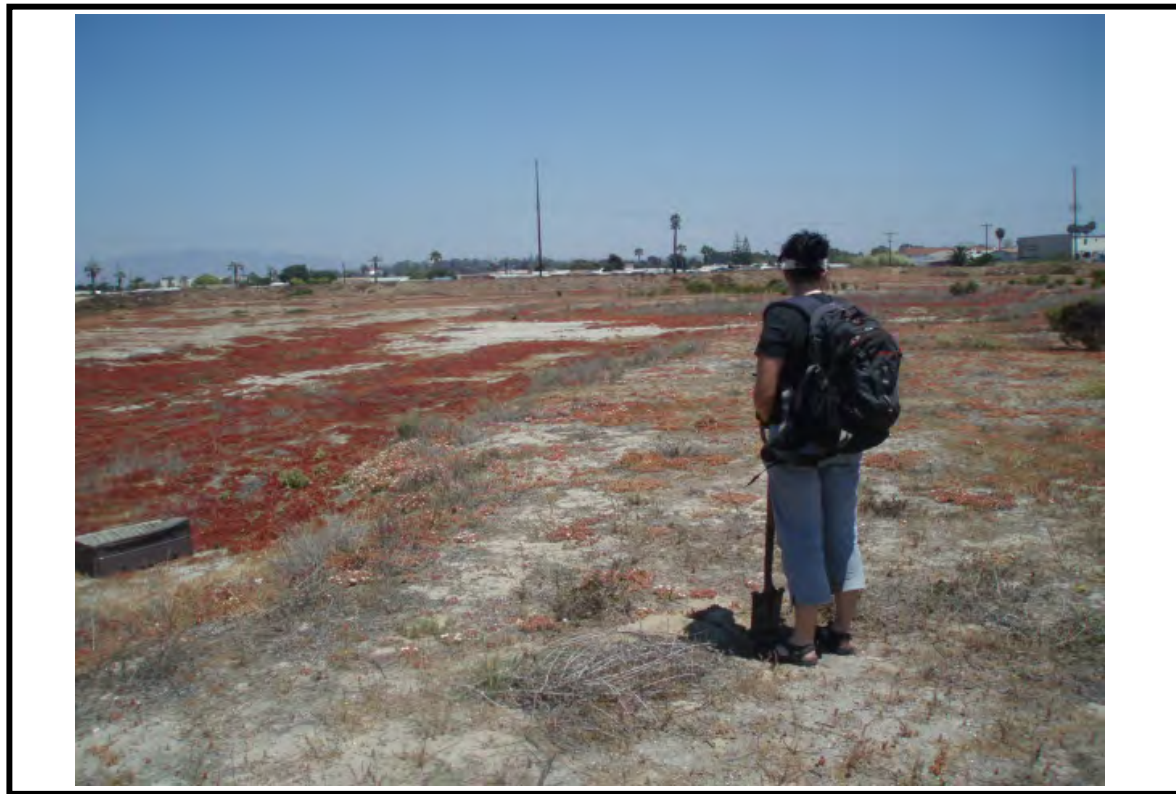
Photo Point 42. Data point 42 is located within the east-central portion of the study area in upland habitat. Photo is directed southeast and was taken July 1, 2008.

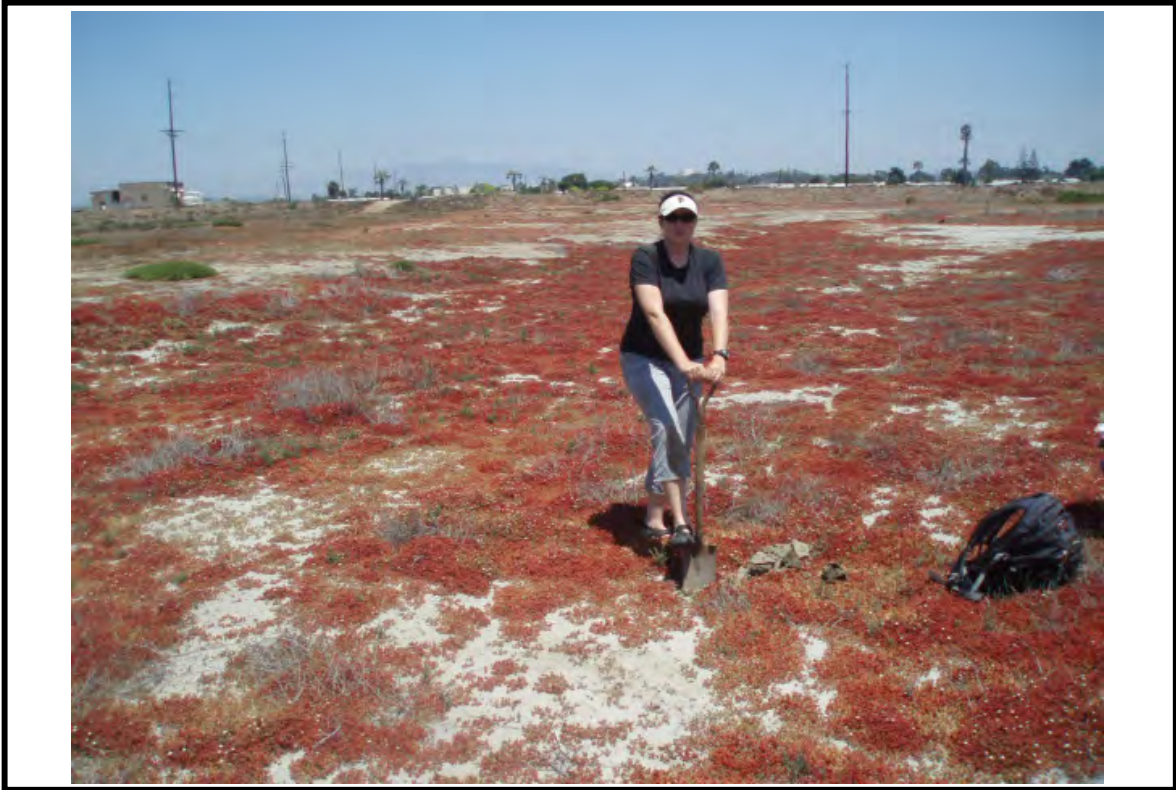
Photo Point 43. Data point 43 is located within the east-central portion of the study area in upland habitat, north of DP 42. Photo is directed east and was taken July 1, 2008.

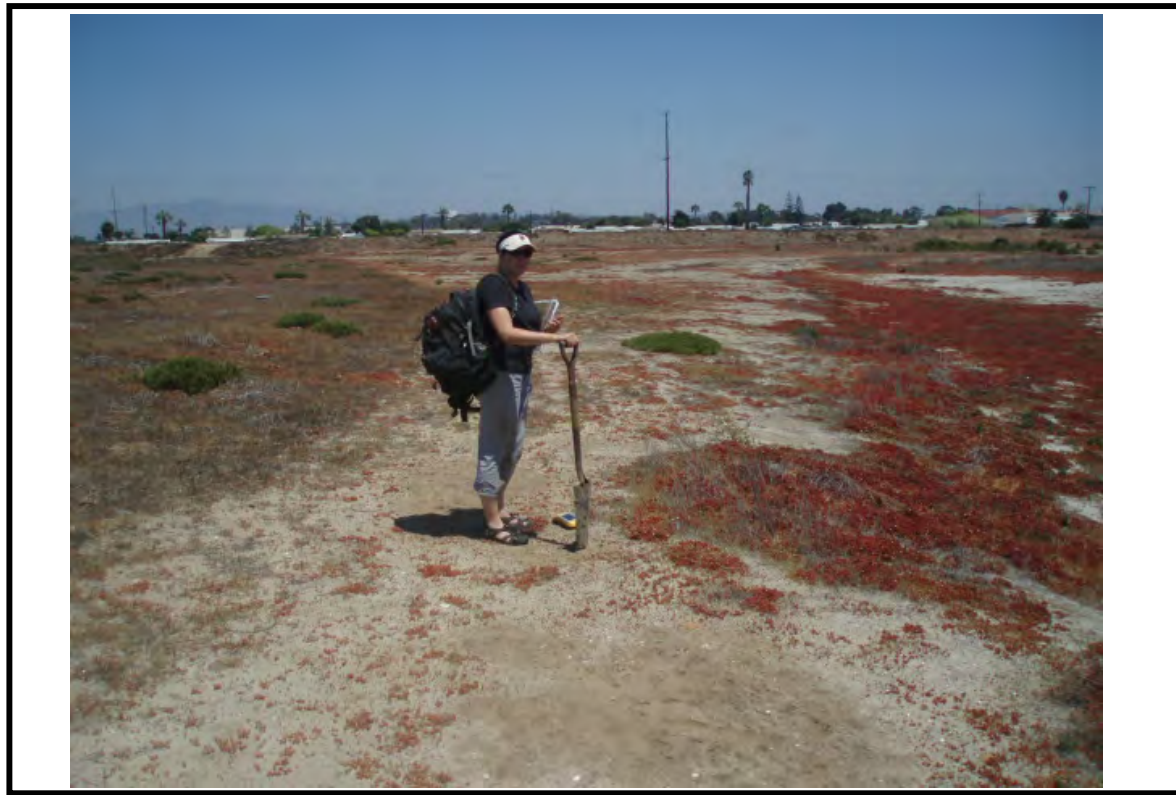
Photo Point 44. Data point 44 is located within the east-central portion of the study area in upland habitat, north of DP 43. Photo is directed east and was taken July 1, 2008.

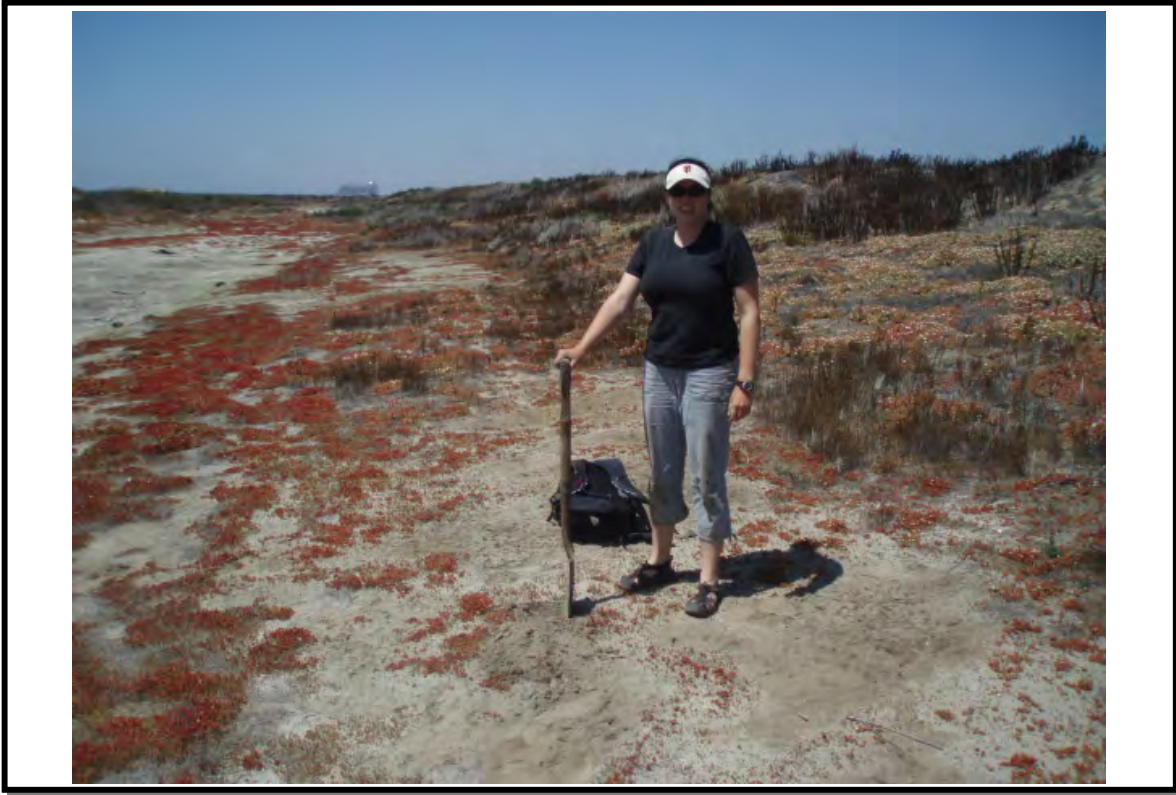
Photo Point 47. Data point 47 is located at the eastern limit of the historically flooded channel in DP 46, above. Photo is directed north and was taken July 1, 2008.

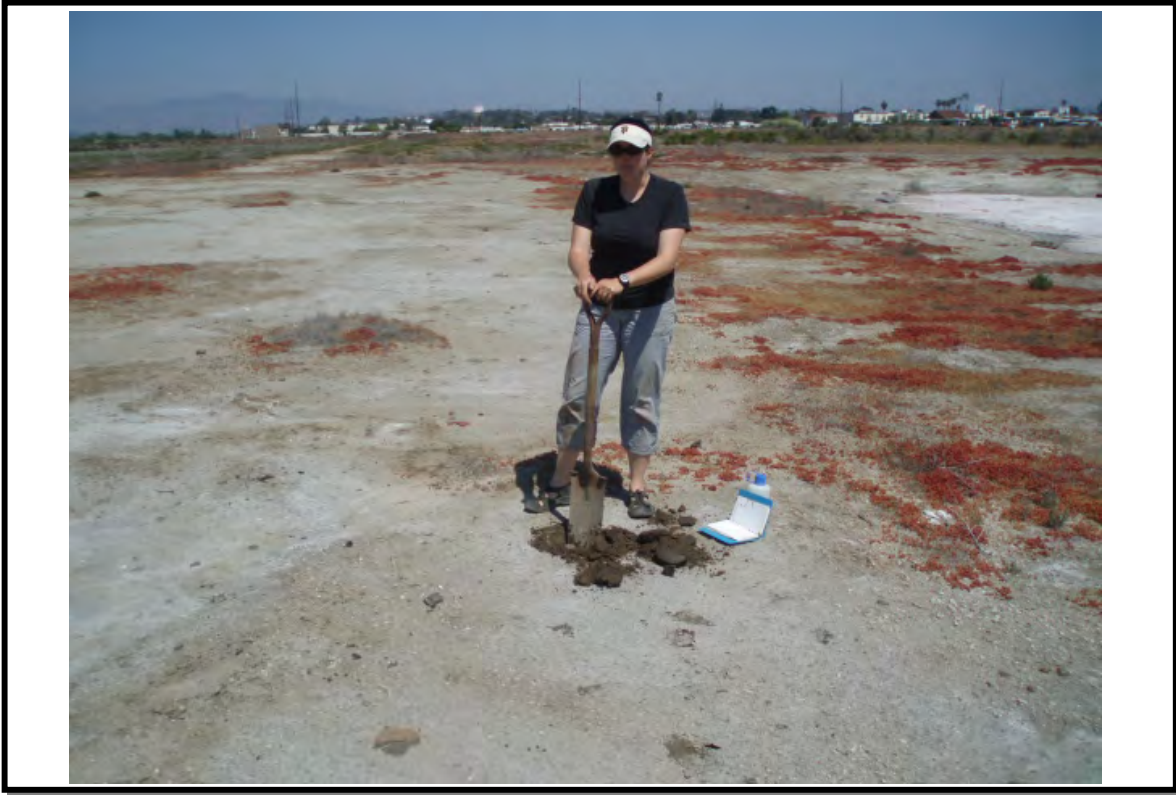
Photo Point 49. Data point 49 is located in the north-central portion of study area in an area of sediment deposits caused by historical hydrologic processes, immediately south of DP 48. Photo is directed east and was taken July 1, 2008.

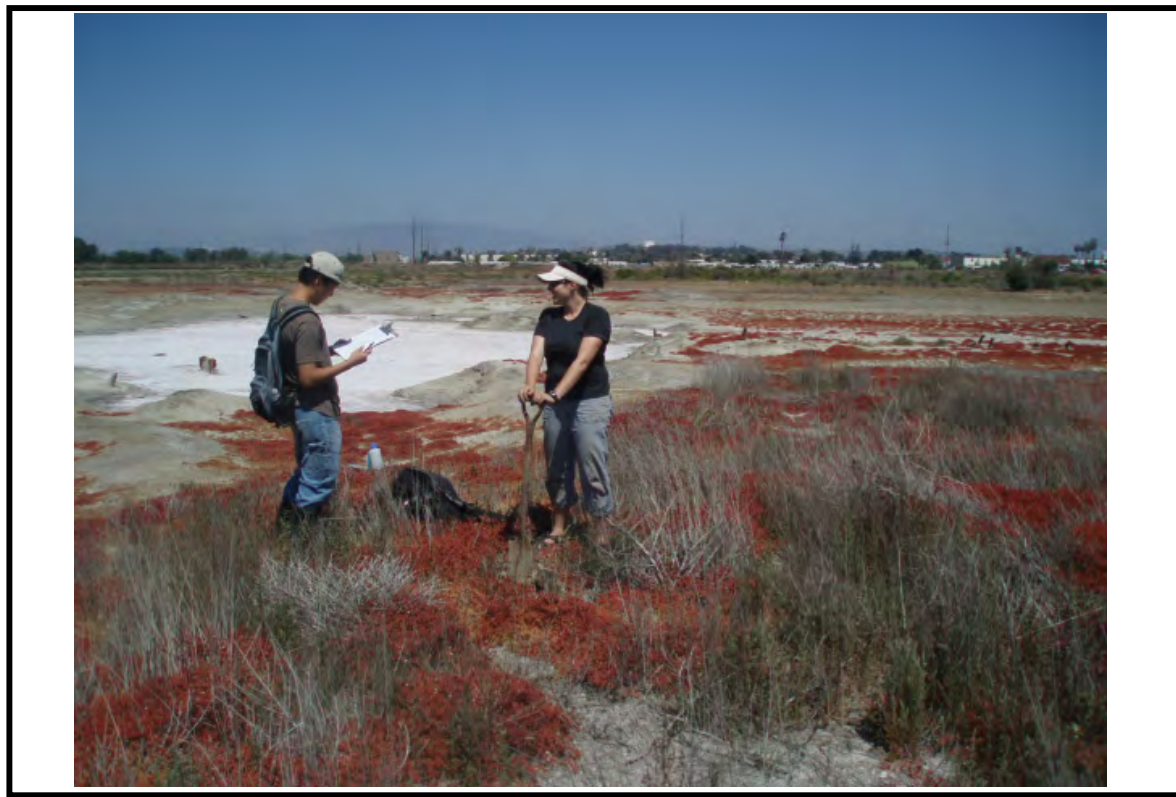
Photo Point 50. Data point 50 is located within upland habitat in the north-central portion of study area, south of DP 49. Photo is directed east and was taken July 1, 2008.

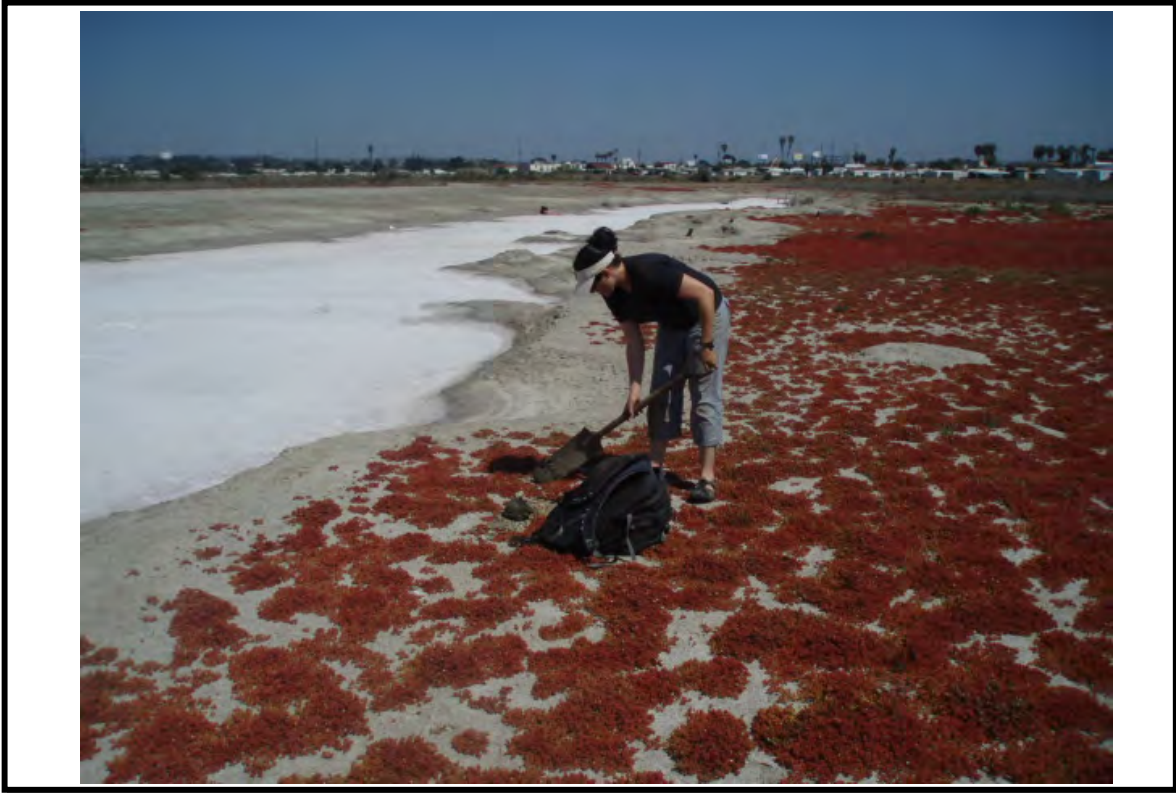
Photo Point 51. Data point 51 is located in an area subject to historical flooding, in the northwestern portion of the study area. Photo is directed southeast and was taken July 1, 2008.

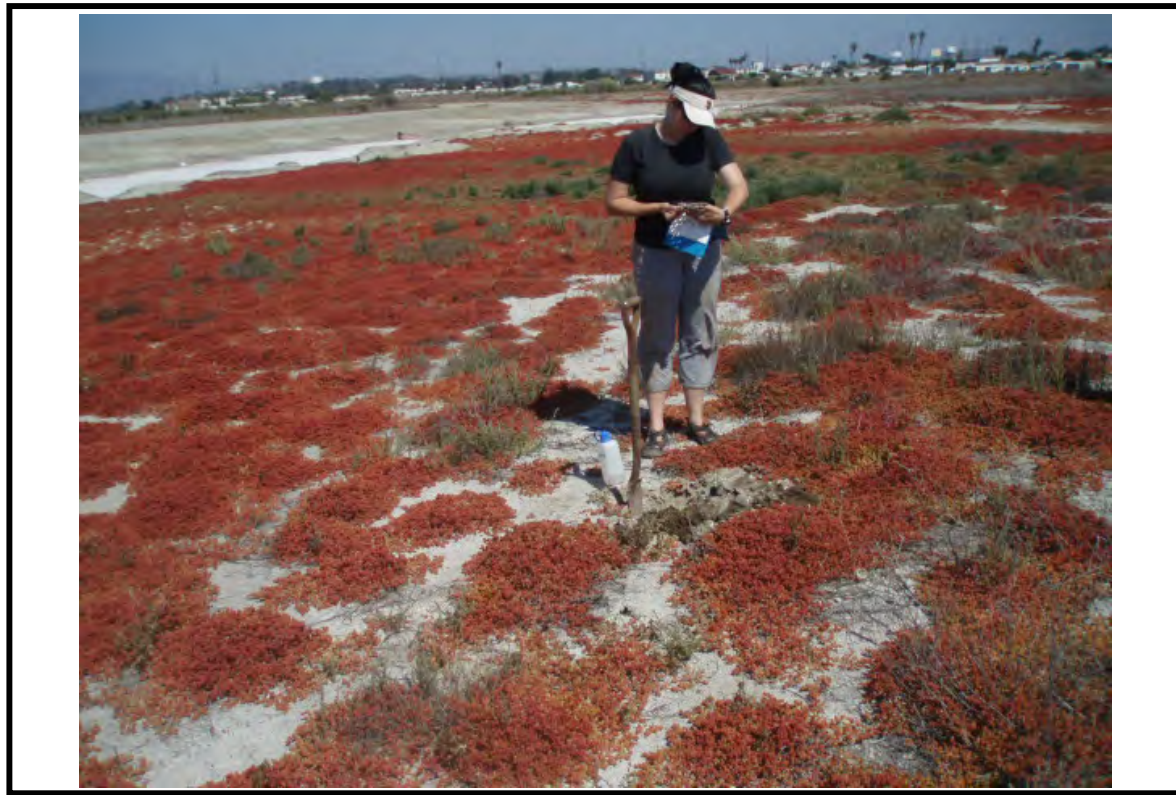
Photo Point 52. Data point 52 is located within upland area just southwest of DP 51. Photo is directed southeast and was taken July 1, 2008.

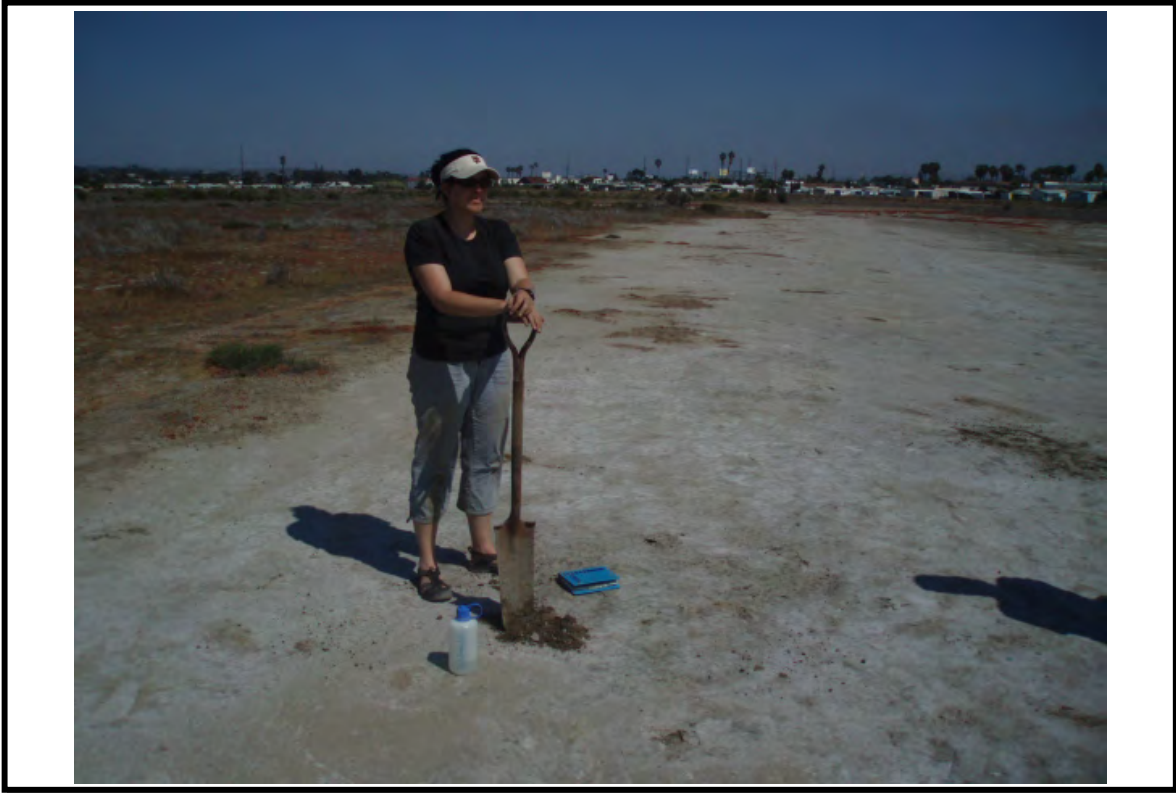
Photo Point 53. Data point 53 is located on the northwestern outside edge of the area in DP 51. Photo is directed southeast and was taken July 1, 2008.
