**JURISDICTIONAL WETLAND
DELINEATION REPORT
FOR WESTERN SALT POND 20
IMPERIAL BEACH, CALIFORNIA**

San Diego Unified Port District
3165 Pacific Highway
San Diego, CA 92101
Attention: Eileen Maher

Merkel & Associates, Inc.
5434 Ruffin Road
San Diego, CA 92123
Phone: (858) 560-5465
Fax: (858) 560-7779

August 18, 2008

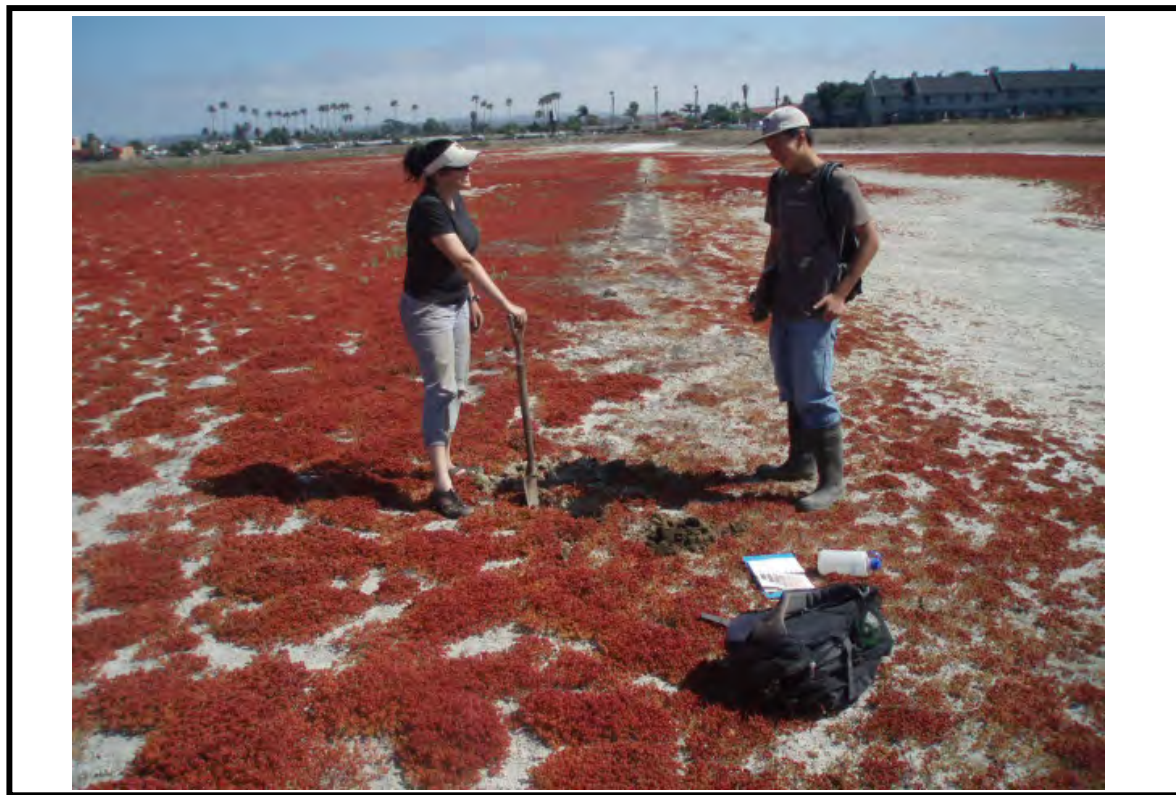
Photo Point 54. Data point 54 is located on the outside edge of an area subject to historic flooding, within the northwestern portion of the study area. Photo is directed south and was taken July 1, 2008.

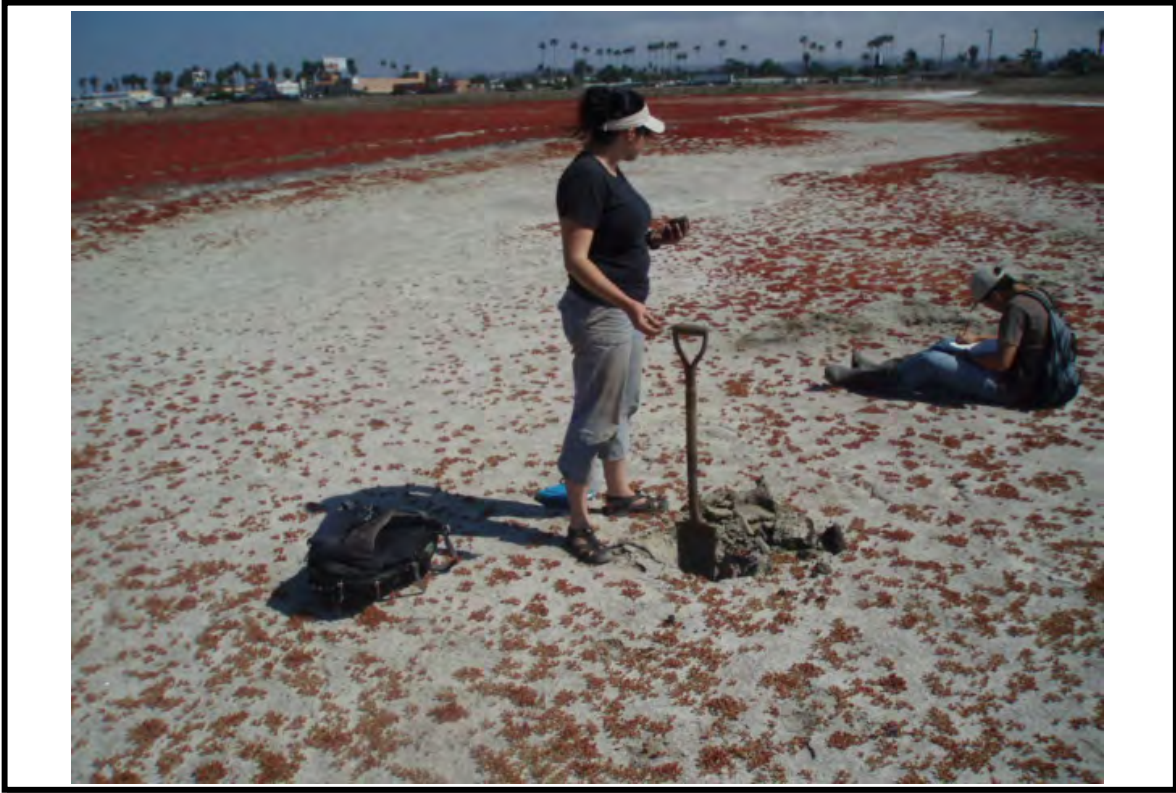
Photo Point 55. Data point 55 is located within an area subject to historic flooding, within the northwestern portion of the study area. Photo is directed south and was taken July 1, 2008.

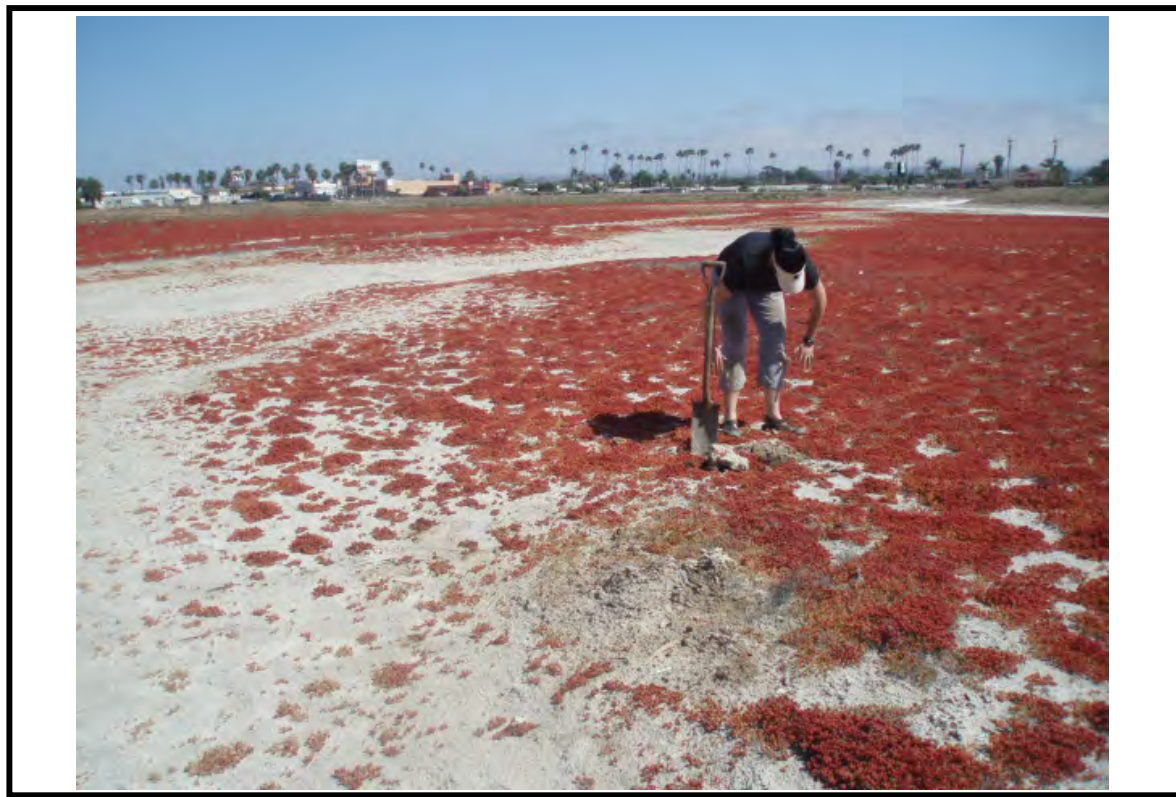
Photo Point 56. Data point 56 is located along slightly elevated area that defines the western limit of the historically flooded area of DP 55. Photo is directed south and was taken July 1, 2008.

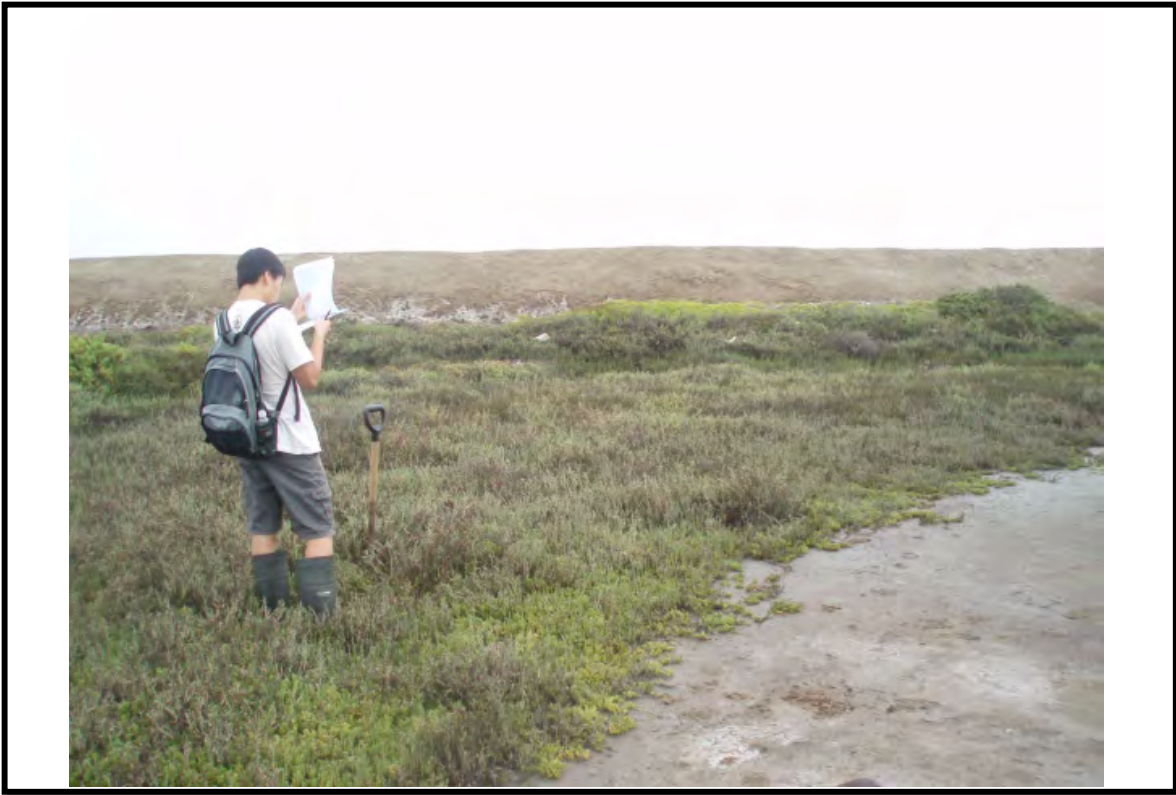
Photo Point 57. Data point 57 is located west of berm in the western portion of the study area. DP 57 is located within an area subject to tidal influence. Photo is directed east and was taken July 7, 2008.

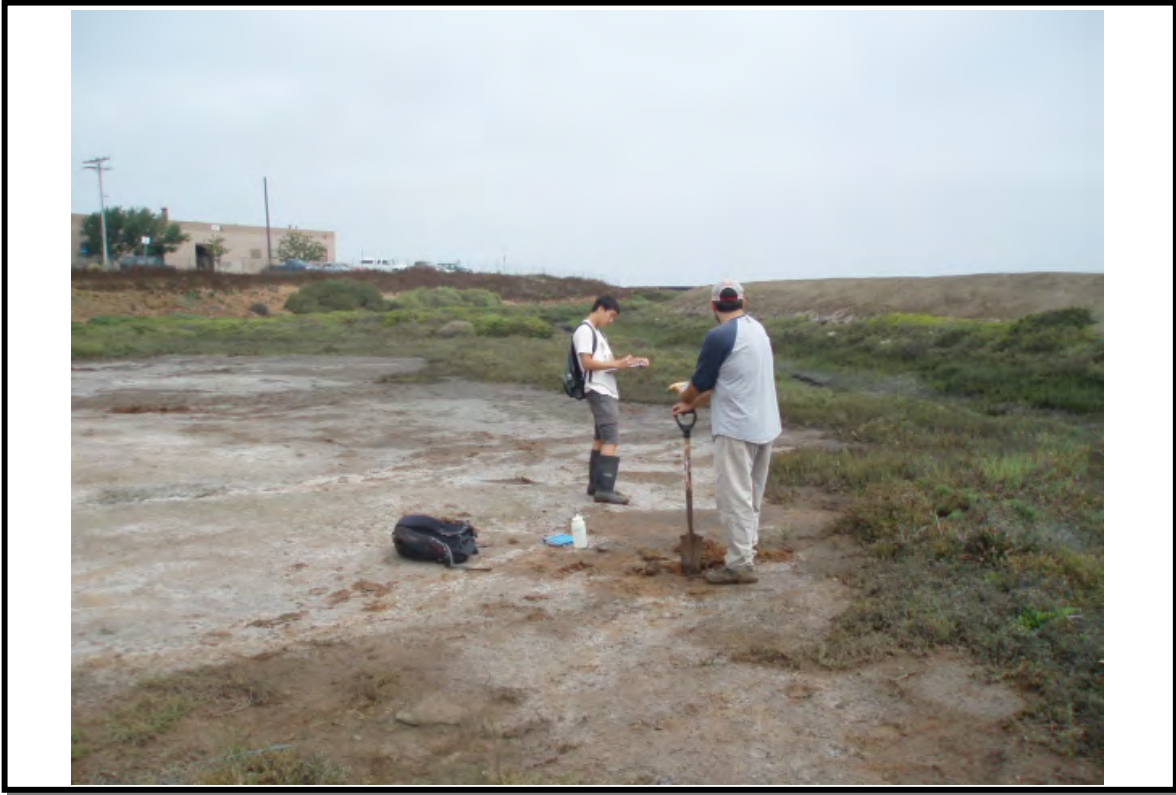
Photo Point 61. Data point 61 is located west of berm in the western portion of the study area. DP 61 is located along the inside edge of the area subject to tidal influence, southeast of DP 60. Photo is directed north and was taken July 7, 2008.

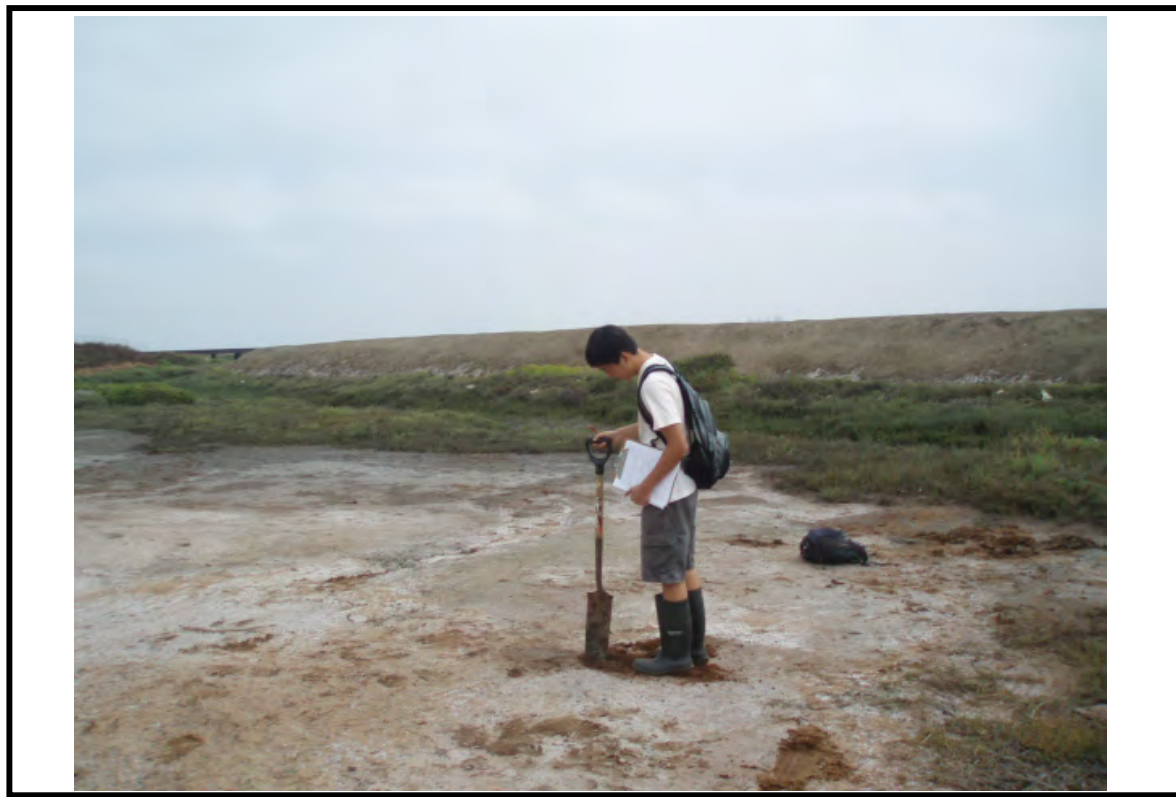
Photo Point 62. Data point 62 is located west of berm in the western portion of the study area. DP 62 is located along outside edge of area subject to tidal influence, west of DP 61. Photo is directed north and was taken July 7, 2008.

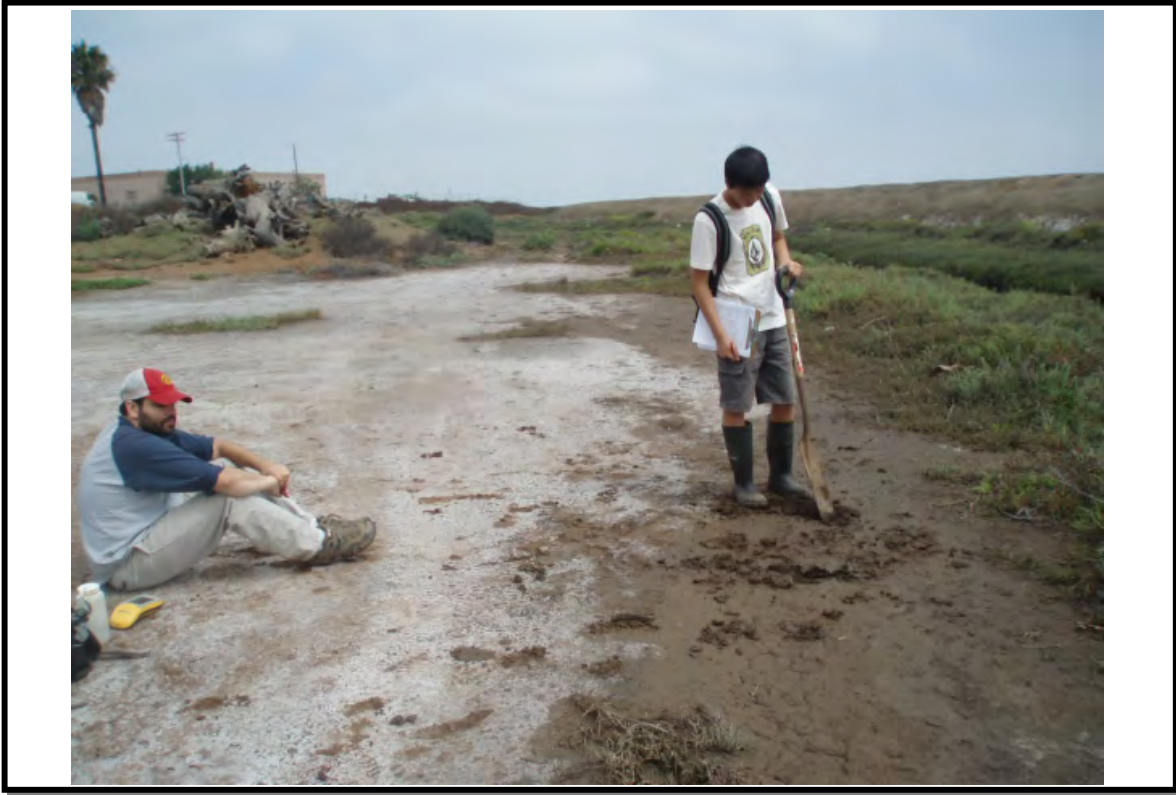
Photo Point 63. Data point 63 is located west of berm in the western portion of the study area. DP 63 is located along the inside edge of an area subject to tidal influence, southeast of DP 62. Photo is directed north and was taken July 7, 2008.

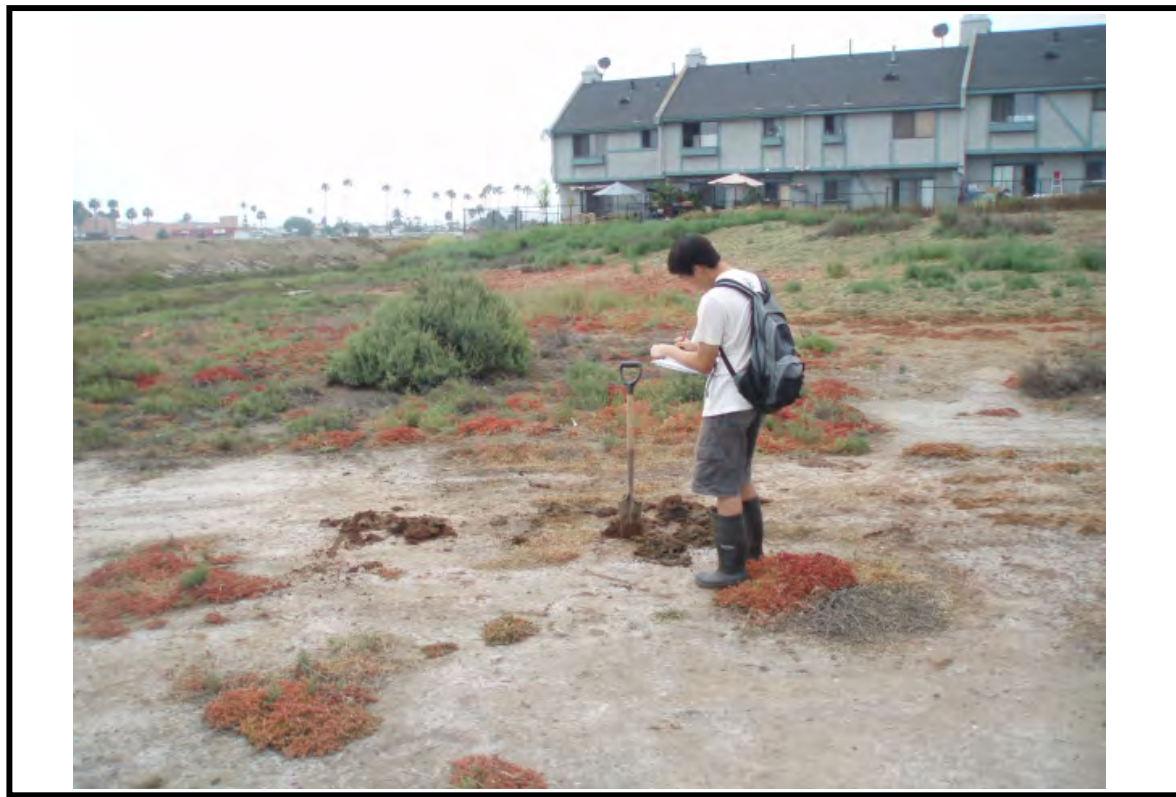
Photo Point 64. Data point 64 is located west of the berm in the western portion of the study area. DP 64 is located along the outside edge of area subject to tidal influence, west of DP 63. Photo is directed south and was taken July 7, 2008.

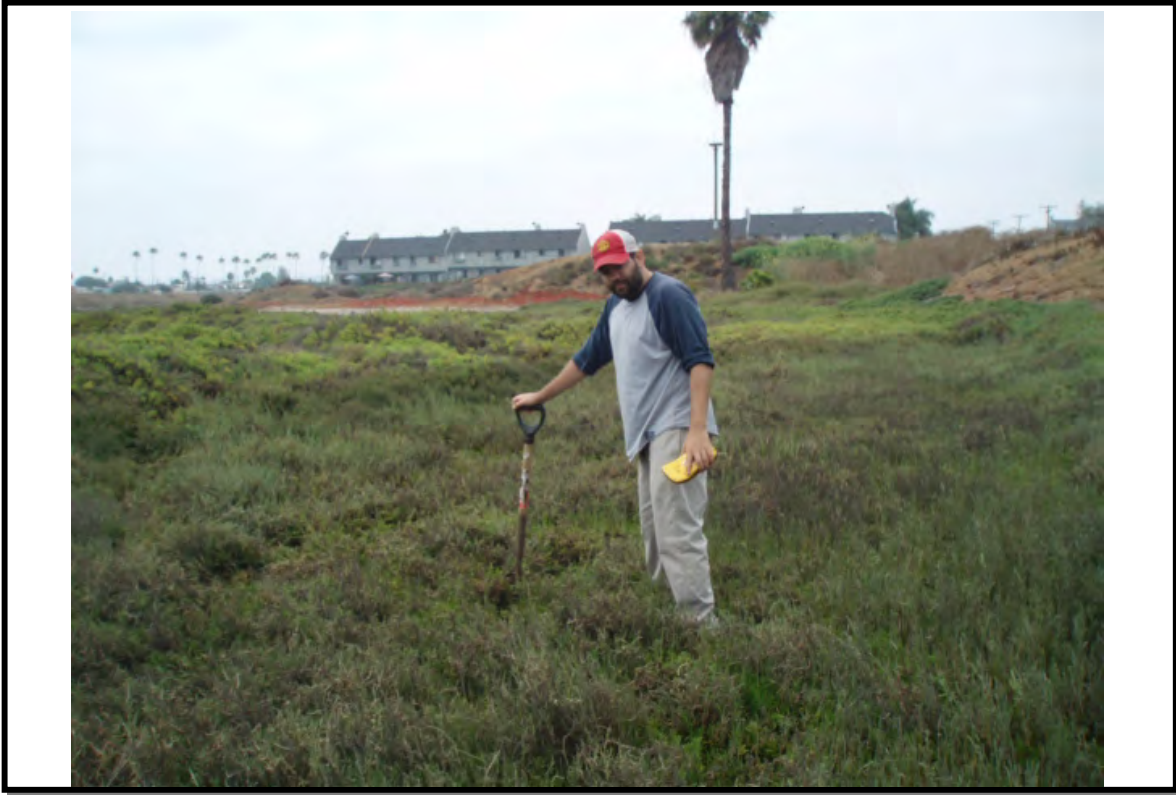
Photo Point 65. Data point 65 is located west of the berm in the northwestern portion of the study area. DP 65 is located in an area subject to tidal influence just outside of the channel, northwest of DP 64. Photo is directed south and was taken July 7, 2008.

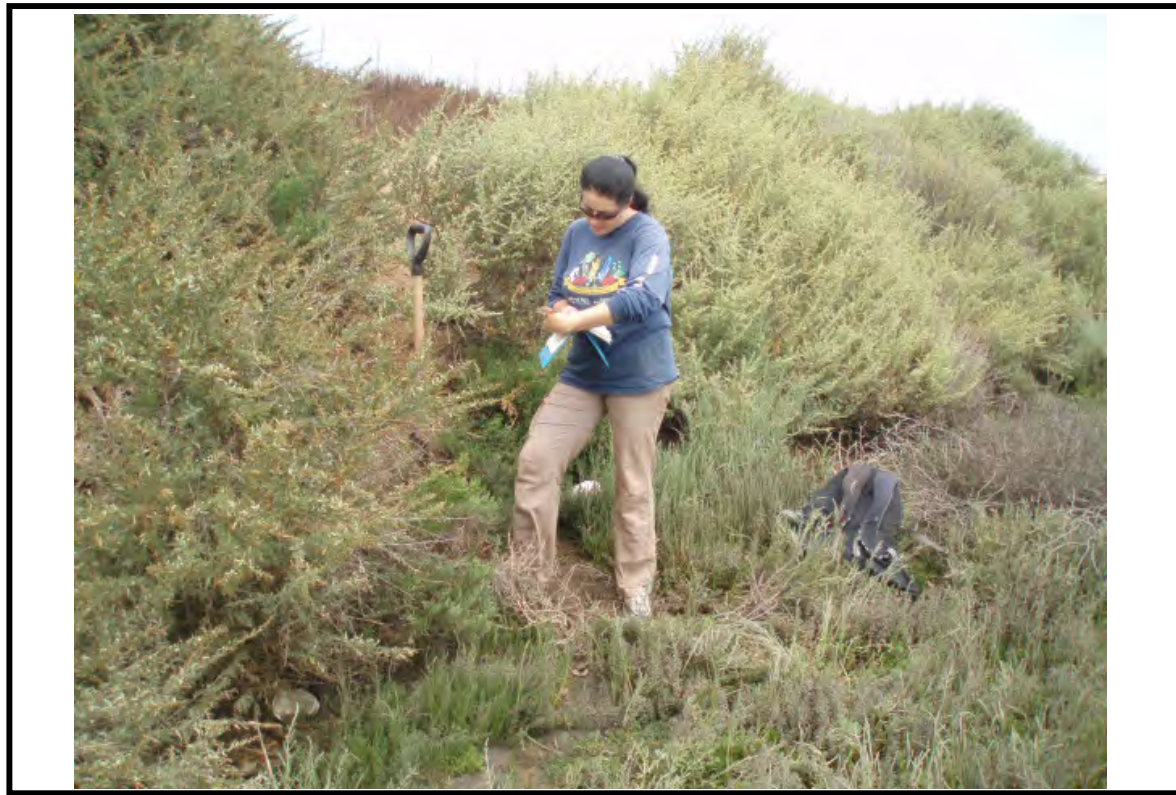
Photo Point 66. Data point 66 is located west of the berm in the northwestern portion of the study area, on a slope going up to the road. DP 66 is located west of DP 65. Photo is directed northwest and was taken July 7, 2008.

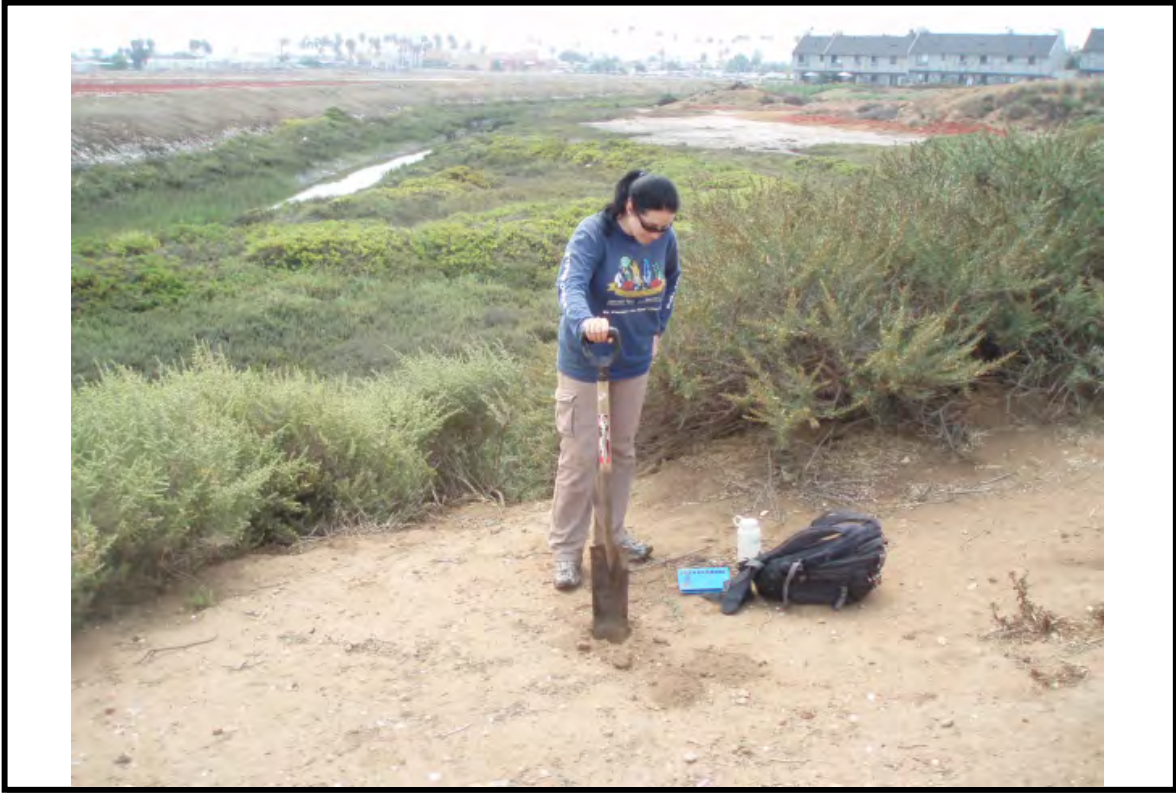
Photo Point 67. Data point 67 is located in the northwestern portion of the study area on the road overlooking the study area. DP 67 is located west of DP 66. Photo is directed southeast and was taken July 7, 2008.

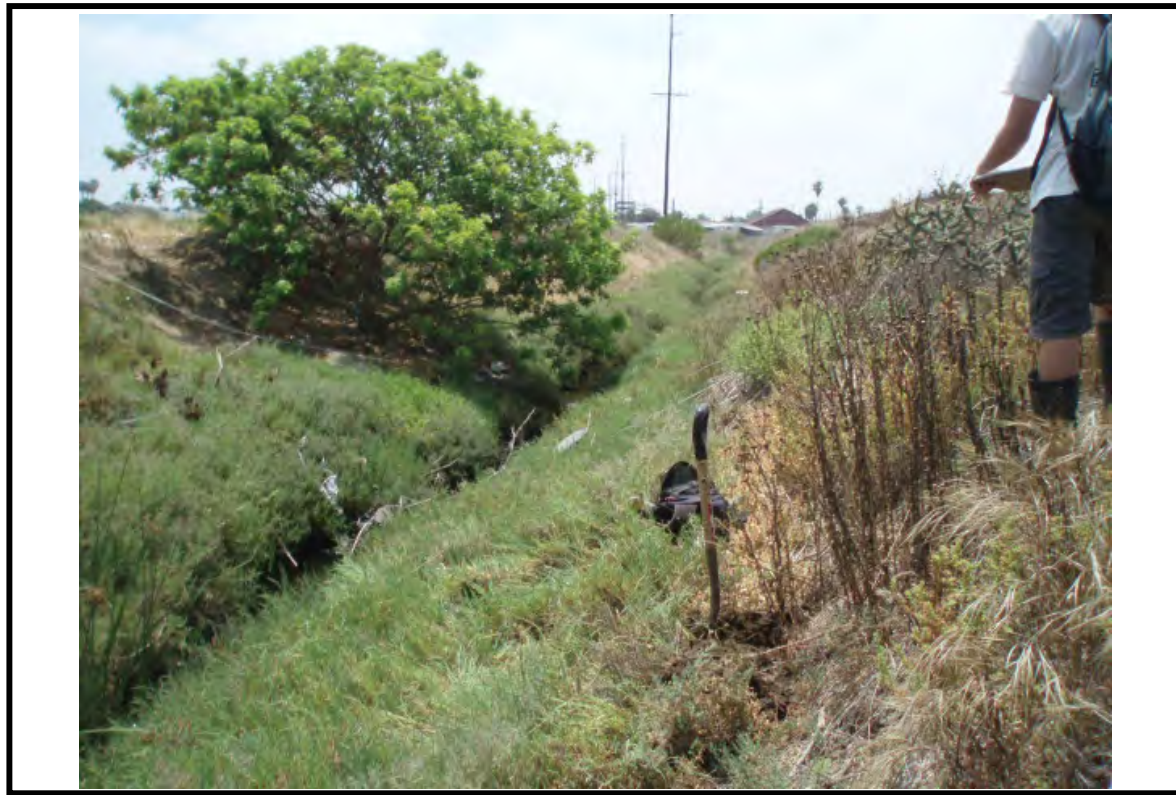
Photo Point 68. Data point 68 is located along the upper bank of the channel that defines the eastern limits of the study area. Photo is directed south and was taken July 7, 2008.

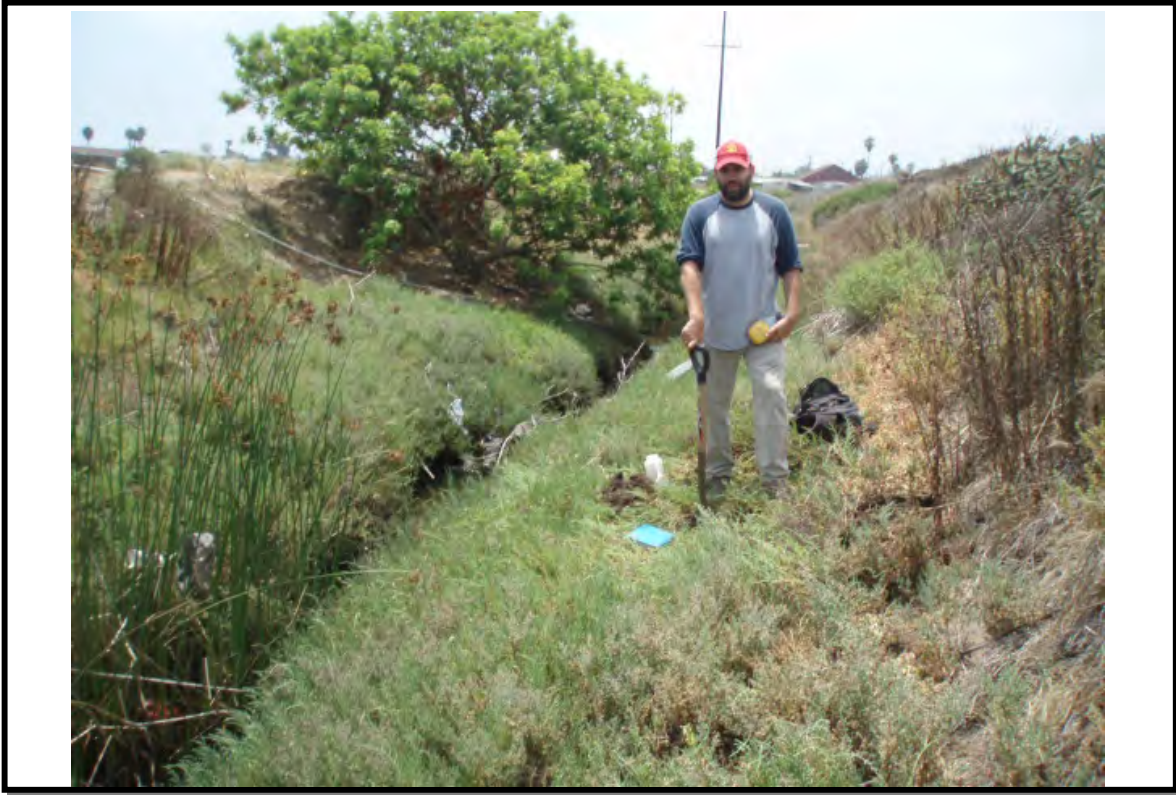
Photo Point 69. Data point 69 is located along the mid-bank of the channel that defines the eastern limits of the study area, immediately east of DP68. Photo is directed south and was taken July 7, 2008.

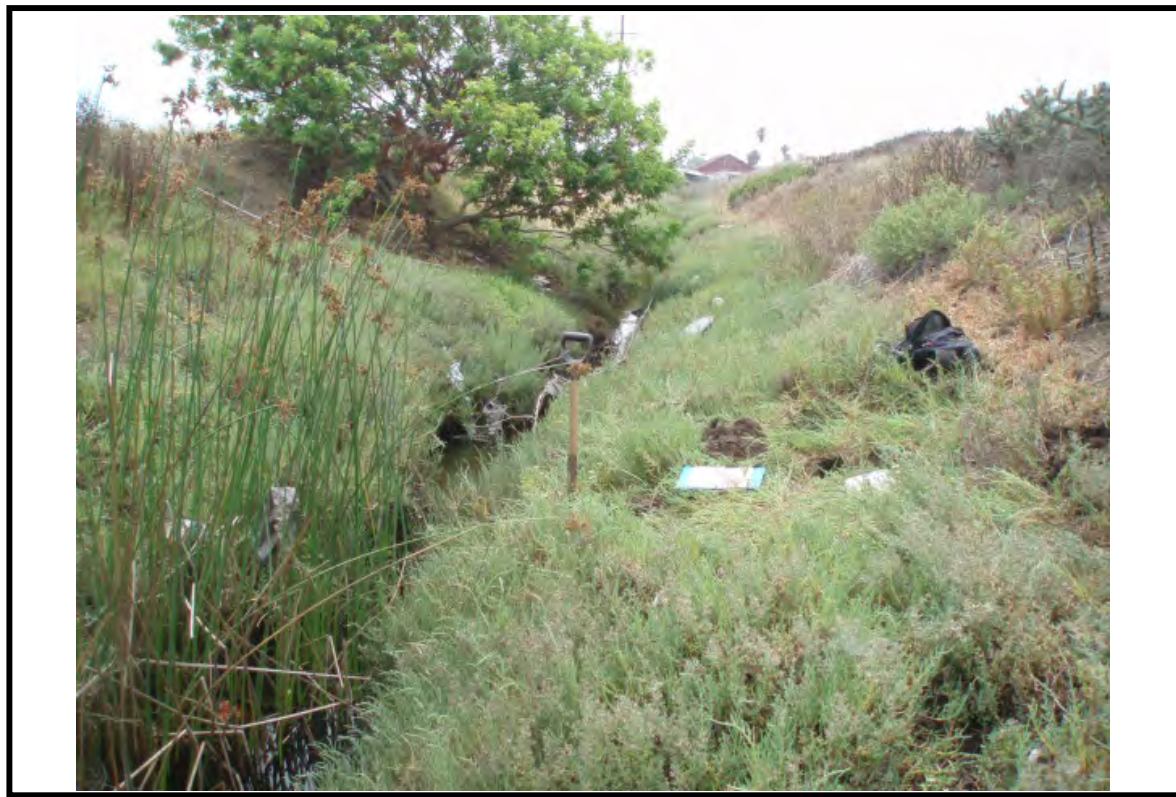
Photo Point 70. Data point 70 is located along the lower portion of the channel that defines the eastern limits of the study area, immediately east of DP69. Photo is directed south and was taken July 7, 2008.

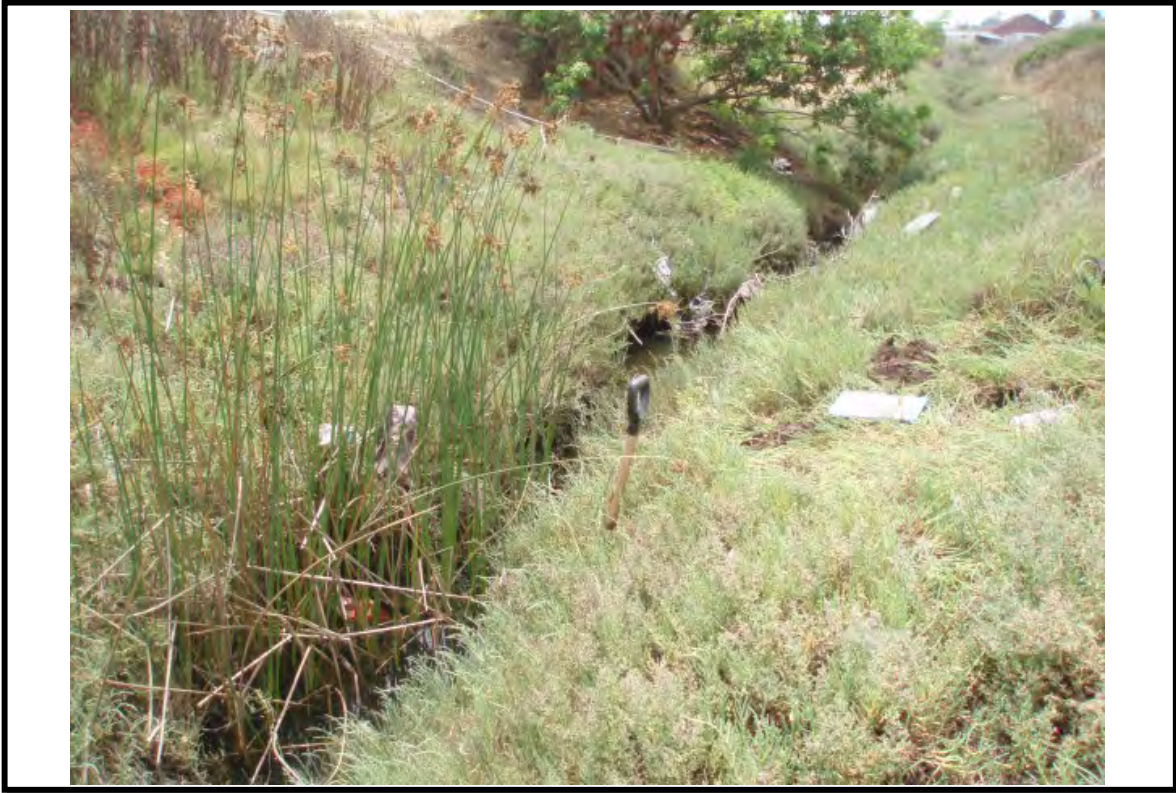
Photo Point 71. Data point 71 is located along the inside edge of the bottom of the channel that defines the eastern limits of the study area, immediately east of DP 70. Photo is directed south and was taken July 7, 2008.

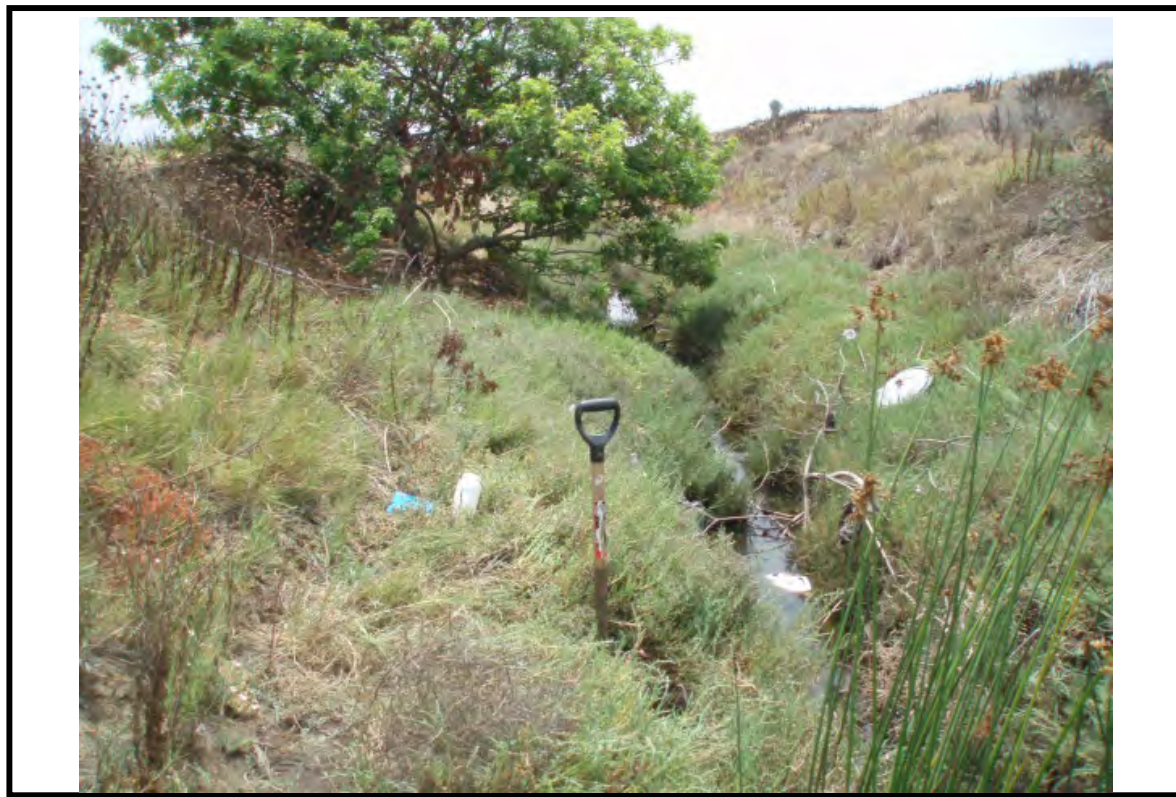
Photo Point 72. Data point 72 is located along the lower portion of the channel that defines the eastern limits of the study area, immediately east of DP 71. Photo is directed south and was taken July 7, 2008.

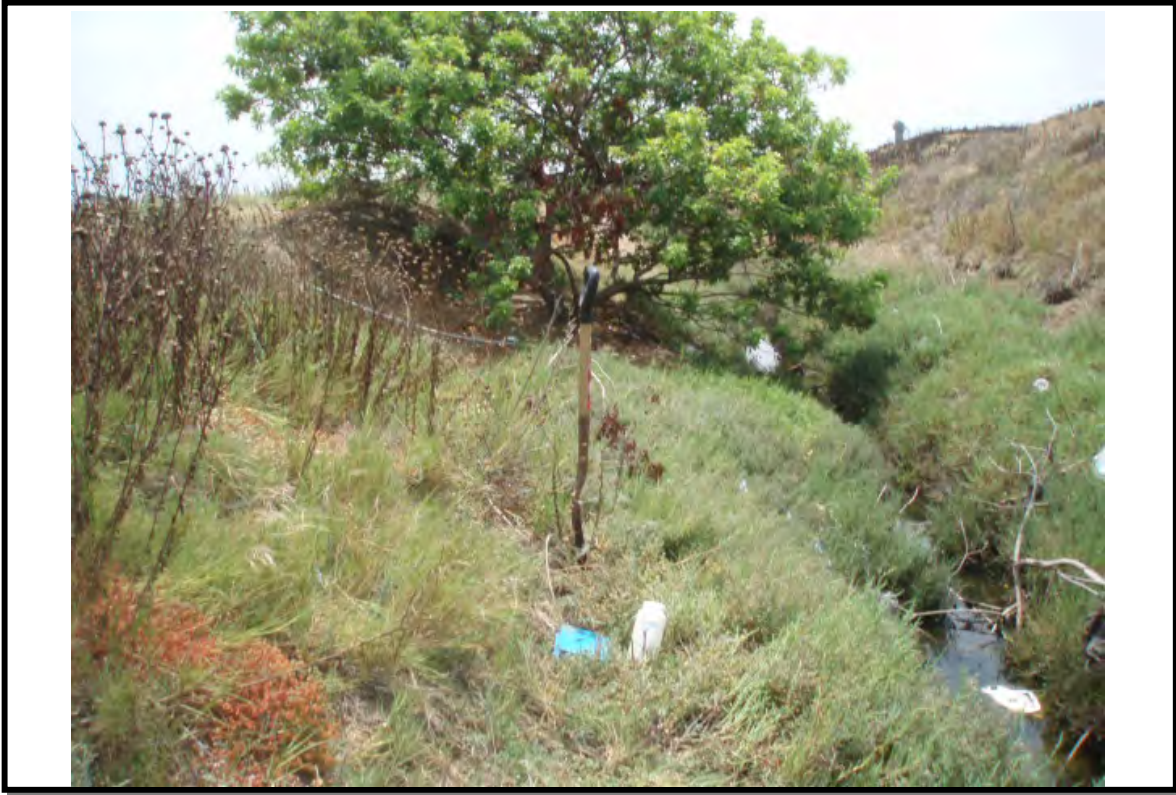
Photo Point 73. Data point 73 is located along the upper bank of the channel that defines the eastern limits of the study area, immediately east of DP 72. Photo is directed south and was taken July 7, 2008.

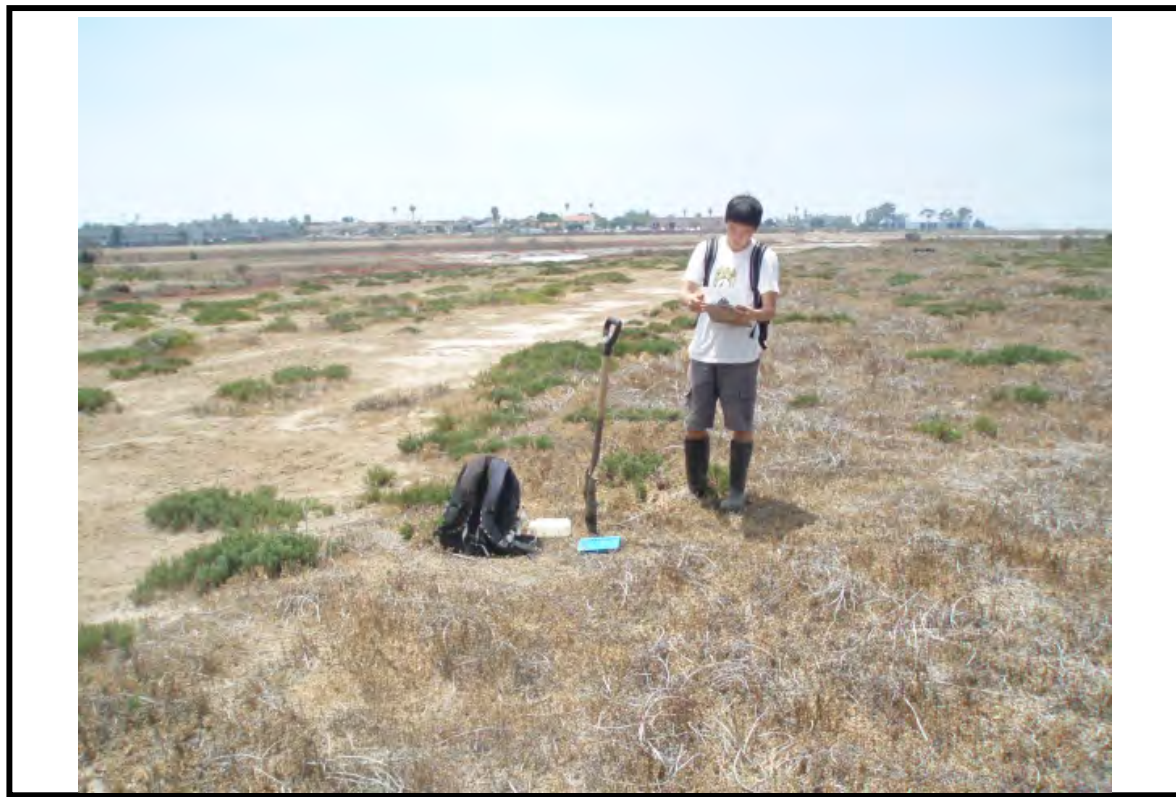
Photo Point 74. Data point 74 is located within upland area in the north-central portion of the site. Photo is directed west and was taken July 7, 2008.

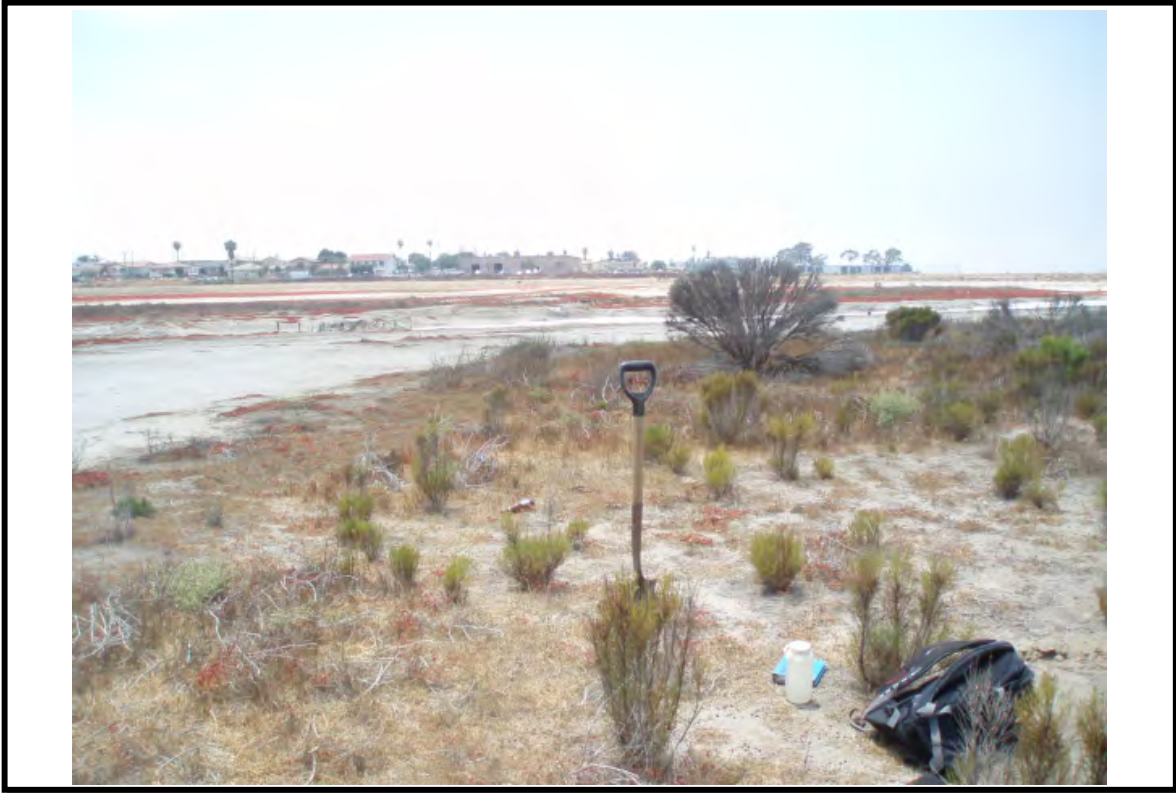
Photo Point 75. Data point 75 is located within upland area in the north-central portion of the site, northeast of DP 74. Photo is directed west and was taken July 7, 2008.

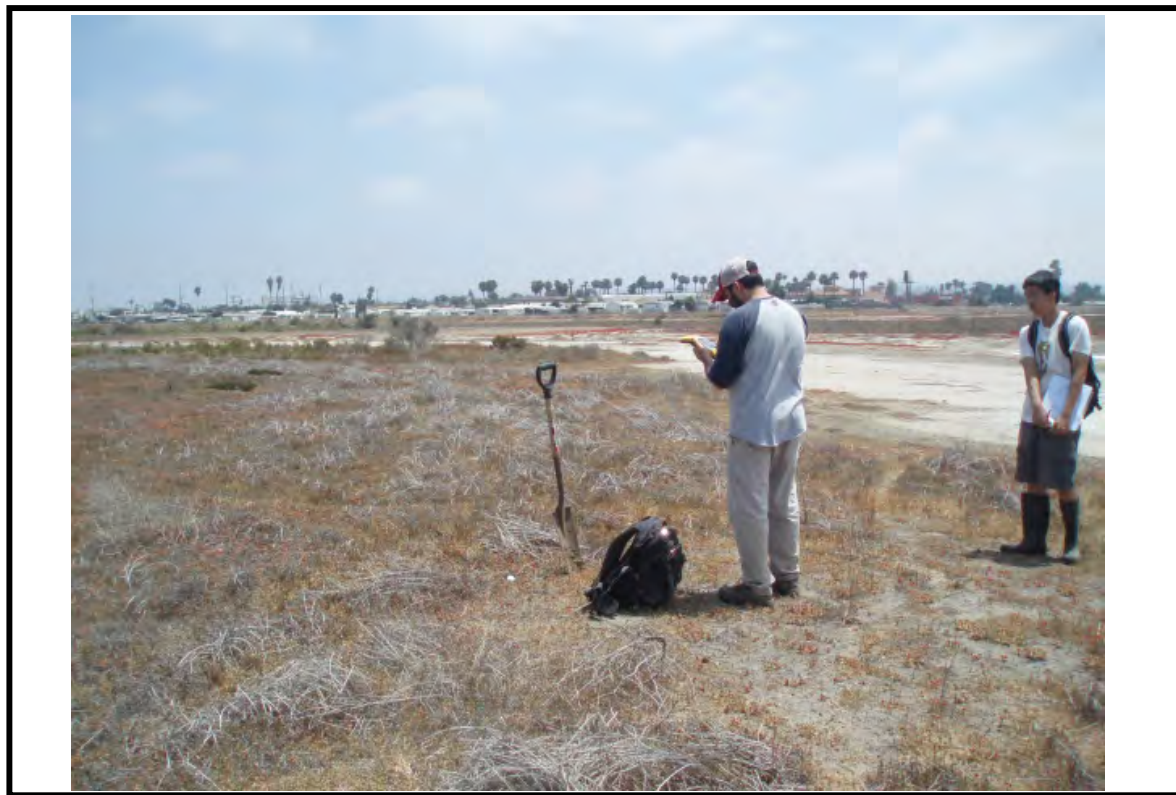
Photo Point 76. Data point 76 is located within upland area in the northwestern portion of the site, northeast of DP 75. Photo is directed southeast and was taken July 7, 2008.

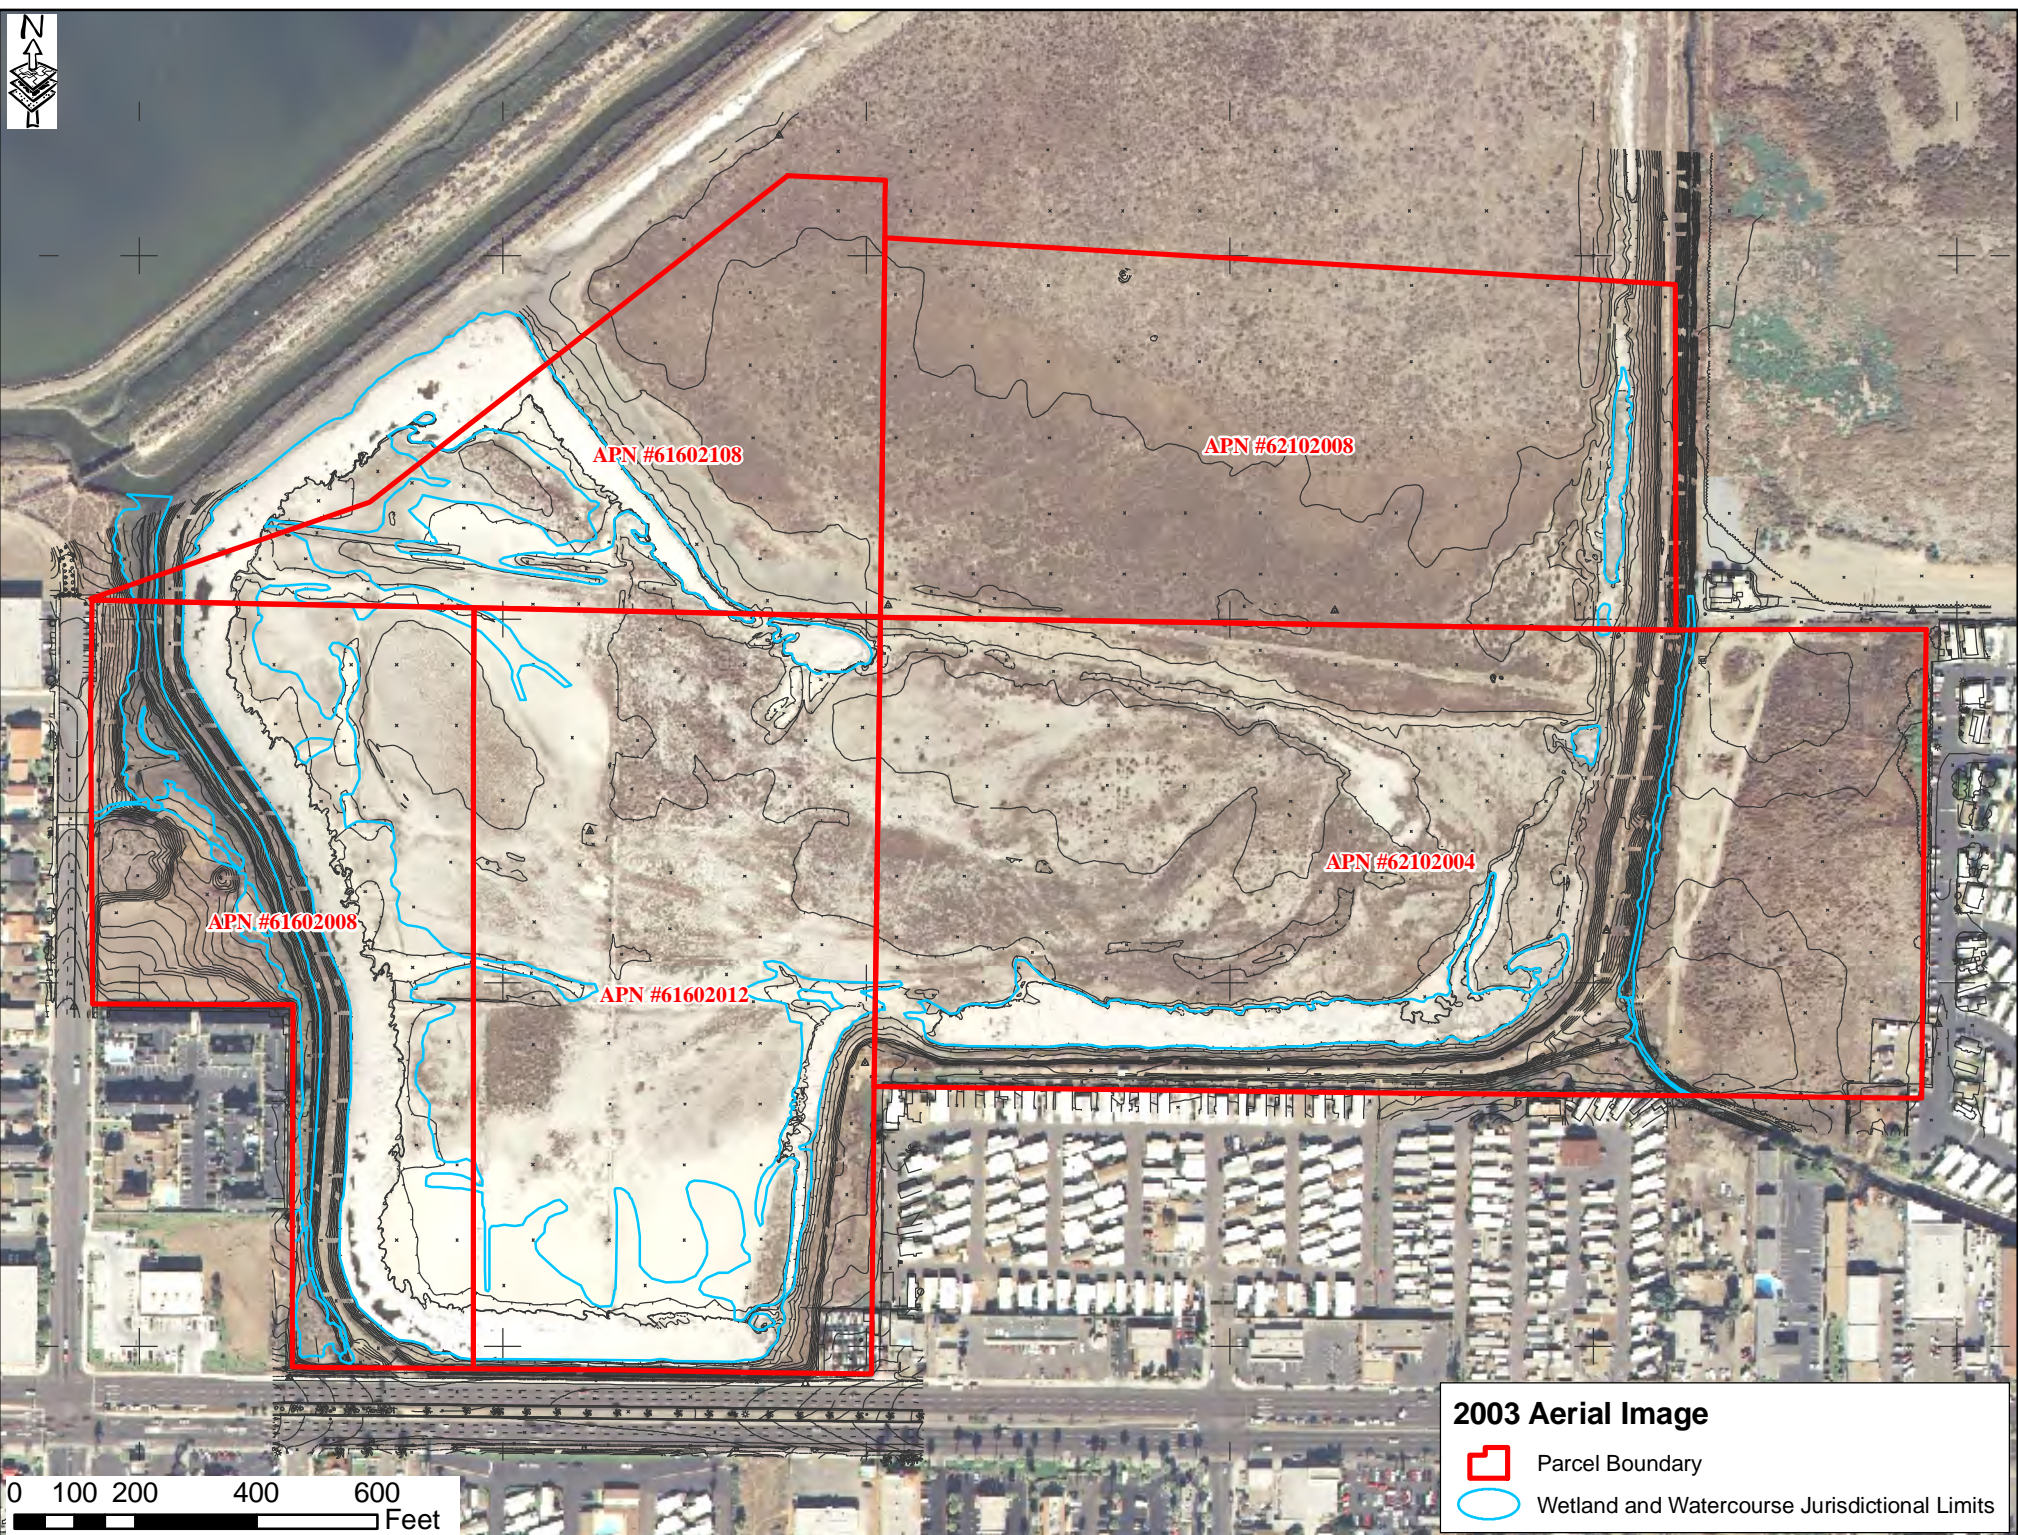
2003 Aerial Image

Wetland and Watercourse Jurisdictional Limits
