**JURISDICTIONAL WETLAND
DELINEATION REPORT
FOR WESTERN SALT POND 20
IMPERIAL BEACH, CALIFORNIA**

San Diego Unified Port District
3165 Pacific Highway
San Diego, CA 92101
Attention: Eileen Maher

Merkel & Associates, Inc.
5434 Ruffin Road
San Diego, CA 92123
Phone: (858) 560-5465
Fax: (858) 560-7779

August 18, 2008

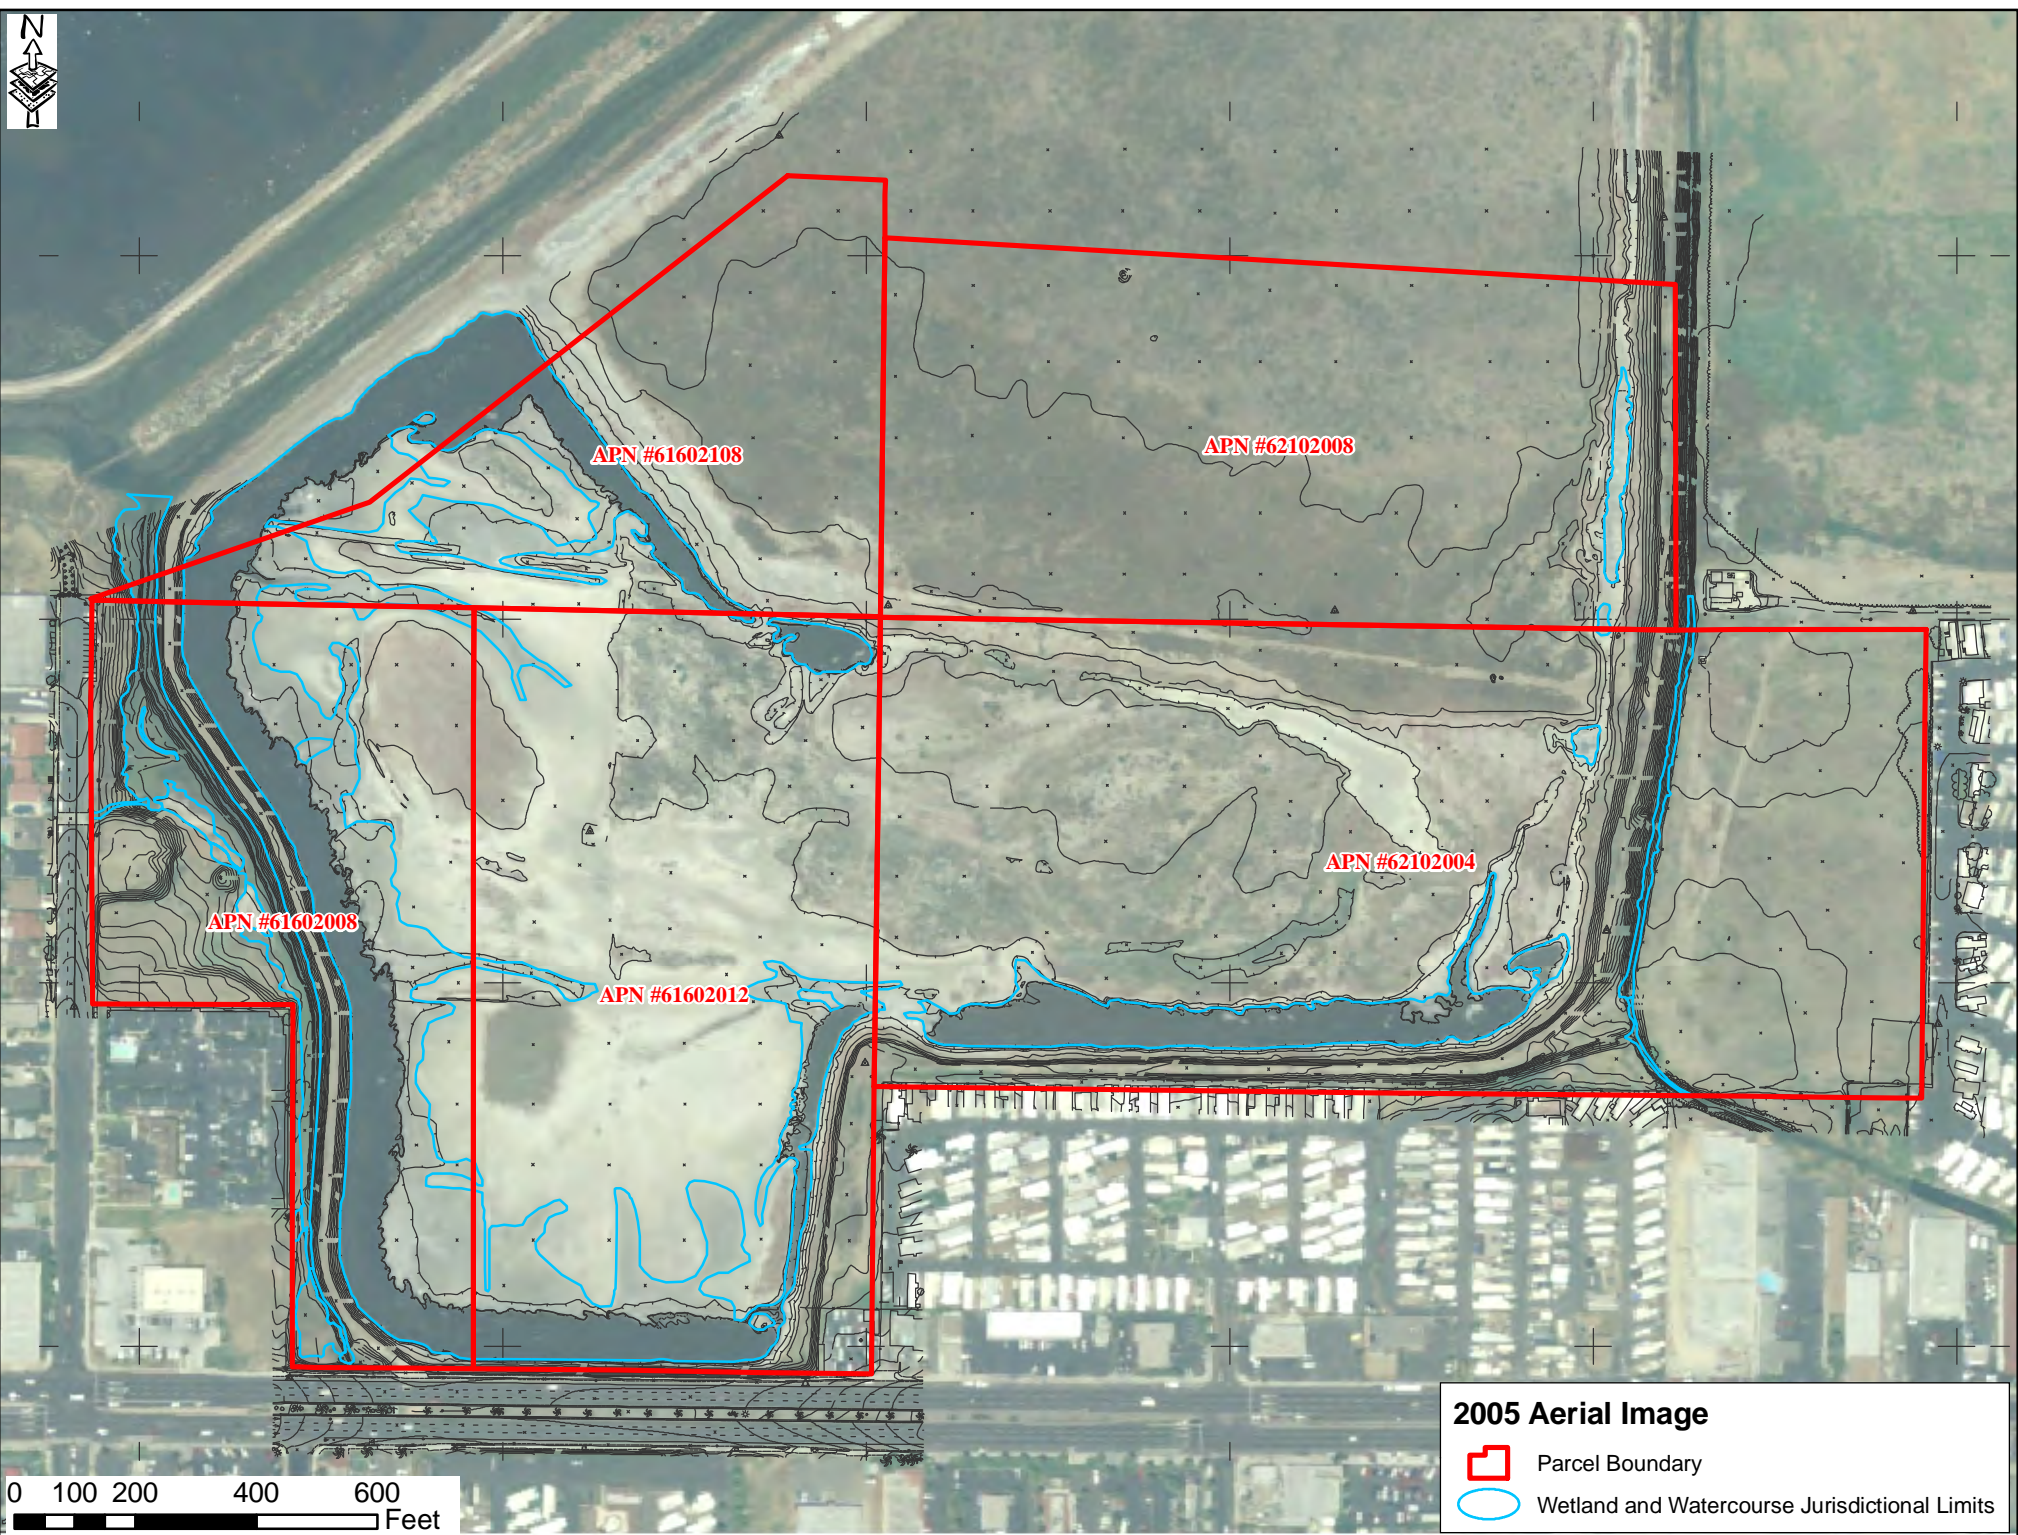
2005 Aerial Image

Wetland and Watercourse Jurisdictional Limits

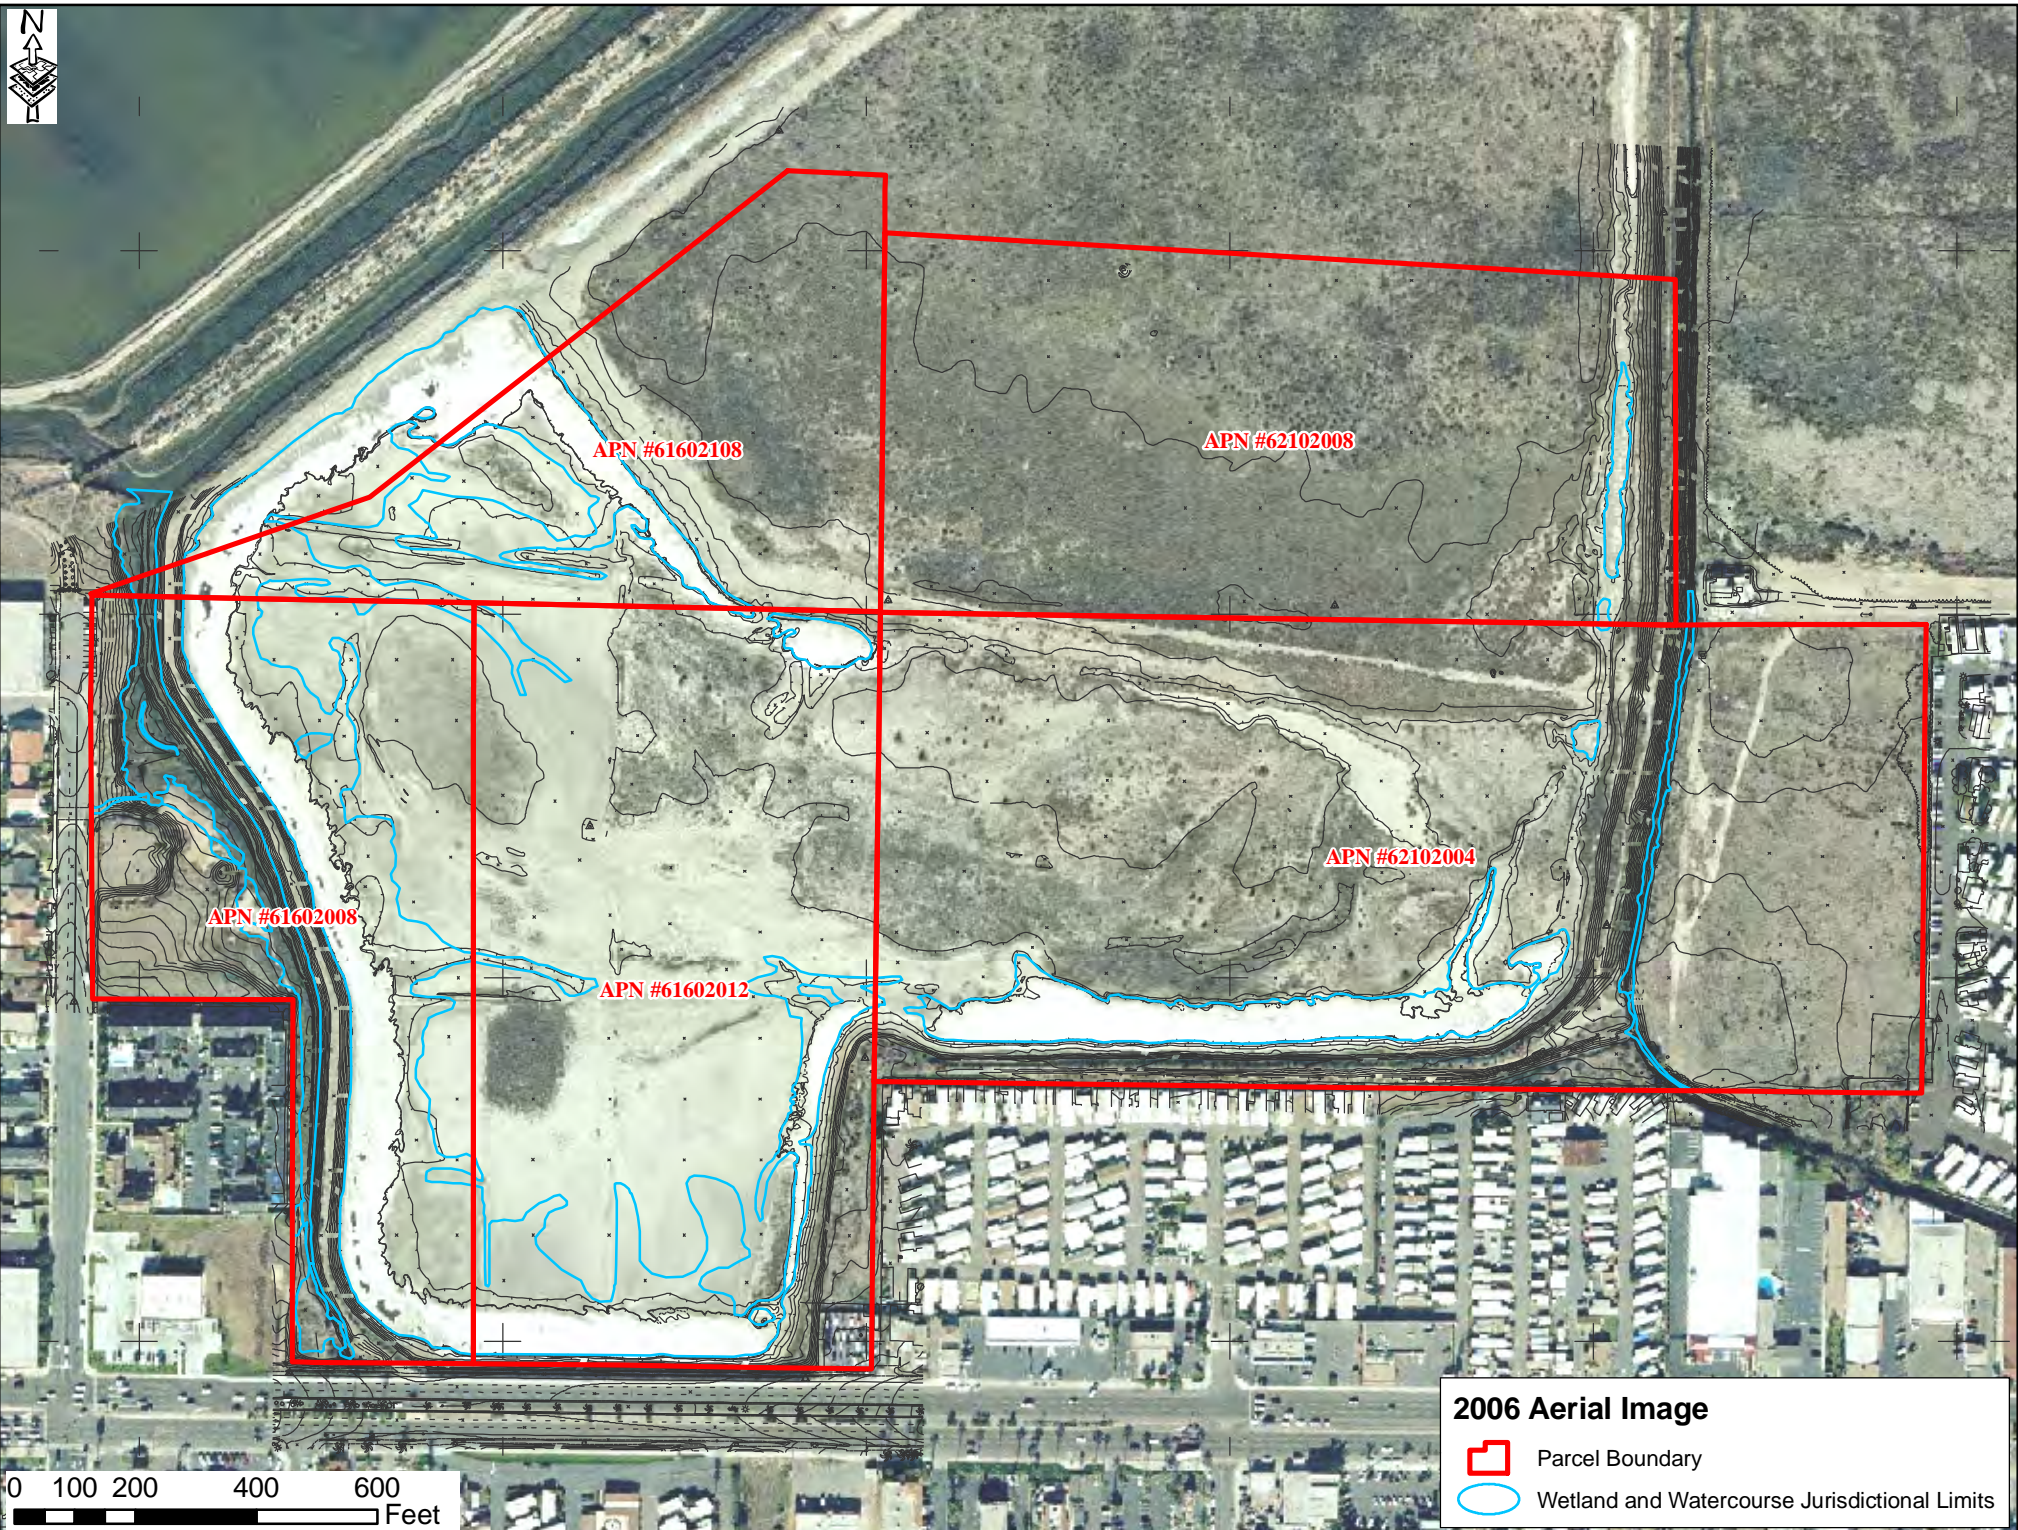
2006 Aerial Image

Wetland and Watercourse Jurisdictional Limits
