U.S. Environmental Protection Agency

Project, NP00946501-4:
**Safer Alternatives to Copper Antifouling Paints
for Marine Vessels**
FINAL REPORT

January 2011

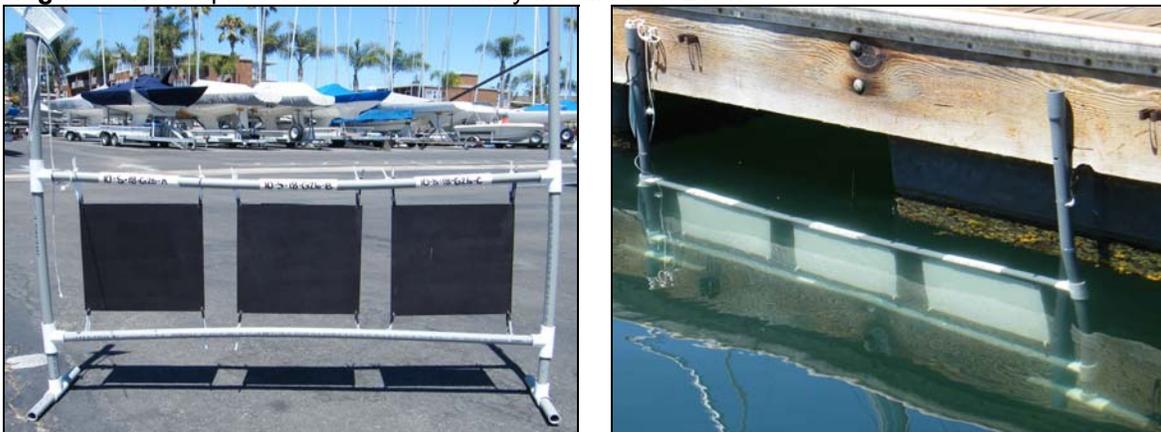
Figure 3-1. Complete Test Panel Assembly Installed On Dock

PVC frames were constructed to stabilize the panels so that a vertical position could be maintained at all times in the water. The PVC frames were modeled after test frames designed by Dr. Geoff Swain (Florida Institute of Technology, Center for Corrosion and Biofouling Control). An example of the type of frame used is shown in Figure 3-1. Each PVC frame held three fiberglass panels comprising a panel assembly. Panels were attached to the PVC frame with cable tie wraps on each corner. The PVC frames were then attached to floating docks and submerged so that the top of each panel was 12 inches under the surface of the water. PVC poles attached to the PVC frame connected the frame to the floating dock.

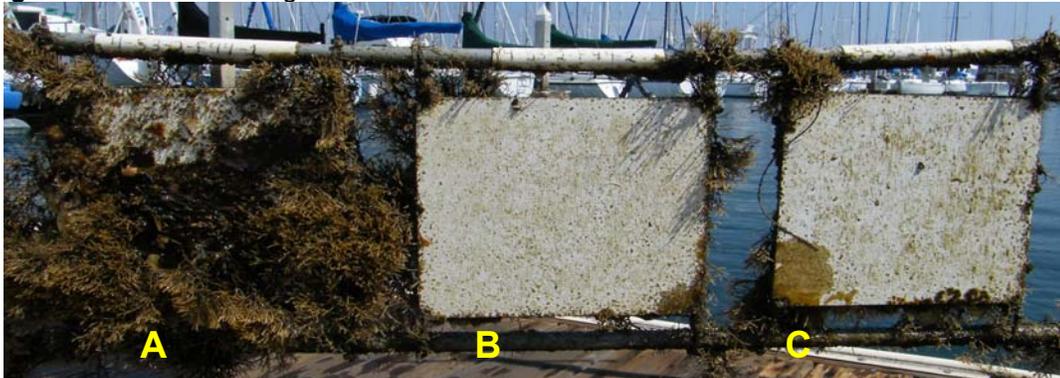
Figure 3-2. Panel Testing Series

A key element of this project was to understand the effort needed to clean the test coatings. In doing so, the Project Team could compare the effectiveness of alternative coatings (in terms of cleaning and cleaning costs) to commonly used copper paints. To accomplish this, the project team investigated the effect of different cleaning regimes, as shown in Figure 3-2. One panel (Panel A) was not cleaned for the entire four month period it was submerged. One panel (Panel B) from each test coatings three-panel series was intended to mimic standard hull cleaning practices¹. It was cleaned using a three-week frequency and a soft, medium to long shag carpet (CPDA BMP Manual, 2008). A third panel (Panel C) was cleaned according to the coating manufacturer's specifications. This regime was included to evaluate whether the supplier cleaning recommendations were effective for their test coatings. The cleaning methods and frequencies used on this panel varied for each of the paints according to the specific suppliers' recommendations.

* A = No Clean Panel; B = Standard Cleaning Panel; C = Manufacturer's Recommended Cleaning Panel

As previously stated, each set of three panels within a PVC "frame" for each test coating were assessed. Only one PVC frame was lifted out of the water and placed on the dock for cleaning at a time. The frame maintained a vertical position during cleaning and assessment by placing feet on the base. While one member of the Project Team actively cleaned a panel, another team member wetted the panel with seawater by using a 12- volt low flow submersible pump immersed adjacent to the dock. Prior to cleaning the panels, the project team received training on proper cleaning procedures and assessment techniques to ensure consistency in reporting results. The Project Team also performed all of the cleaning during this study to ensure consistency.

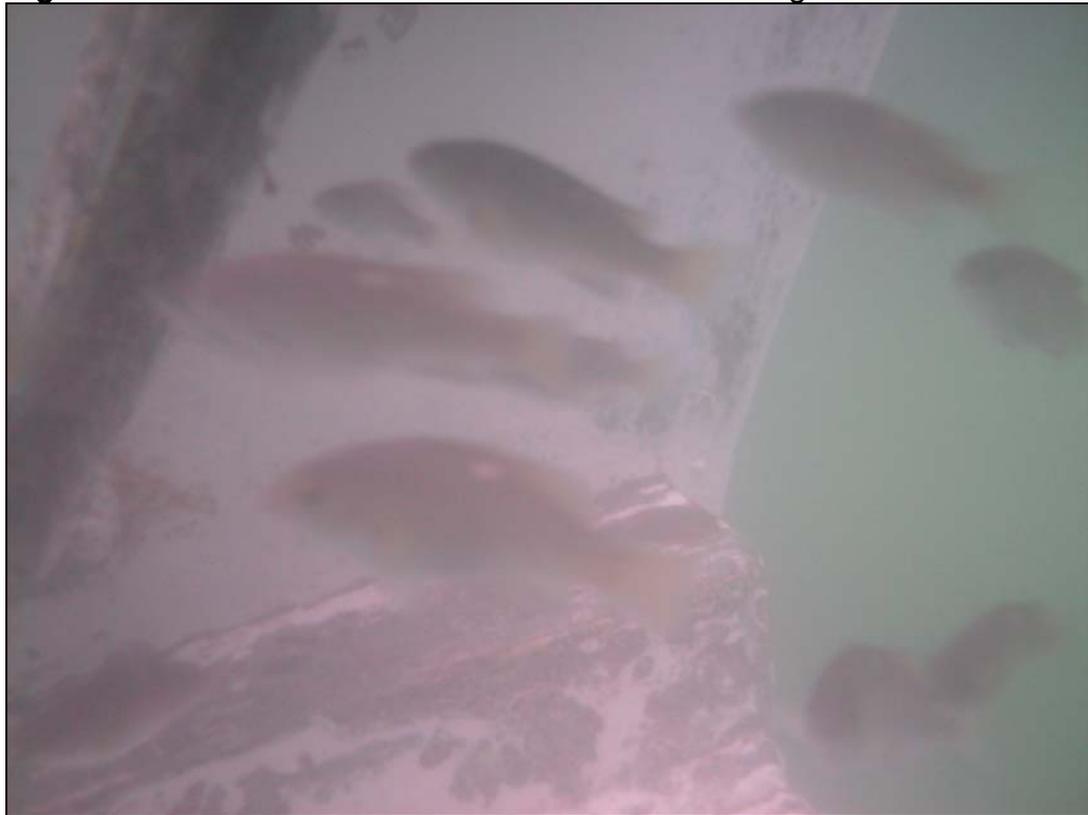
Figure 6-2. Surf Perch near Intersleek 900 Test Coating

A unique situation arose with Intersleek 900 during the study. Small imprints were observed on the bottom of both boats (Quadrants I-IV). Upon closer examination the Project Team concluded the imprints were caused by fish, such as surfperch. In fact, during one inspection of the 30'sail boat, the hull cleaner observed surfperch actively nipping at the boat hull (Figure 6-2). At the conclusion of the study, there did not appear to be any structural side effects of the feeding of the surfperch. There is concern that this feeding behavior may potentially lead to coating damage, and the potential effect on long term performance is unknown.
