Appendix D
Boat Hull Testing Protocol

“Safer Alternatives to Copper Antifouling Paints” Standard Operating Procedures For Field Efforts Associated with Hull Testing

June 1, 2009

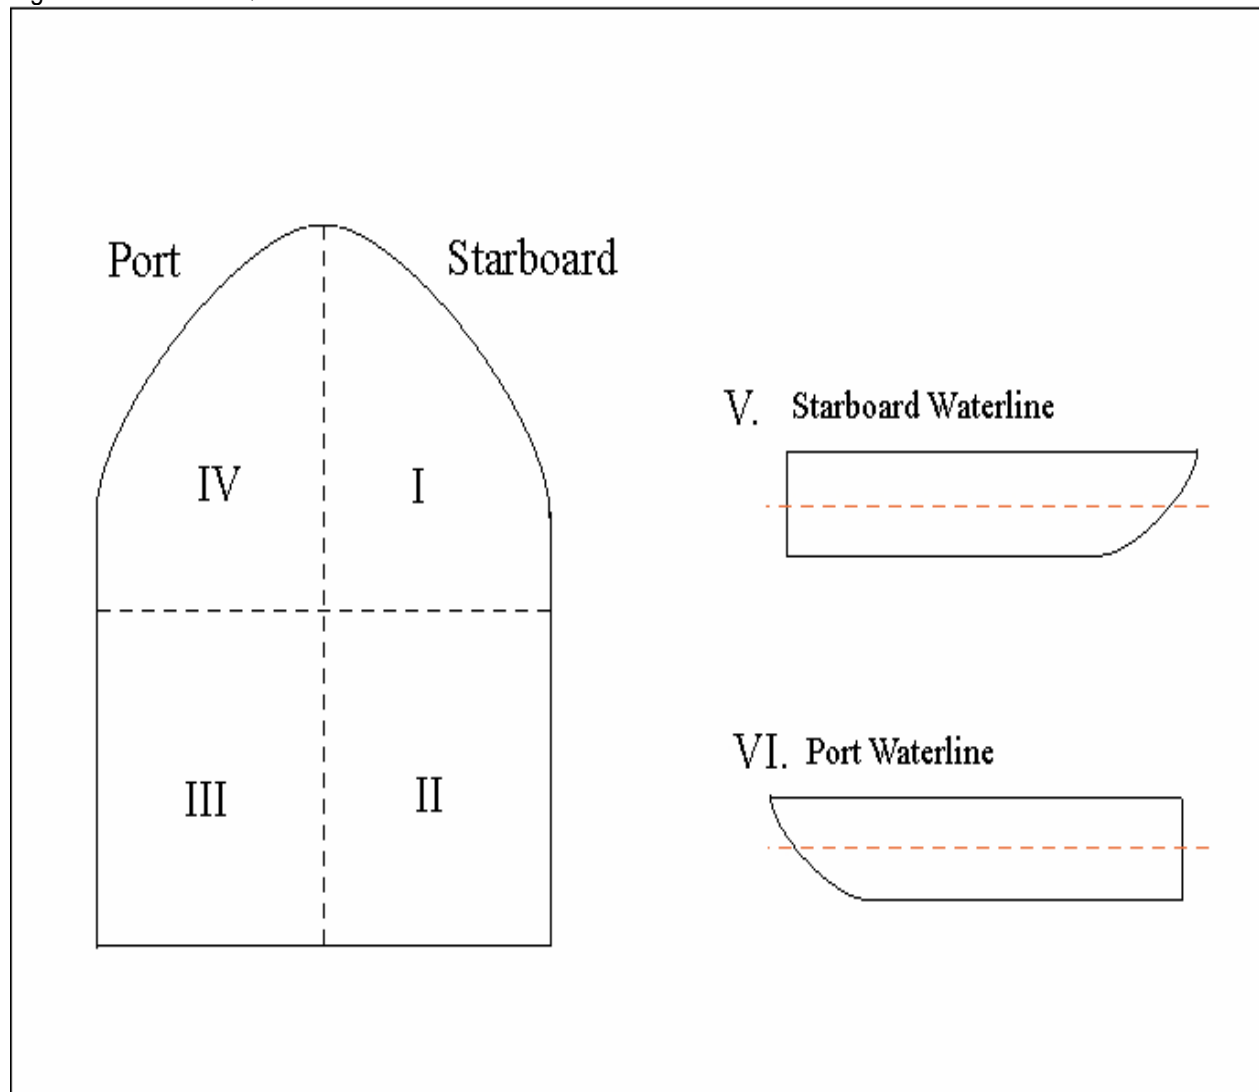
Figure 1 – Boat Hull Quadrants

The hull cleaner will evaluate the boat hull in six quadrants (Figure 1). This will account for the potential variation in fouling growth due to position or location on the boat hull. The six quadrants are: I - starboard forward, II - starboard aft, III - port aft, IV - port forward, V - starboard waterline, and VI - port waterline. The bottom of the boat will be assessed using the first four quadrants. The last two quadrants will be from the waterline to the first chine below the waterline, from bow to stern, including the transom.

Inspection of the boat hull will begin by assessing the condition of the coating in Quadrant 1, followed by evaluating Quadrants 2 through 6, in similar fashion to the fouling evaluation. The hull cleaner will record a single coating condition rating for the entire boat on the diver field form and will provide additional observations or comments, such as noting the location or type of damage observed on the boat hull, if any is observed.
