2011 San Diego Bay Eelgrass Inventory

*U.S. Navy Region Southwest
Naval Facilities Engineering Command*

Merkel & Associates, Inc.

**2011 SAN DIEGO BAY
EELGRASS INVENTORY UPDATE**
Merkel & Associates, Inc.
December 2011

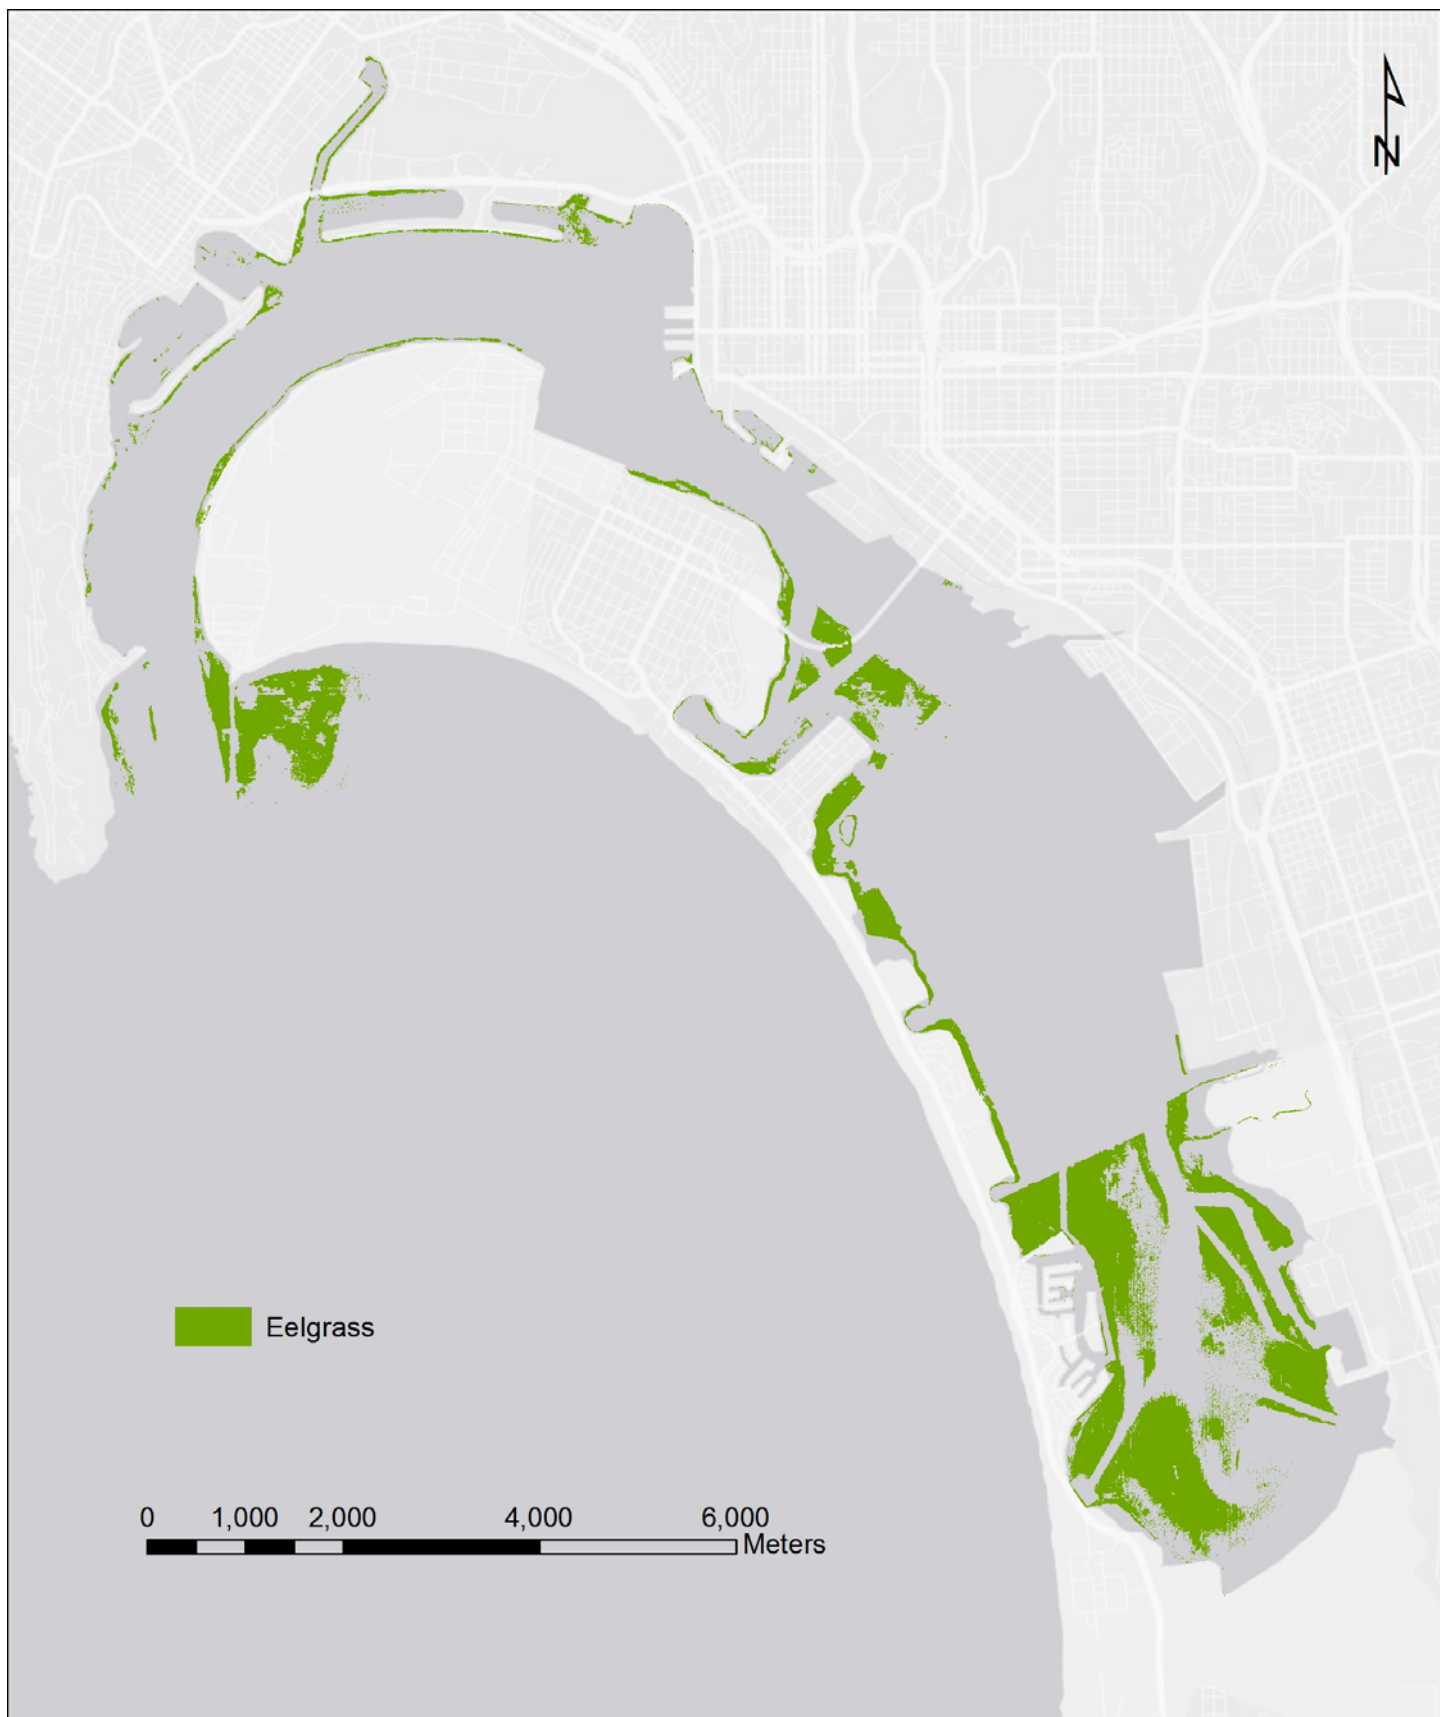
Figure 2. Eelgrass spatial distribution for San Diego Bay 2011 baywide survey

The 2011 eelgrass distribution within San Diego Bay extended over a total bottom area of 1,830.4 acres (Figure 2). The distribution of eelgrass follows the general patterns of distribution noted in prior surveys. The greatest extent of eelgrass is found within the shallow southern ecoregion of the Bay with more extensive eelgrass also being found on the shallower fringes of the western Bay shorelines where more gradual soft shorelines are more prominent (Figure 1). Other smaller beds are scattered throughout the more developed regions of the Bay where shallows allow for adequate light levels to support eelgrass habitat. Fairly extensive eelgrass beds also exist at the mouth of San Diego Bay within the shallows outside of Ballast Point and along Zuniga Jetty on North Island.
